## 2.11 Post-event analysis of industrial structures behavior during L'Aquila earthquake

B. Faggiano<sup>1</sup>, I. Iervolino<sup>1</sup>, G. Magliulo<sup>1</sup>, G. Manfredi<sup>1</sup>, I. Vanzi<sup>2</sup> ■

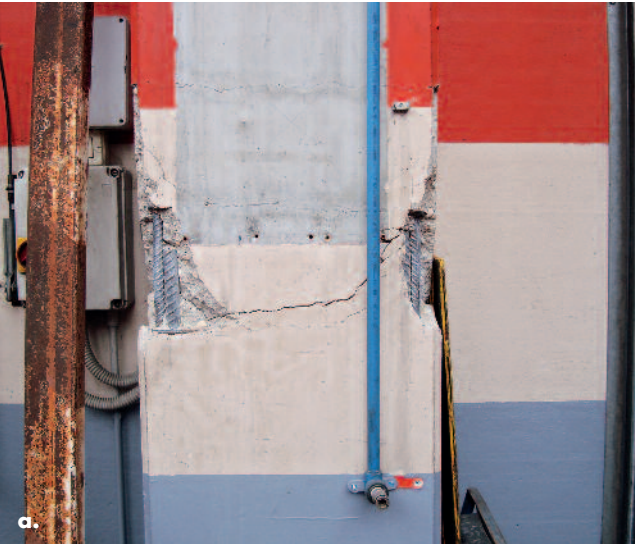
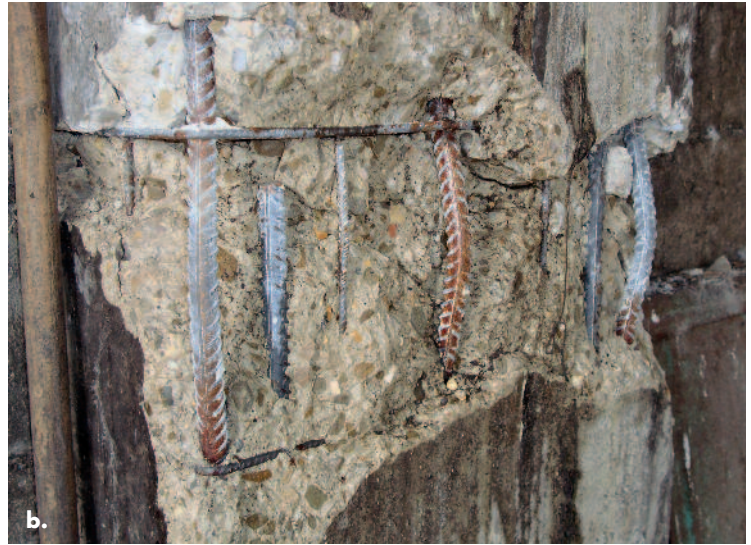
The response of the structural elements of the industrial buildings to the April the 6<sup>th</sup> 2009 earthquake was generally in accordance with their design level: no column collapsed, even though, in many cases a plastic hinge was observed, due to the high intensity of the seismic action (Fig. 1). In some cases such plastic hinge was not observed at the column base, i.e. at the column-foundation joint, but even one meter above, where the longitudinal reinforcement decreases. Furthermore no plastic hinge was observed in beams or tiles due to the increment of the vertical action. However, the damage of the precast industrial buildings should be well analysed; indeed, it was characterised by collapse of parts of the buildings, which, if the main-shock had happened during the working time instead of at 3 a.m., it would have caused victims. The static scheme of such structures is characterised by large deformability; consequently, the most of the observed damages of structural elements (made by reinforced concrete) depend on the relative displacements between the elements. Indeed, many cases of pounding between elements of the same structure were observed. Furthermore, pounding between adjacent buildings was frequent, in the case of both precast and cast in situ structures, due to the insufficiency of separation joints. In figure 2, taken by Giordano et al. (2009), the pounding between the tiles and the beam of an industrial precast building placed at Bazzano is shown.

Fig. 1  
Plastic hinge in columns of industrial buildings: (a) FIAT garage at Pile; (b) building used for bovine-breeding at Fossa.

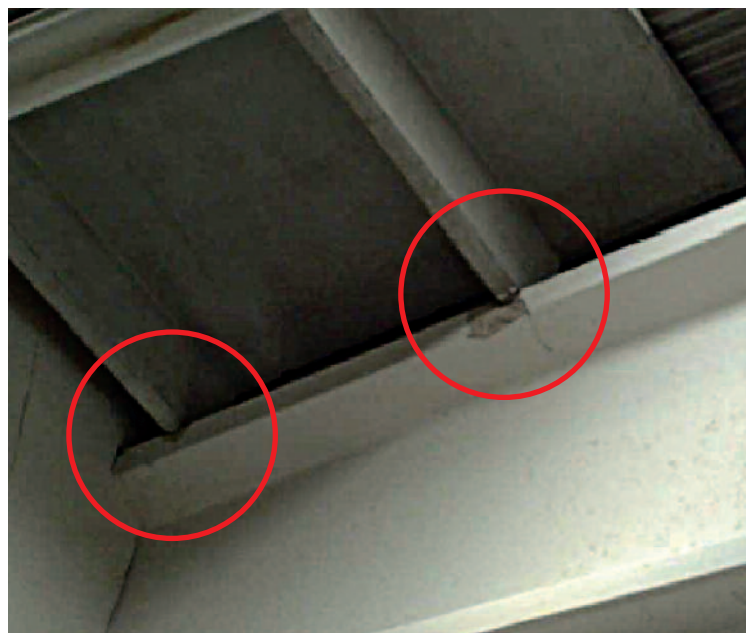
Fig. 2  
Effects of pounding between the cover tiles and the beam (Giordano et al. 2009).

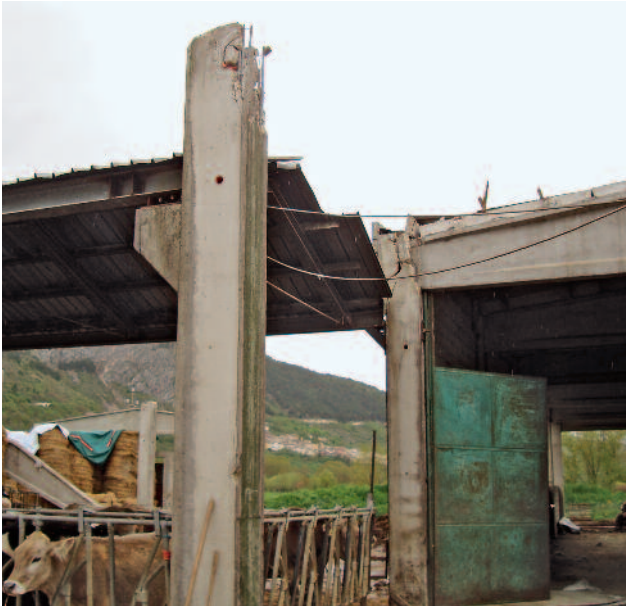
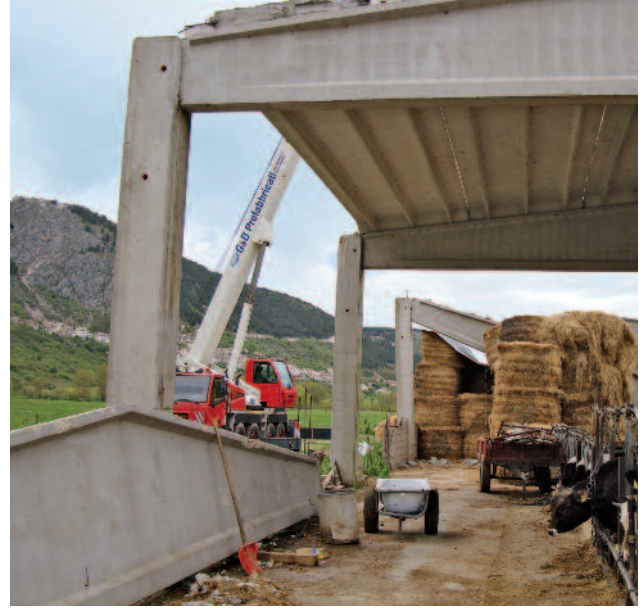
Confirming the numerical studies (Magliulo et al., 2008; Capozzi et al., 2009) performed in the last years, the connections represented the weak parts in terms of seismic performance of both old and new precast buildings. Some buildings have shown damages at the beam-column connection: the only observed case of precast beams collapse was due to the damage of such connection and to the following support loss. Indeed, as shown by numerical analyses (Capozzi et al., 2009), the splitting of the joint bar cover happened where the thickness was minimum. In other frames of the same structure, it is also possible to observe the collapse of the beam due to support loss at the side without joint bar, caused by too large displacements, and the pounding between the beam and the column top

fork (Fig. 3).

Fig. 3  
Collapse of beams due to loss support of a building at Fossa used for bovine breeding.

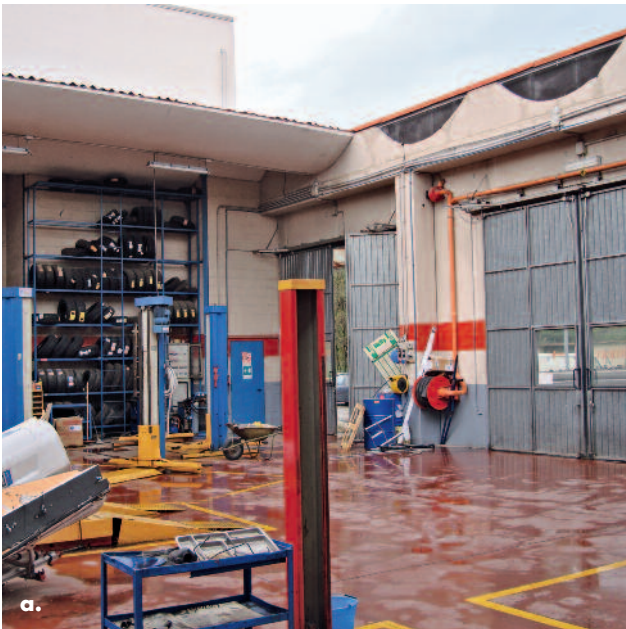
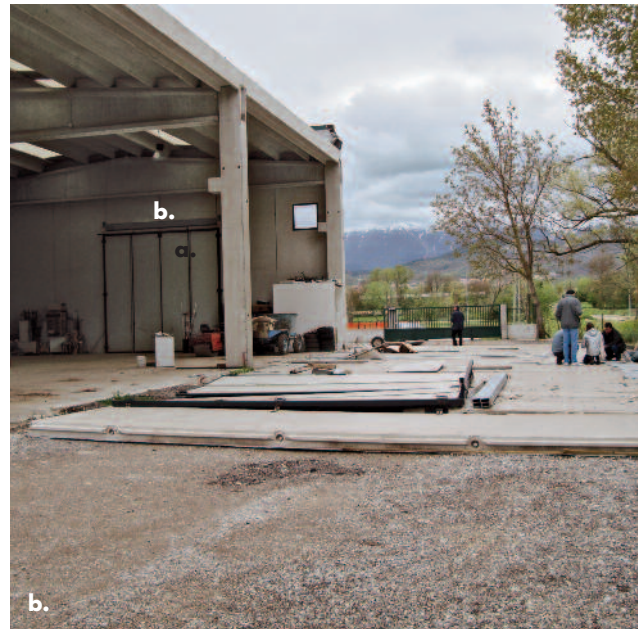
The phenomenon of the joint bar cover splitting can be also noted at the intermediate level of some two-storey precast buildings, where, as already written, the beam-column joint is on corbel. The same phenomenon has also characterised the collapse of some tiles. In this case, indeed, even where the joint had been fastened by a steel bar, the little thickness of the bar cover of the beam, also characterised by the lack of stirrups, collapsed, causing the tile support loss (Fig. 4a). Obviously, such support loss easily happened where the tile-beam connection was not fixed and/or there was no connection between tiles; particularly unlucky situations were characterised by buildings in phase of assembly, where the floor slab, joining the tiles, was not made yet.

Fig. 4  
(a) Tiles collapse due to cover splitting and support loss of a FIAT garage at Pile. (b) Collapse of perimeter panels due to the breaking of the angle stirrup or to the bolt head going out from the profile in a building used as material and machine deposit at Bazzano.

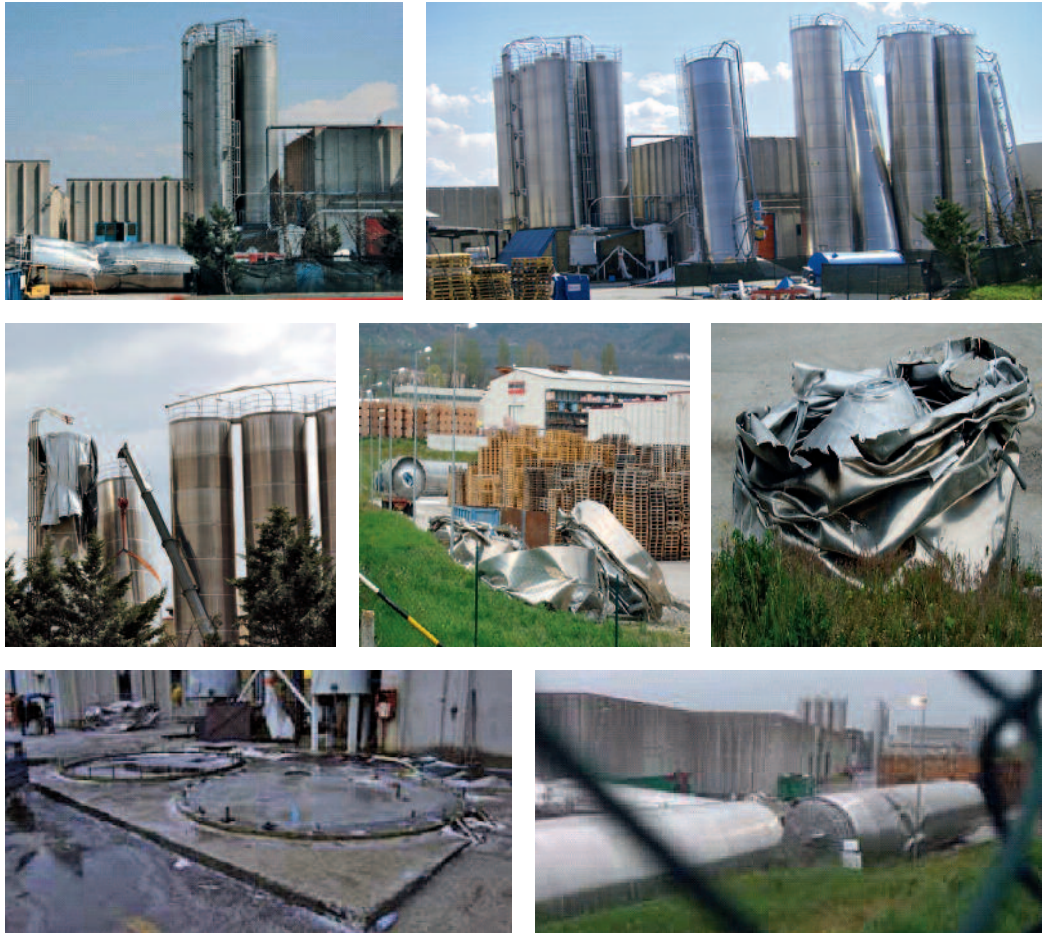
The sili of the Vibac multinational (a chemical company which produces plastic films), located in Bazzano, close to Onna (Fig. 6) represent an exceptional case of damage to steel constructions. They also represent an emblematic case of damage induced by the earthquake of April 6<sup>th</sup>. The sili are used for the storage of polypropylene pearls and they were full when earthquake struck (EERI, 2009). Some sili collapsed, some other remained standing even though strongly deformed, both locally at some rings and diffusely (Fig. 7).

A more close visual inspection indicated that the collapses occurred for overturning due to the crushing of the base rings and the hopper. Moreover, along the sili height, deformations induced by buckling phenomena of the wall panels are apparent. In some cases an effect of pounding on the adjacent precast reinforced concrete constructions took place, the latter have achieved the partial failure of the curtain walls, which have induced strong deformations of the shells of the sili. Such type of damages are a clear effect of the earthquake vertical component, whose importance they highlighted (Fig. 7).

sion in the sili walls, causing buckling, the contemporary seismic action in all the components accentuated the effect of possible asymmetrical distributions of pressure, due either to structural eccentricities, or to the silos filling method, or to the anisotropy of the silage material, causing a reduction of the stabilizing effect of the radial pressures themselves. Furthermore, buckling

could also occur due to constructional imperfections at the joints between the coating ring bands of the silos, where joints in any case represent a discontinuity in the flow of longitudinal stress in compression, with high concentrated stress. The above mentioned considerations fully justify the collapse behaviour observed during the April 6<sup>th</sup> L'Aquila earthquake.

Fig. 7  
Pictures of the sili after the  
seism. Photo by G.  
Verderame, ISPRA, F.M.  
Mazzolani.

Concerning non-building-like structures, the case of the sili of Vibac in Bazzano highlights that design of these structures is poor with respect to earthquake resistance. In fact, it is necessary to control the risk of damaging these structures and the likelihood that an earthquake event may trigger industrial accident. In fact, in the case of sili containing hazardous material, this may greatly increase the earthquake risk. Finally, the observed damages in industrial structures, building-like and non-building-like, may have been affected by the near-source fea-
