2.12 Emergency management for lifelines and rapid response after L'Aquila earthquake

M. Dolce¹⁻³, S. Giovinazzi², I. Iervolino³, E. Nigro³, A. Tang⁴ ■

2.12.1 Introduction

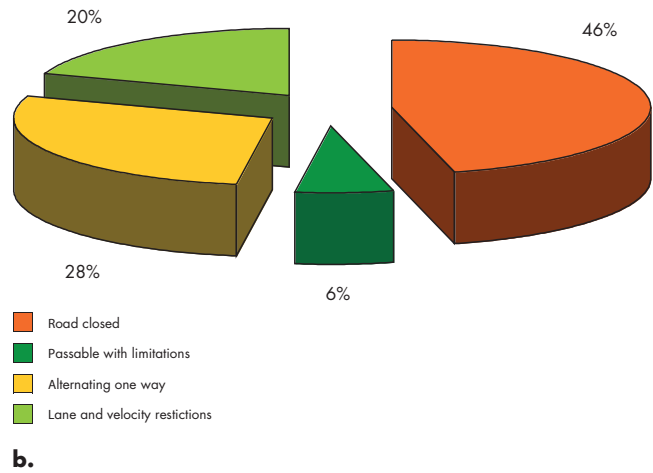
Temporary traffic management measures were extensively implemented in order to minimize road closures; these measures included traffic flow restrictions; alternating one-way; lane and velocity restrictions (Fig. 1b).

Fig. 1 Impact of the earthquake on the road network: (a) SS80 "Gran Sasso d'Italia" road affected by rock falls, but featuring rock-proof tunnels. (b) Distribution of traffic management solutions (updated to 01/05/09) for the 61 road tracts affected by the earthquake (red = road closed; dark green = passable with limitations; yellow = alternating one way; light green = lane and velocity restrictions).

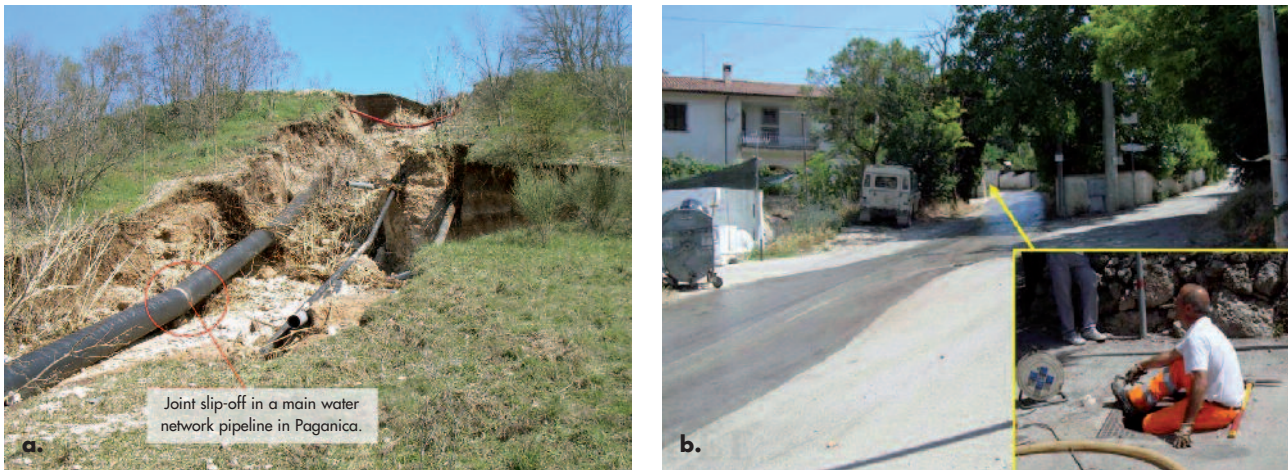
Fig. 2
Impact of the earthquake on the water distribution network: (a) Joint slip-off in a main water network pipeline in Paganica. (b) Repair on a cast iron pipe in a Paganica at the moment when some of the evacuated people were returning home.

The equipment connected to the remote control system revealed, on the morning of April 6, a significant and sudden change in the water flow for a main pipeline in *Paganica*. The immediate closure of the relative shutters for that pipe was operated directly from the GSA headquarters, before the technician team reached the affected site. The cause of the rupture was identified in the fault crossing the *Paganica* pipe. Because of that, the steel joint of the pipeline (diameter $\varnothing = 600$ mm; pressure 25-30 atm) slip-off, causing a violent escape of water (Fig. 2a).

A connection portion at the joint, however, was still grasped for a length of 6cm. In order to quickly respond to the emergency, the repair was limited to the welding of the pipes at the joint.

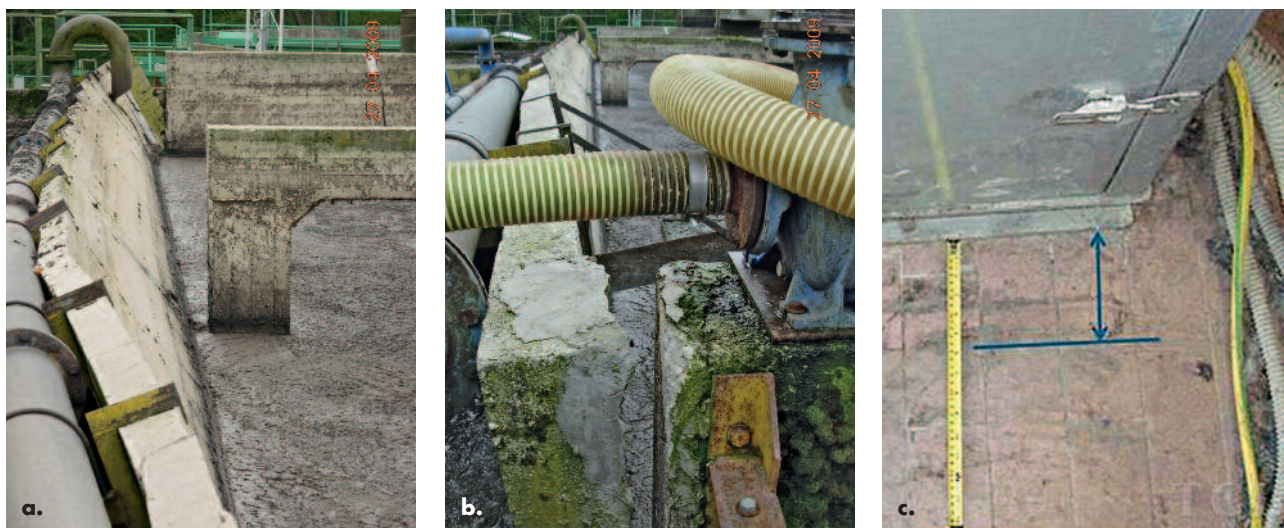
The facility in Ponte Rosarolo is located near the historical center of L'Aquila (42°20'18.10"N - 13°23'39.09"E). Structures were built the '60-'70. The reinforced concrete digestion tank suffered partial collapse of a longitudinal wall (Fig. 3a), several vertical cracks on a transversal wall and the separation of orthogonal walls at the edges (Fig. 3b). The partial collapse of the wall also involved the steel pipe adducting wastewater that was connected to it. In buildings used as offices, local technological and laboratory equipment (RC framed structure) were also found cracks of both internal partitions and external walls. However, there were no evidences of damage to structural elements: the cracks detected on non-structural elements did not represent significant damages and did not prevent the use of building. The inspected facilities were therefore useable at the time of inspection, except the digestion tank that was useless. Due to this damage the tank has lost water and the plant were partially closed by reducing the disposal capacity of about 60%. The remaining

Fig. 3
Ponte Rosarolo Plant.
Digestion Tank: (a) partial collapse of a longitudinal wall and of the pipe connected to it. (b) Detail of the detachment of the orthogonal walls at the edges. (c) Displacement of the pump in the control room.

- Ponte Rosarolo facility is located near the epicenter and close to the AQK accelerometric station, which recorded ground accelerations equal to 3.7 m/s^2 equal to about 50% of the maximum value recorded for the same seismic event (station AGV - 6.6 m/s^2); after the earthquake, the plant has shown damages to the tanks with rectangular walls larger than those found in circular tanks of the Pile plant, despite the geographical proximity. The structural behavior of the circular tanks was essentially better than that of the rectangular ones, mainly because of the lack of structural details ensuring effective connection between the orthogonal walls;

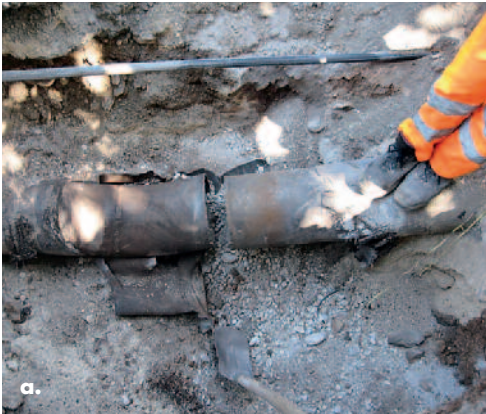
To ensure this priority, the entire network managed by Enel Rete Gas S.p.A. in the affected area was shut off via the closure of the 3 reduction cabins. Thanks to this decision, and to the rupture of a pipeline near Onna (Fig. 4a), it was possible to timely and significantly reduce the gas pressure and to avoid the occurrence of secondary effects. The subsequent closure of the 300 reduction groups ensured the full securing of the network in less than two hours after the earthquake. In the days following the event, the gas valves external to each residential building were as well closed. The pipeline damaged in Onna was replaced with a new one that was too rigidly connected to a reinforce-concrete support. It is worth highlighting that, as a result of the earthquake, the Enel Rete Gas headquarters in L'Aquila resulted unusable. Because of that the chief executive and the staff had to manage the emergency without the support of their data, software and maps. Luckily, the national society Enel Rete Gas has, at a national level, an integrated information system, including a data base and a geographical information system GIS. Making reference to the closest Enel Rete Gas headquarters in Teramo and Pescara, it was possible to reprint the maps and all the documentation necessary to operate.

Fig. 4 Impact of the earthquake on the gas distribution network: (a) Onna (AQ), damaged pipeline. (b) End-user gas connections activated on June 8 2009 (Green = end-users that can be potentially reconnected; Bleu = end-user reconnected with respect to total that can be potentially reconnected).

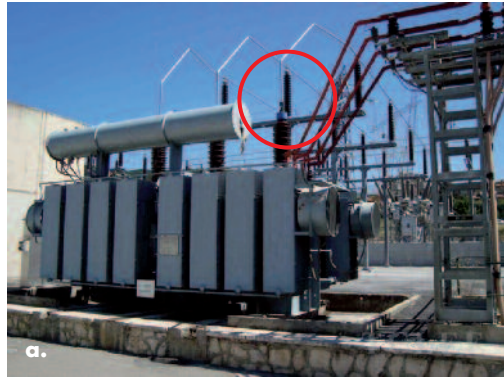
It was reported that two substations serving the greater L'Aquila had damaged connections between a rigid bus and insulator, figure 5a. That was due to shifting of the un-anchored transformers during the earthquake. Also due to sloshing of the cooling oil within the transformer, cooling oil pressure increased, and actuated the safety shut off feature to avoid costly damage. One of the transformers moved about 14 cm. In the distribution system, 30 posts were damaged causing severed links that resulted in service disruption. More than 180 pedestal type connection boxes were dislocated and severed cable connections at the termination lugs that resulted in localized power failure (Fig. 5b). The Electric Power Control Center at L'Aquila sustained severe damage, both building and equipment, and it had to be moved to a temporary building in the yard of the building premise. It took three days to complete the move, while the essential part of the system was functional by 9 AM the day after the earthquake (Fig. 4). Transformers in substations were not anchored. We noted that steel angles were welded on the tracks that the transformers were supported to stop sliding, figure 6a. This was done after the earthquake. However the steel angles seemed to be under sized. In the control

Fig. 5
 (a) Damage to rigid connection of a transformer.
 (b) Typical damage to pedestal box.

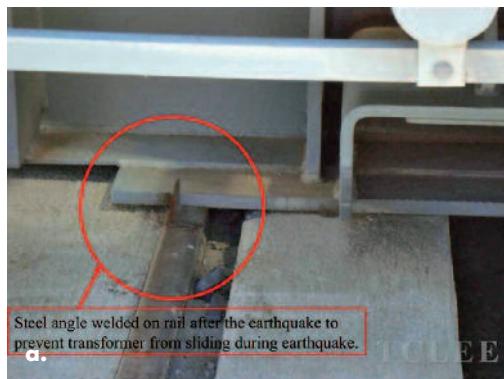
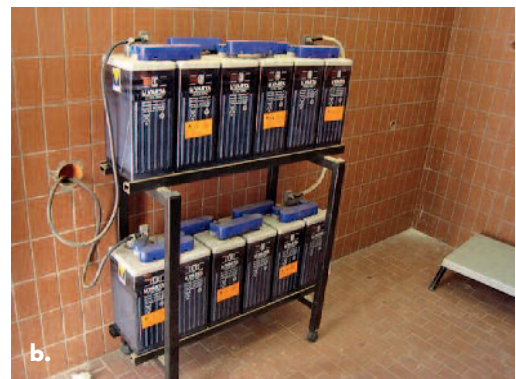
house of substations, the batteries were not anchored or tied to the racks, figure 6b. There was no batteries damage reported at these substations. Some locations were without power for three days, e.g. wastewater treatment plant.

Fig. 6
 (a) Steel anchors installed after the earthquake to avoid sliding of transformers.
 (b) Unanchored batteries' racks in substation.

From the seismic risk reduction point of view, it was concluded that components in facilities should be anchored and that the use of flexible connections should become a standard practice. As for the emergency management, the Civil Defence effectively coordinated a rapid and effective response. Chief executive and administrators of lifelines networks participated to the strategic decision making process since the very beginning of the post-event emergency-man-
