# SEISMIC PERFORMANCE IMPROVEMENT OF THE BELL TOWER IN SERRA S. QUIRICO BY COMPOSITES

EDOARDO COSENZA AND IUNIO IERVOLINO

The focused structure is an aging bell tower affected by the Umbria-Marche earthquake (1997). the S. Lucia's church bell tower is a sac-masonry structure built during the xv century. It is a very tall structure (approx. 32 m; 1100 tons in weight) at the centre of the little town of serra S. Quirico that is a mid-age suburb near ancona (see Figure 1a).

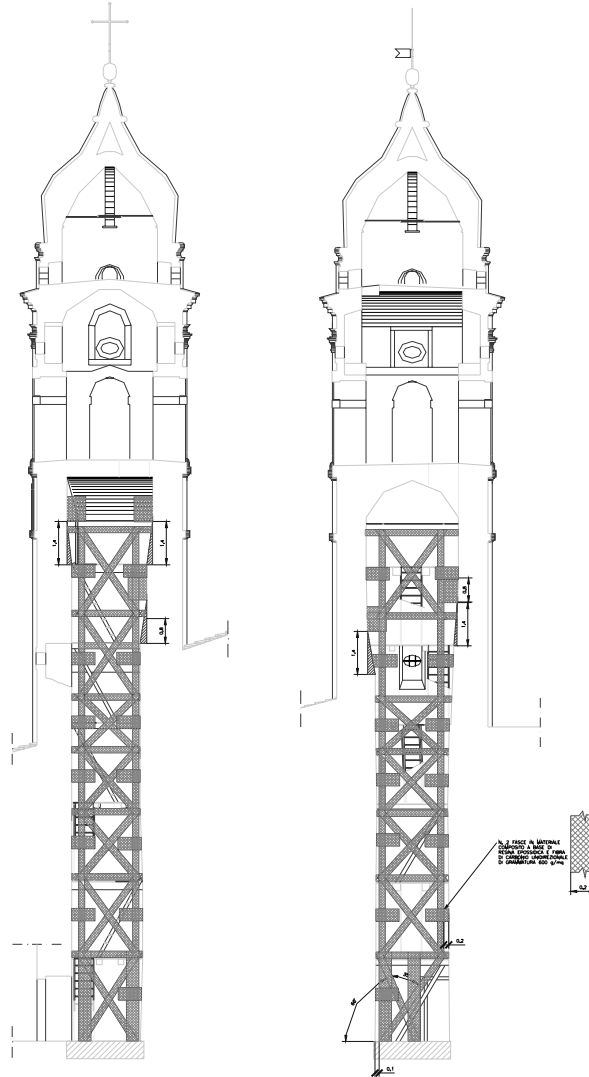
Design process intended to get the principles listed above, then the planned intervention avoids local masonry failures<sup>4</sup> and improve the seismic strength of the structure (see Figure 3).

Figure 3. Bell tower composites intervention relief into two sections.

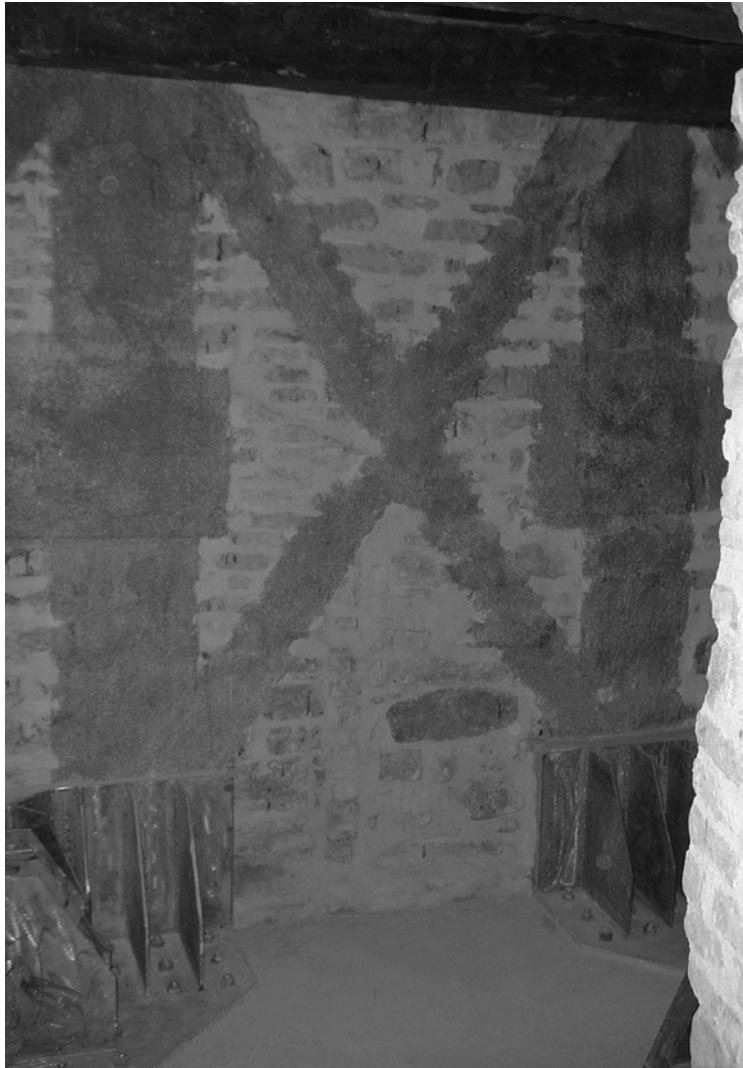
The composites installation strictly followed the design specifications. Even though the small available space and the presence of the wood beams, the composite textile allowed a simple intervention installation. To obtain a good grip masonry samples were analysed to get the optimum surface treatment. In Figures 4-6 aspects are highlighted. In Figure 4 and 5b an anchoring steel plate detail is shown, also the horizontal and oblique elements are displayed close to an original wooden beam.

Figure 4. Installed composites and base anchorage.

A reticular system, made of horizontal and vertical carbon fibre, was gripped on the inner walls of the tower (see Figure 4). The FRP was

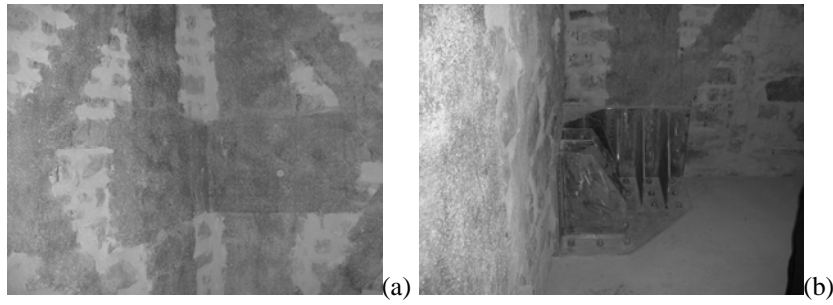
In Figure 6 another anchoring plate is pictured; it's very stiff since it should not be the weakest element of the whole system. The focused plate is in the most irregular corner of the inner part of the bell tower, and then a large quantity of filling resin was needed. In Figure 5 some details are shown; in the first one there's a horizontal element improving the grip on the masonry.

Figure 5. Intervention walls gripping (a) and anchoring details (b).

installed without removing the original wood beams at floors; only wood panels were temporarily removed and restored at the end of the whole process. Horizontal short composite elements were spaced in the walls corners to improve the grip (see Figure 5a). From the structural point of view FRP design aimed to greatly improve seismic capacity of the tower. Usually structural engineering practice neglects masonry tension strength, while FRP ensure a monolithic behaviour for high intensity earthquakes. The structure keeps its static mechanism for low intensity seismic activity because the added stiffness is very low in comparison to the one of the bell tower, but in case of strong motion the tension side of masonry goes losing cohesion allowing the composites start working; then the masonry behave as reinforced structure. A reinforced concrete slab (70 cm thickness, 40 micro poles), built as foundation for formerly proposed steel structure, was used for anchoring composites to the ground without overloading the original tower's foundation. The strength improvement was computed by ultimate limit state analysis. What comes out is that the critical cross section is the one correspondent to the connection between the tower and the church. Applying the composites the overturning moment, considering a ultimate stress in the masonry of 4 Mpa, jumps from 1650 tm to 2750 tm (limit strain in the masonry equal to 0.2%) or 3000 tm (limit in strain of 0.5%), meaning 70-85% strength improvement. A simplified analysis, considering unlimited masonry strength and full strength development of the FRP, gives an OTM of 1780 without considering intervention, and 3440 tm with composites, meaning a 90% of strength improvement. The calculations show that this solution gives a higher strength improvement with a very low invasivity. The composites used were made of. 20 cm wide double layer fabric, 600 gr/mq in weight and 0.67 mm in thickness. A key aspect of the intervention was the composites-masonry grip system, the fabrication details and the anchoring of the composites to the foundations. All those problems were managed by the expertise of professor Alberto Balsamo.

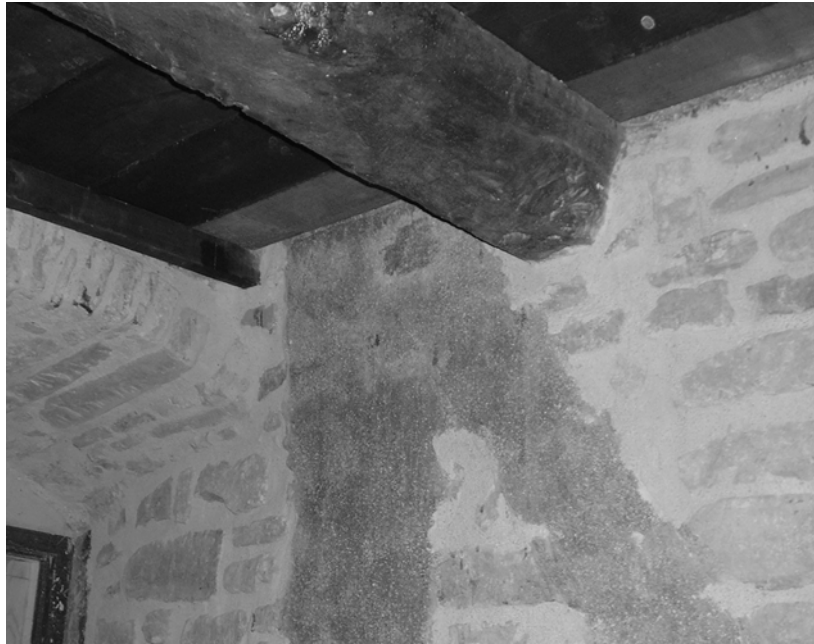
In Figure 6 is shown how the composite structural system geometry was locally modified to do not pass over the tower openings.

Figure 6. Composites near to unremoved wooden floor.
