*7<sup>th</sup> International Seminar on  
Seismic Isolation, Passive Energy Dissipation and Active Control of Vibrations of  
Structures  
Assisi, Italy, October 2-5, 2001*

**STRUCTURAL DYNAMIC INVESTIGATIONS ON THE BELL TOWER  
FROM THE S. LUCIA'S CHURCH – SERRA S. QUIRICO (ANCONA)**

In order to support the innovative design activities for the post-earthquake structural rehabilitation of the S. Lucia's Church bell tower, structural dynamic investigations were executed in February 2001.

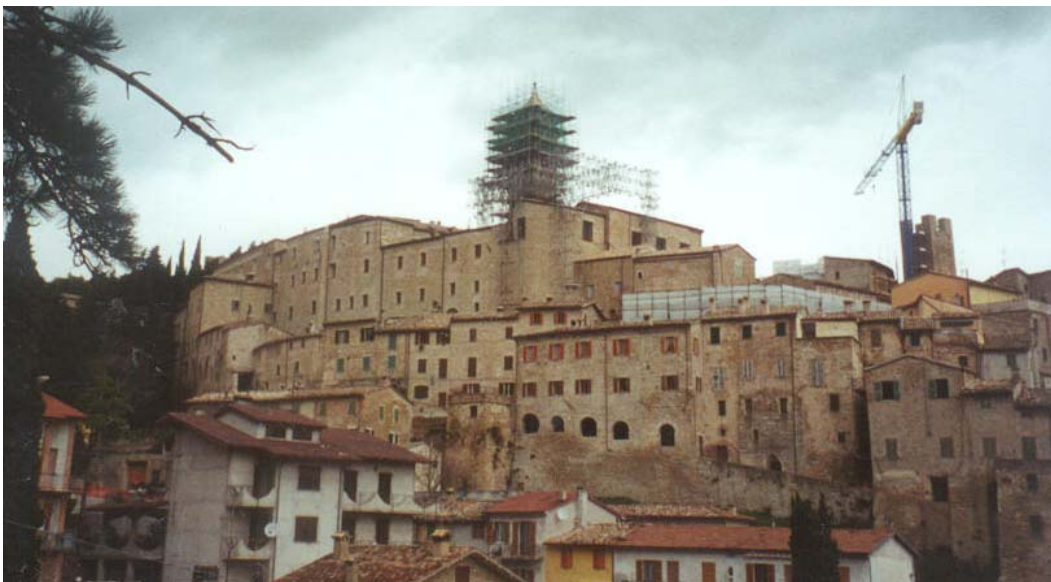
Fig.1 The bell tower in Serra S.Quirico (Ancona)

The bell tower of S. Lucia's church (Fig. 1 and Fig. 2) is in Serra San Quirico, a little town near Ancona, it's 325 m on the sea level in a second category seismic and windy zone. The tower is in the center of the town and it's surrounded by many ancients residential buildings.

It is a calcareous masonry building, walls thickness is 1.20 meters at the basement and 0.80 meters on the top. The building has a rectangular plant and is about 32 meter tall and 1100 tons in weight. The structure is connected on two sides to the contiguous buildings up the height of nine meters and on the others side to the vault roof of S. Lucia Church.

It was built in XV century, but recently, in 1997, it was affected by the *Umbria and Marche earthquake*. On this kind of tall structures seismic actions are strong because the overturning moment is proportional to weight and center of gravity position. So a reliability evaluation and a structural safety improvement were necessary.

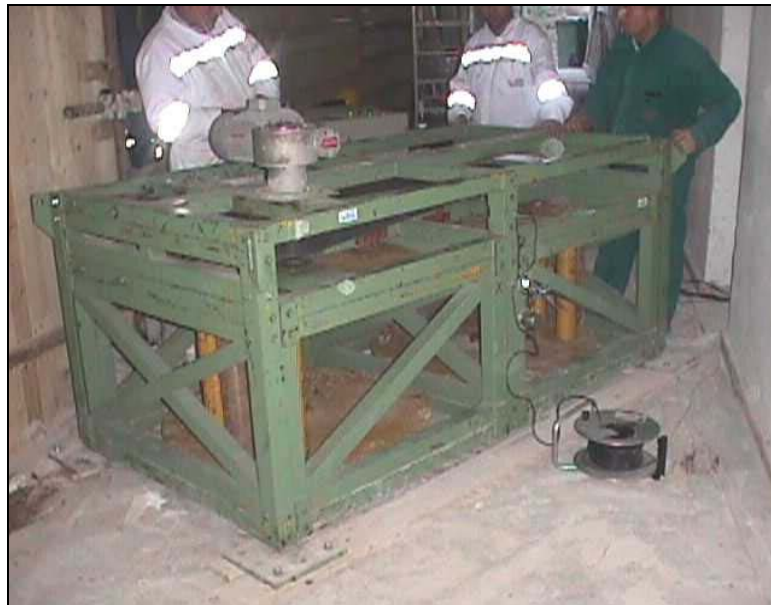
Fig.9 The vibrating machine

Test were executed by S.T.R.A.G.O. s.r.l. in march 2001 using a vibrating machine (Fig.9). For the structural response measurements were used 16 force-balance accelerometers. The accelerometers were positioned in each measurement point across two perpendicular measurement directions, see fig.10 for accelerometers positions.

The forced excitation was applied at 45° angle to the bell tower's walls, to generate a vibration in both x and y directions.

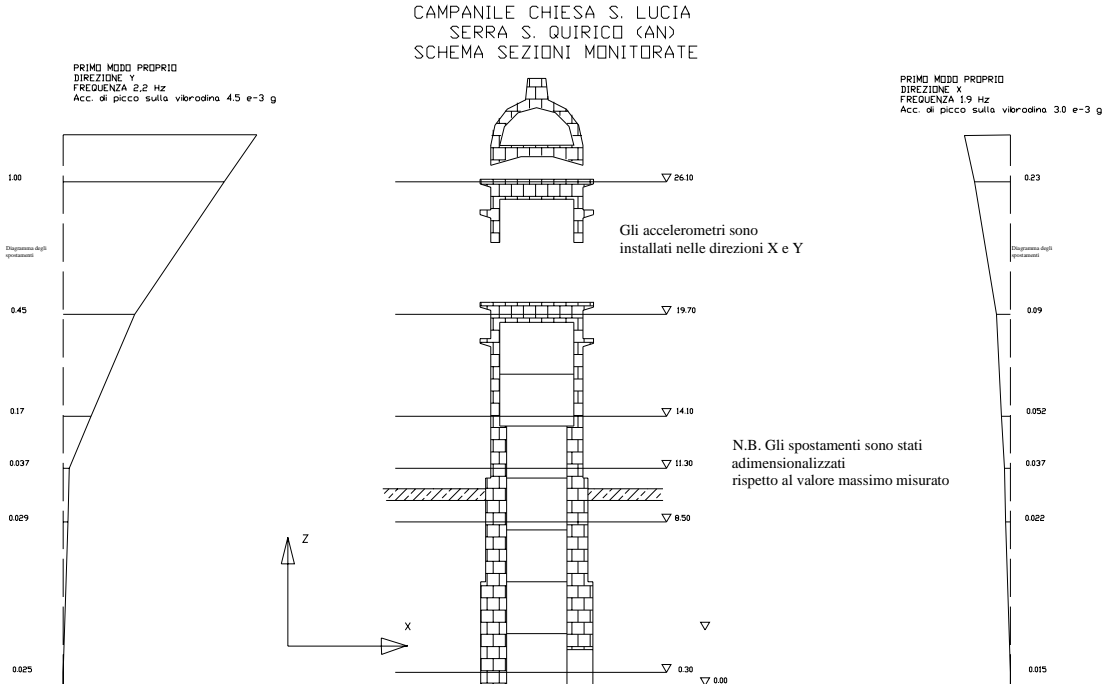
Fig.10 The experimental first mode in x and y directions

The bending mode natural frequency in the X direction is lower than in the Y direction (Fig. 10). This is because of a lower bending stiffness in this direction and/or because of the different constraint conditions. There is a slope changing of the displacement diagram at the bell tower's junction with the rest of the structure. It demonstrates a good connection between the structure and the other buildings.

As showed by table 3 this behavior is more obvious in the 2.2 Hz shape (direction Y). The vibration amplitude is higher in the Y direction than in the X direction. The conclusion of the data analysis is that there aren't particular abnormalities in the dynamical behavior of the structure in applied load conditions.
