Performance of the L'Aquila (central Italy) gas distribution network in the 2009 (M_w 6.3) earthquake

Simona Esposito · Sonia Giovinazzi ·
Ludovica Elefante · Iunio Iervolino

Received: 28 December 2012 / Accepted: 23 June 2013 / Published online: 2 July 2013
© Springer Science+Business Media Dordrecht 2013

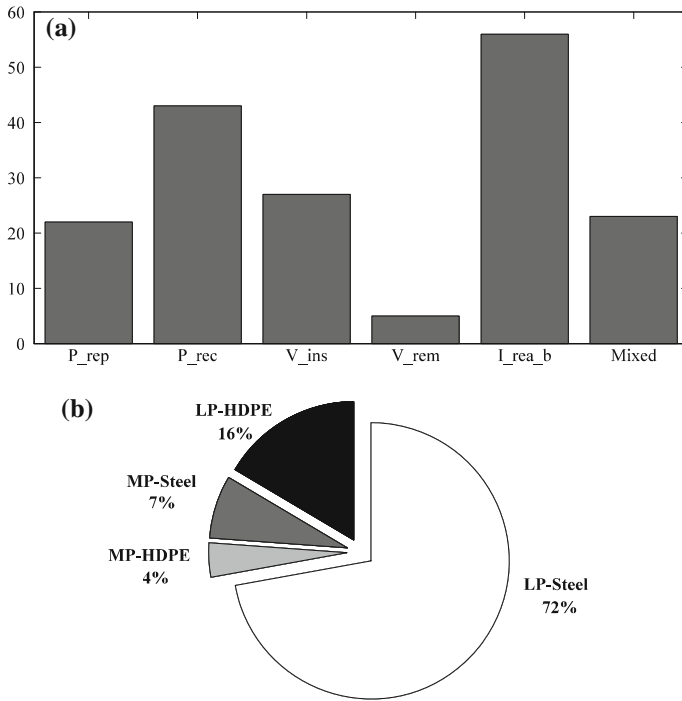
Fig. 5 Repair operations addressing damage to buried components for the entire gas network: **a** number of repairs for the different buried component and intervention category; **b** number of repairs distinguished with respect to pressure level and pipe material

Following the screening process, it resulted that 176 repair/maintenance operations addressed the damage to different buried components (Fig. 5a) in the following proportion: pipelines (37 %); valves (18 %); demand nodes (32 %); mixed (13 %), namely repairs made to more than one component (e.g., repair to pipe and unburred node; or repair to valve and unburred node). Figure 5b illustrates the repair/maintenance operations with respect to: pressure level of the distribution network, namely MP and LP; and pipe material, namely steel or HDPE. The largest proportion of repairs (72 %), and therefore of the damage, was localized on the LP distribution network, made of steel pipes (Fig. 6a). The repair and replacement for the steel pipes of LP distribution network were mainly due to breaks or leaks in correspon-

It has to be mentioned, however, that the damage distribution to different buried components reported in Fig. 5a might be biased by the mentioned inaccuracy and incompleteness issues affecting the maintenance/repair database. To enhance the understanding of the proportion of damage suffered by different buried components, reference has been made to a reduced database, composed of 85 repair records, corresponding to the Zone 1, the only area where the maintenance/repair database resulted completed and reliable. It is worth noting that any data belonging to the network included in the crater, located within the central area, was excluded from the analysis. In fact, the complete replacement of the gas network for this part of L’Aquila downtown was planned by the network operator.

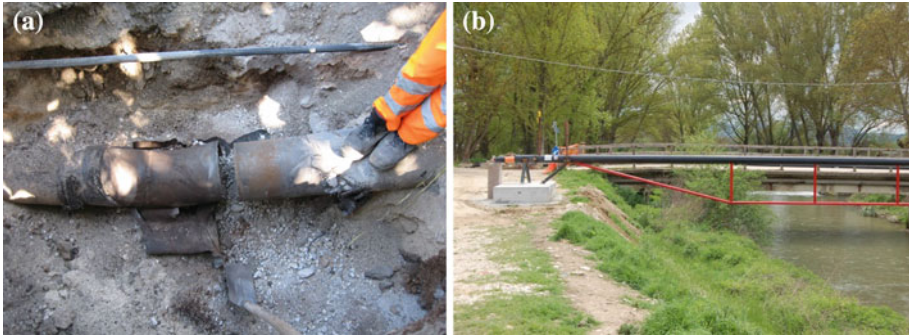
Fig. 6 Damage to gas pipes following the L’Aquila earthquake: **a** gas welded joint of a LP steel pipe pulled apart in Paganica (AQ); **b** gas pipe connected to a damaged bridge in Onna (AQ) replaced with a stand-alone pipe (photos courtesy of ENEL Rete Gas)

dence of the gas welded joints (Fig. 6a). One of the pipe of the MP distribution network, connected to a damaged bridge in Onna, was replaced with a new stand-alone supported on either side of the crossing by two new concrete abutments. The pipe was rigidly connected to the abutment with no flexible connection between the pipe and the bridge foundations (Tang and Crooper 2009). A flexible join for the river crossing pipe would have been preferable solution (Fig. 6b).

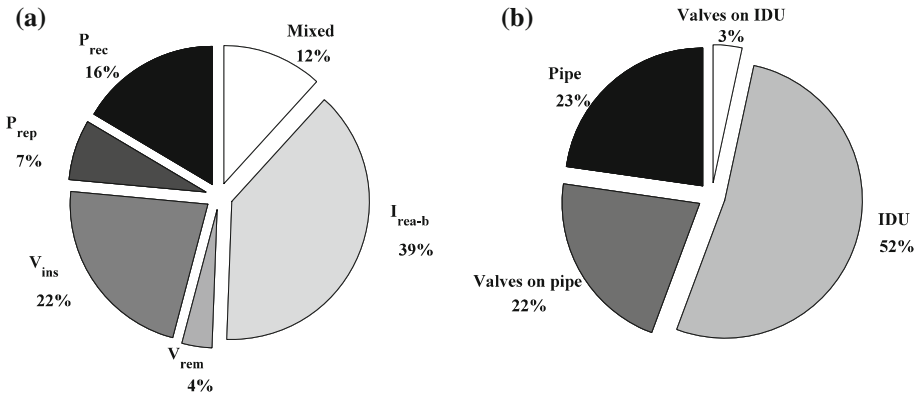
Fig. 7 Repair operations addressing damage to buried components for the portion of the gas network located in Zone 1: **a** number of repairs for six intervention categories; **b** number of repairs for different buried components

Figure 7a shows the percentages for the six macro categories associated with the repair operations to buried components (Table 1, excluding first row) for the portion of gas network

located within the selected area (Fig. 8). Figure 7b groups the same percentages for the four buried system components considered in this analysis, namely: pipe; service laterals (IDU system); valves along pipes; and valves along IDU systems.

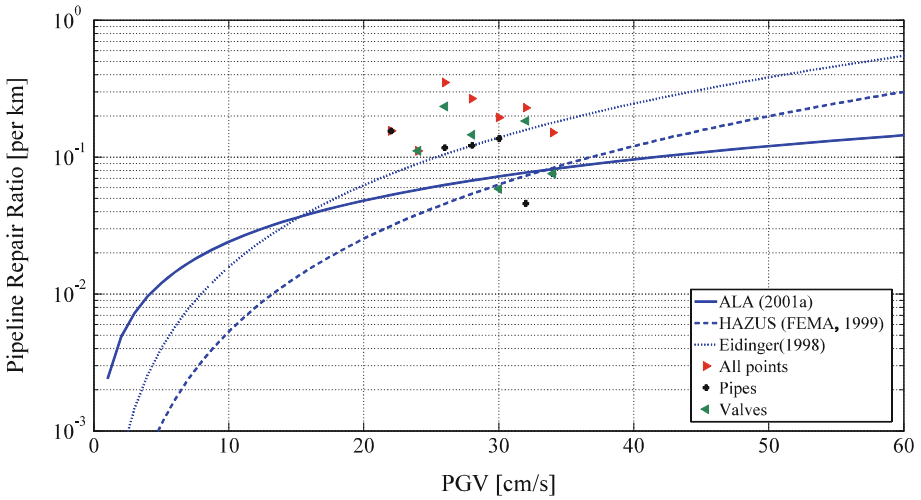
Figure 9 shows that the repair rates trend estimated for L'Aquila seems somewhat underestimated by existing fragility curves; however, it must be highlighted that the considered fragilities relations have been obtained combining data from different kinds of pipes (e.g., ALA 2001b). Moreover, the different sources of uncertainties related to PGV values and repairs may have influenced the results obtained. The estimates of repair rates were in fact based on *Shakemap*TM to retrieve local ground motion intensity; these are large-scale emergency management tools affected by large uncertainty. Finally, repair reports analyzed for the damage assessment are not post-earthquake standardized forms, and the processing could be affected by missing data or inaccuracy of the maintenance technicians.

Fig. 9 R_R -PGV points compared with some existing fragility curves

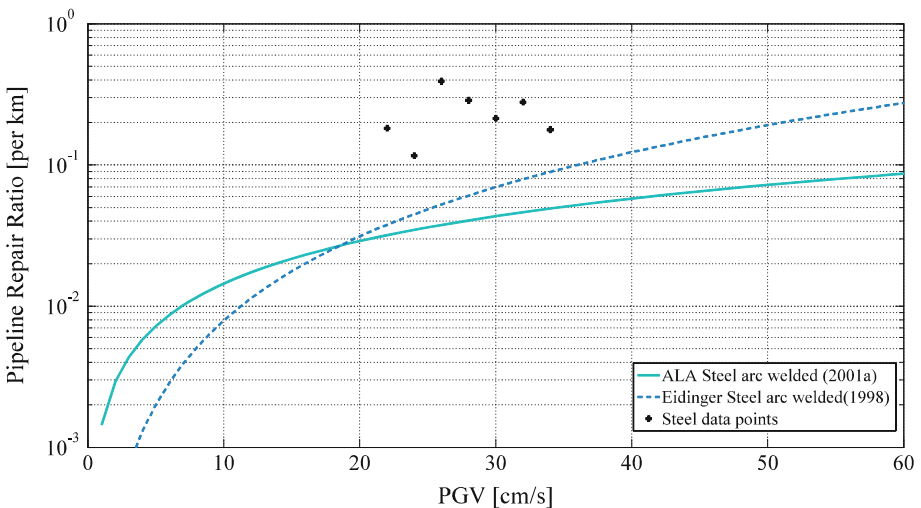
Regarding the comparison as a function of pipe material, Fig. 10, the repair rate trend observed in L'Aquila is larger with respect to existing fragility curves. A reason may be that selected fragility relationships were derived for arc-welded joints steel pipes. L'Aquila network, in the selected area, is instead characterized by gas welded steel pipes (for which fragilities are unavailable in literature) that, according to Ballantyne (1995), are more vulnerable to earthquakes with respect to arc-welded joint. Moreover, also in this case, the different sources of uncertainties related to PGV values and repairs may have influenced the results obtained.

Fig. 10 R_R -PGV with respect to pipe material
