Post-Earthquake Physical Damage Assessment for Gas Networks

S. Esposito, I. Iervolino, L. Elefante

Università degli Studi di Napoli Federico II, Naples, Italy.

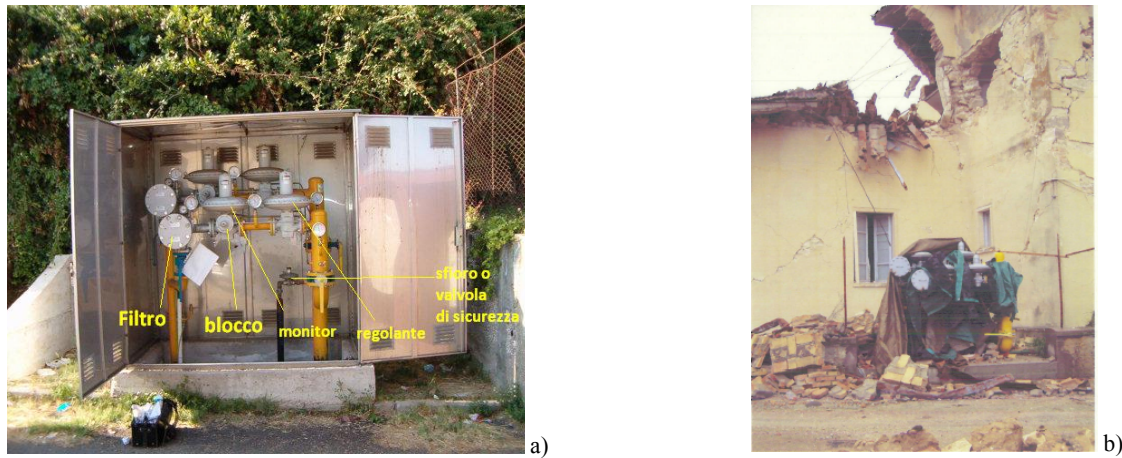
Figure 3. Reduction Group in L'Aquila, Italy: a) GR housed in a metallic kiosk; b) GR housed in a masonry kiosk closed to building and damaged following the 6th April 2009 earthquake.

- M/R station in Onna: gas leak reparations including excavations, welding joints with special pieces like dielectric joints, welding pipes and recovery steel/polyethylene piping connections;
- M/R station in Centicolella: valve replacements and input/output substation network repair;
- GR in L'Aquila and Onna: replacements concurrently with the laying of new pipe.

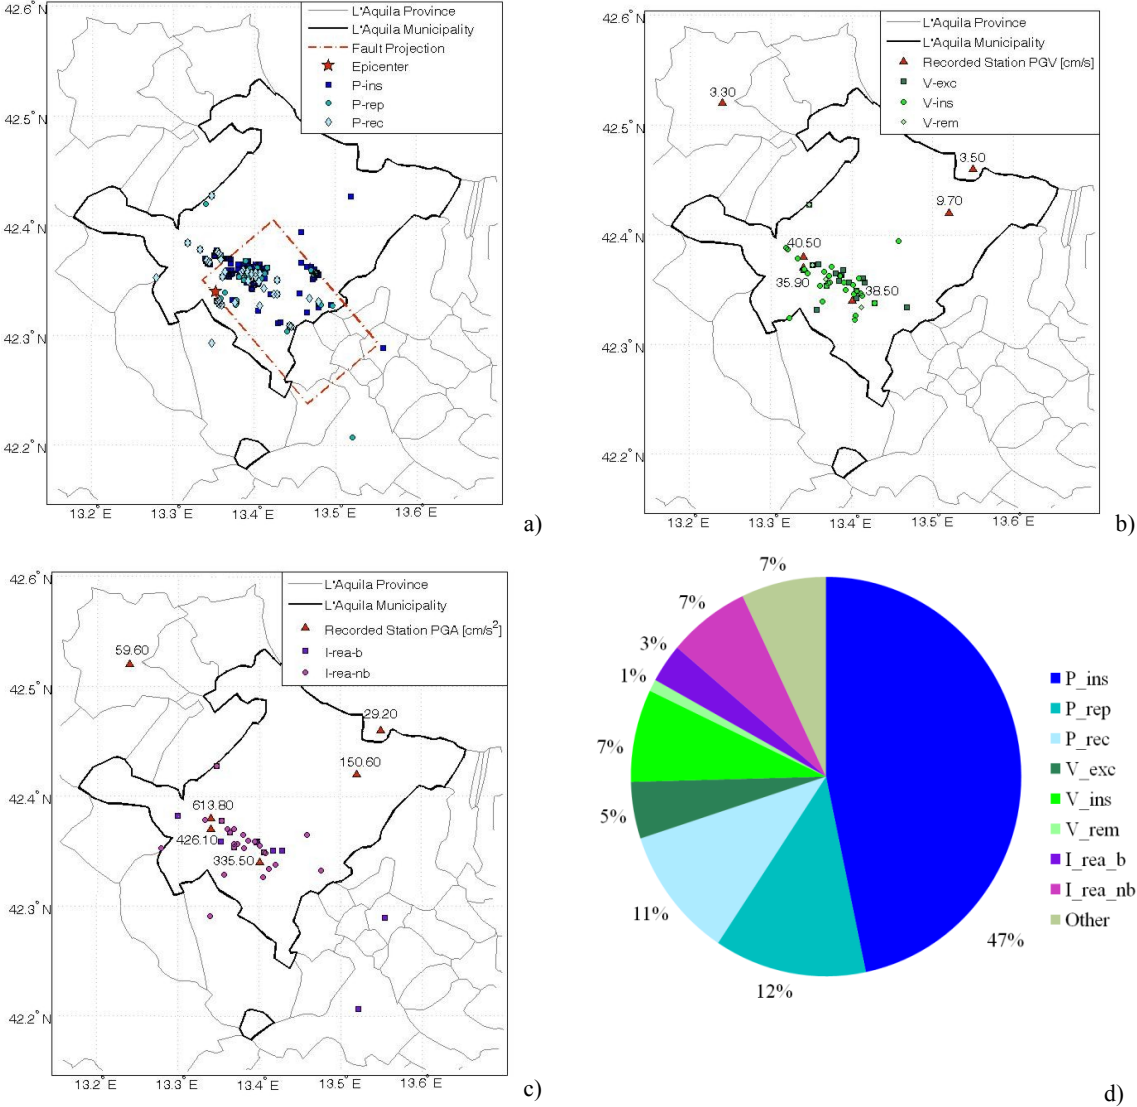
Figure 4. Spatial distribution of the macro categories for repair operations of each component and recorded values of PGV[cm/s²]: a) pipelines, fault projection and location of the epicentre; b) valves; c) demand nodes; d) pie chart summarising the percentages of the maintenance operations.

Figures 4a-4c show the spatial distribution of the aforementioned repair macro-categories over the Municipality of L'Aquila. From Figure 4a it is possible to notice the high concentration of the damage to the pipelines and to the other network system components (Figg. 4b and 4c respectively for valves and demand nodes) in the area close to the epicenter of the 6th April L'Aquila main-shock, occurred in proximity of the L'Aquila city centre.

Considering the level of PGV registered in the affected area (Figg.4a-c), the damage scenario resulting from the data processing is coherent with what described in the international literature (ALA, 2001). Continuous pipelines, built with rigid welded joints have shown generally speaking a good performance: P_ins=222 pipelines inspections have been performed over the 621km pipeline networks, requiring P_rep=52 repair interventions and P_rec=44 reconnection interventions. The repair and reconnection interventions have been operated mostly to address leakage problems at the joint locations mainly caused by poor quality welds or the presence of corrosion at the joint location. In very few cases repair/substitution interventions, have been operated because of the deformation of the pipeline affecting the gas flow (ENEL Rete Gas representatives, personal communication). Discontinuities, including in-lines valves and connections to IDU, have shown to represent vulnerability points; 23% of the interventions have addressed problems at valves and IDU (Fig. 4d).
