Field inspection after the May 20th and 29th 2012 Emilia- Romagna earthquakes

Fulvio Parisi, Flavia De Luca, Fabio Petruzzelli, Raffaele De Risi, Eugenio Chioccarelli,
Iunio Iervolino

Dipartimento di Ingegneria Strutturale, Università degli Studi di Napoli Federico II

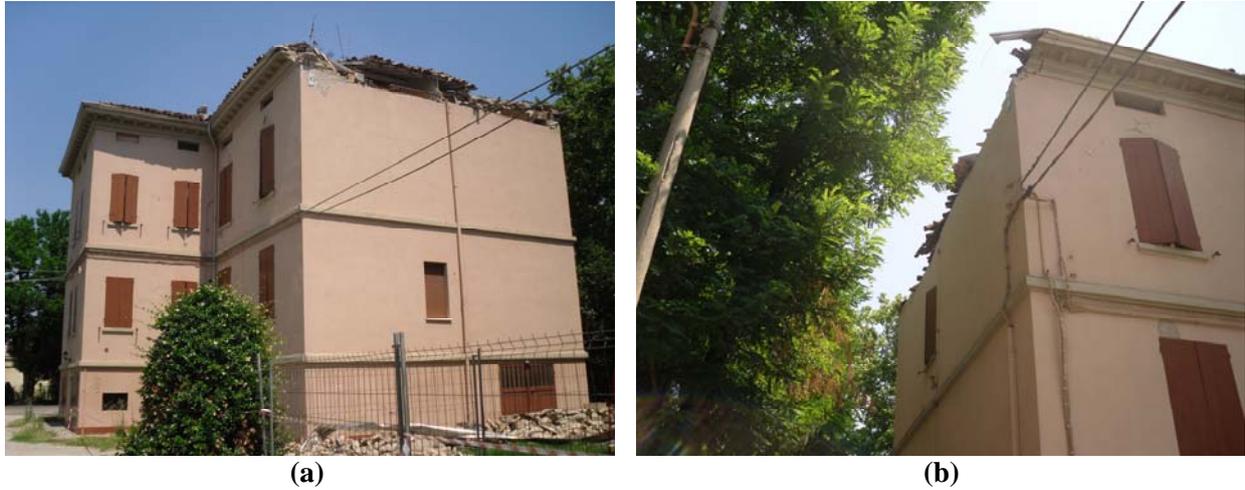
Figure 2.1. Brick masonry buildings in Mirandola (Lat. 44.886969, Lon. 11.062936): Out-of-plane failures of walls due to lack of roof-to-wall connections (e.g., RC ring beams, wooden or steel ties, reinforced masonry stringcourses).

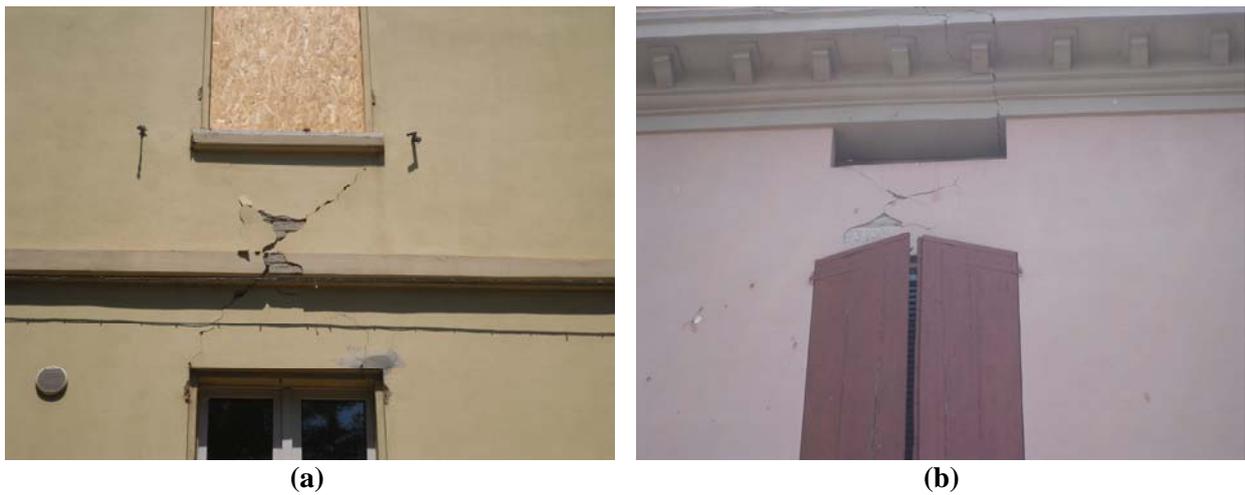
Figure 2.2. In-plane diagonal shear cracks of spandrel panels of brick masonry buildings located in Mirandola (Lat. 44.886969, Lon. 11.062936): (a) Floor level; (b) Roof level.

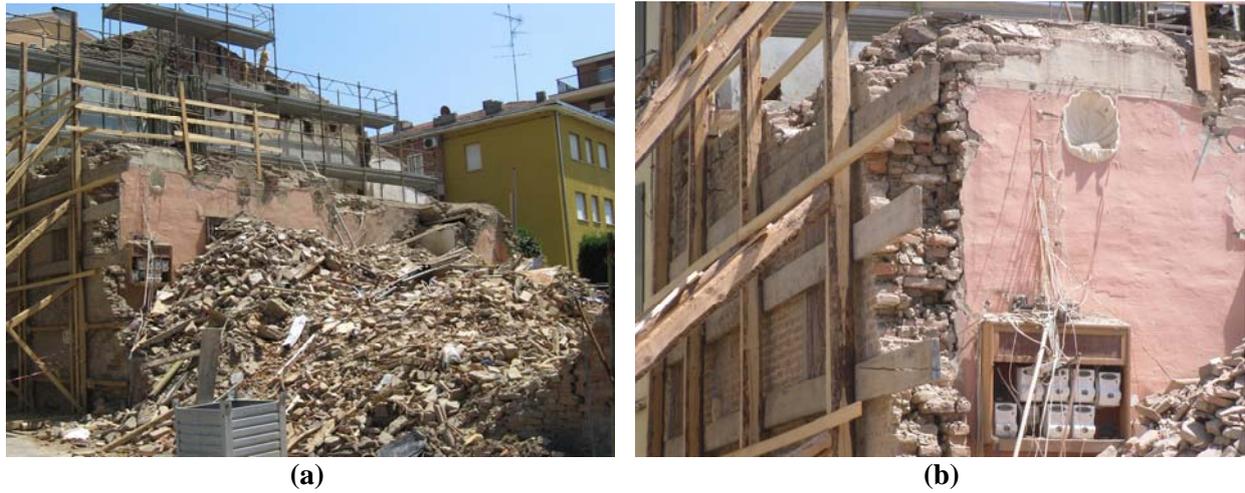
Figure 2.3. Global collapse of corner building unit in Mirandola (Lat. 44.886417, Lon. 11.064429): (a) General view; (b) Temporary shoring system supporting the adjacent multi-leaf masonry building unit.

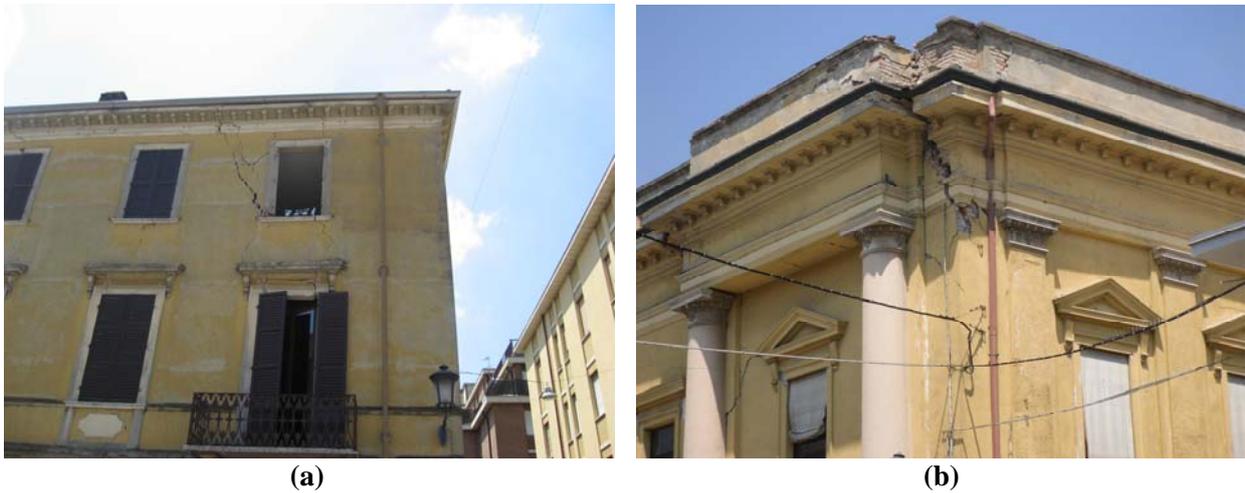
Figure 2.4. Building aggregate in Mirandola (Lat. 44.884998, Lon. 11.066348): (a) Beginning of corner failure mechanism; (b) Beginning of vertical overturning mechanism due to bad corner connection.

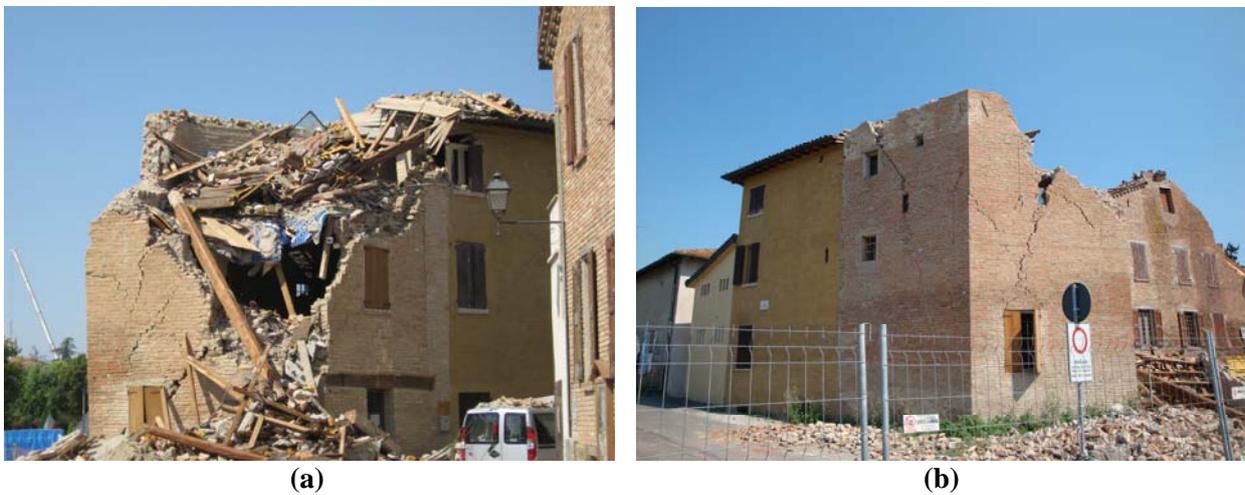
Figure 2.5. Partial collapse of corner brick masonry building unit in San Felice sul Panaro (Lat. 44.839492, Lon. 11.140061): (a) View of collapsed corner; (b) Opposite view.

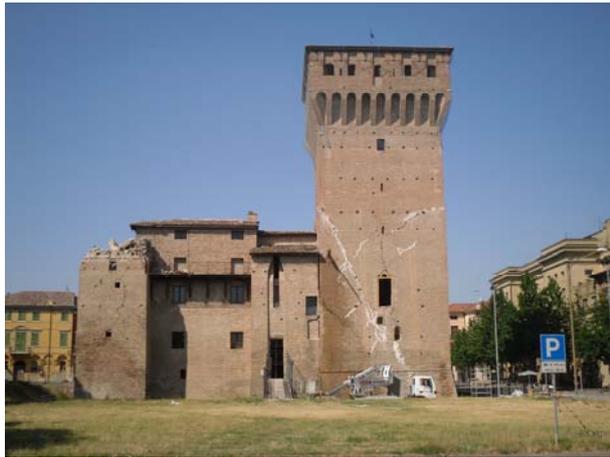
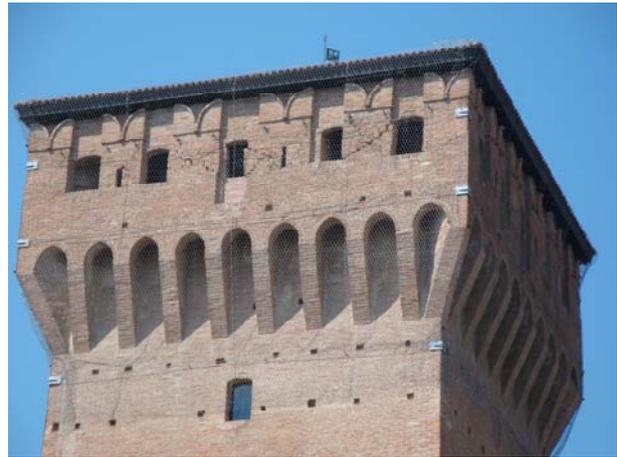
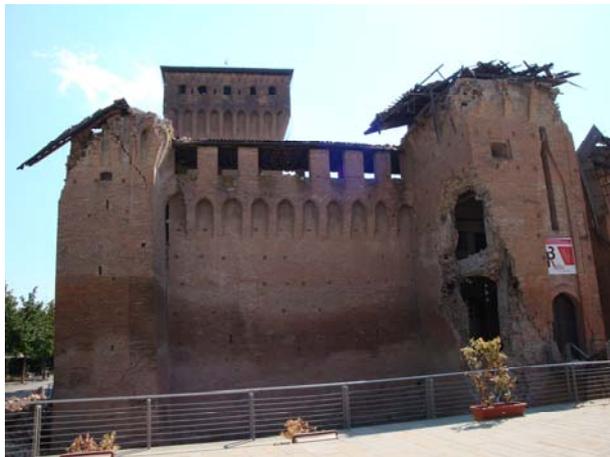
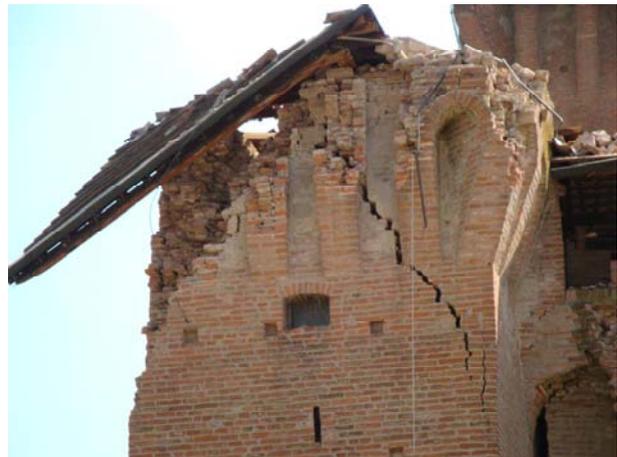
Figure 2.6. Heavy damage to the Castle of San Felice sul Panaro (Lat. 44.839492, Lon. 11.140061):
(a) Totally collapsed left tower on lateral façade and diagonal cracks on the right tower due to torsion;
(b) Detail of shear damage to the upper part of the right tower; (c) Main façade; (d) Detail of damage to the upper part of the left tower on the main façade.

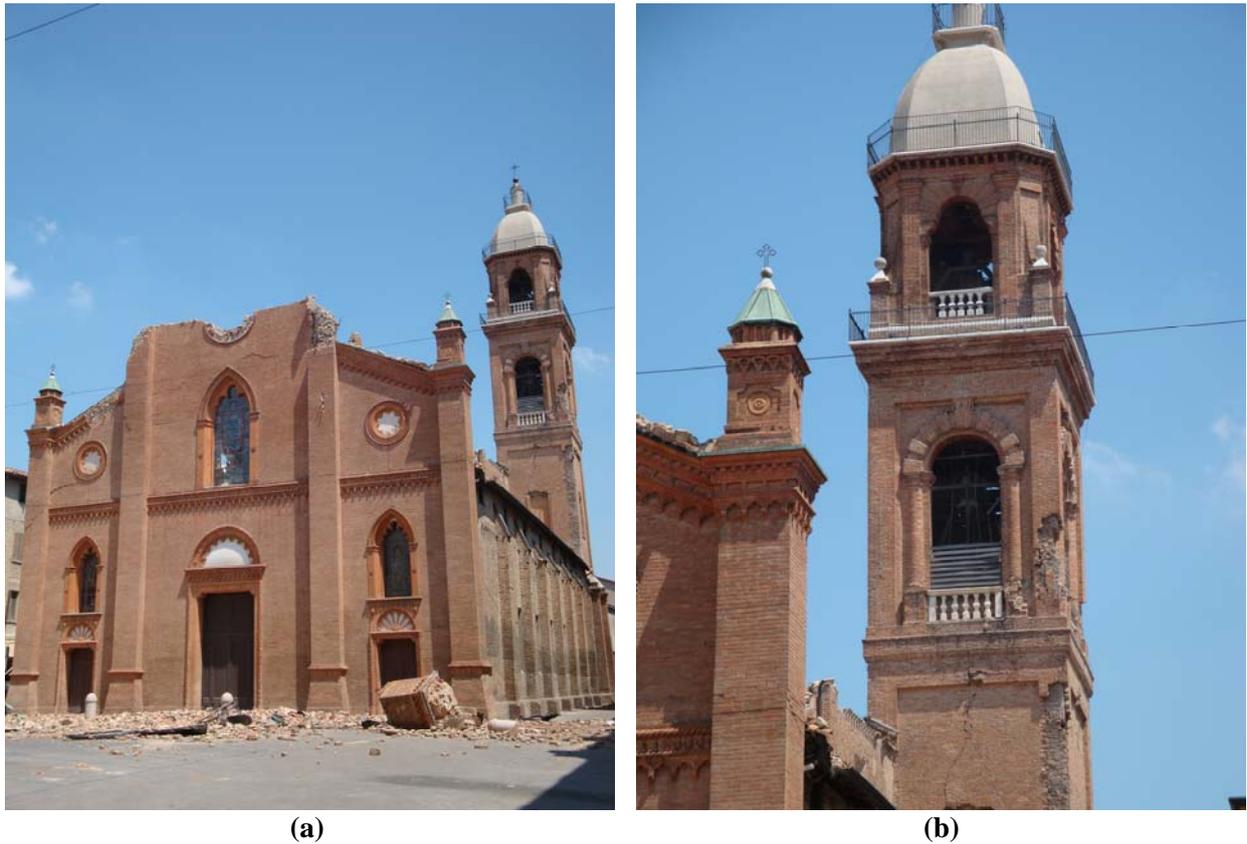
Figure 2.7. Cathedral of Santa Maria Maggiore in Mirandola (Lat. 44.886027, Lon.11.066543): (a) Front view of the brick masonry structure (Note the collapse of tympanum due to out-of-plane seismic excitation.); (b) Diagonal cracks of bell tower.

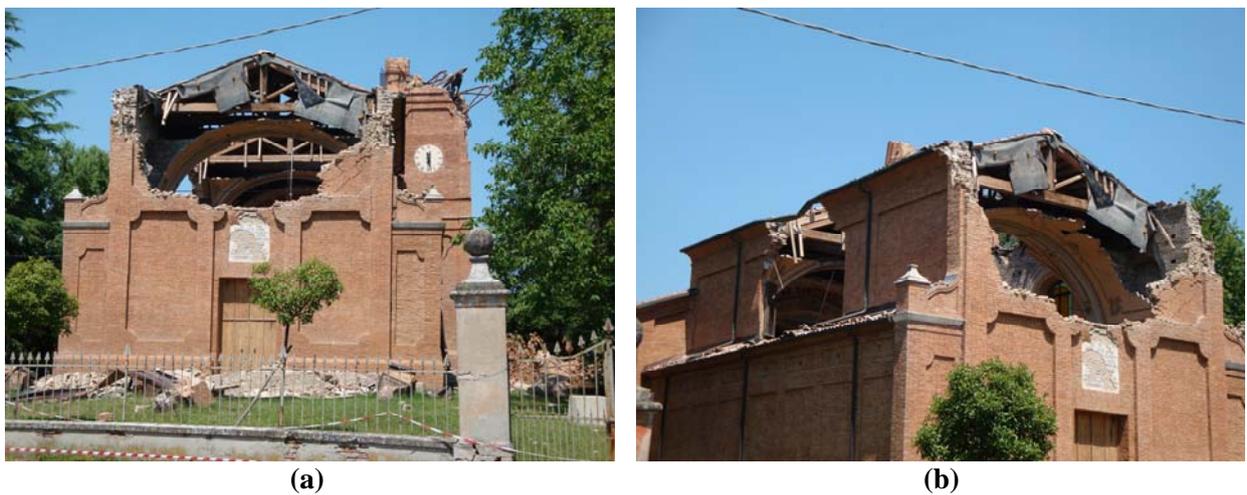
Figure 2.8. Brick masonry church in Mirandola (Lat. 44.863452, Lon. 11.077511): (a) Out-of-plane partial collapse of main façade; (b) Corner view.

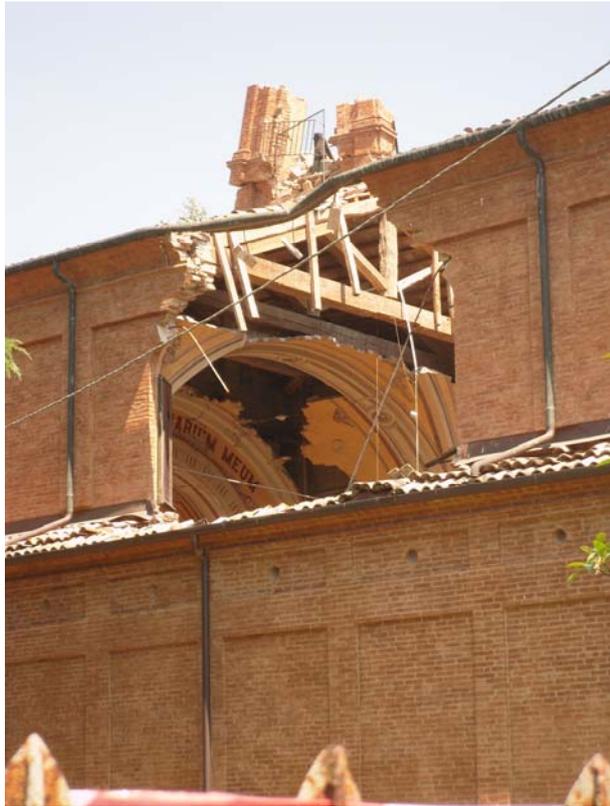
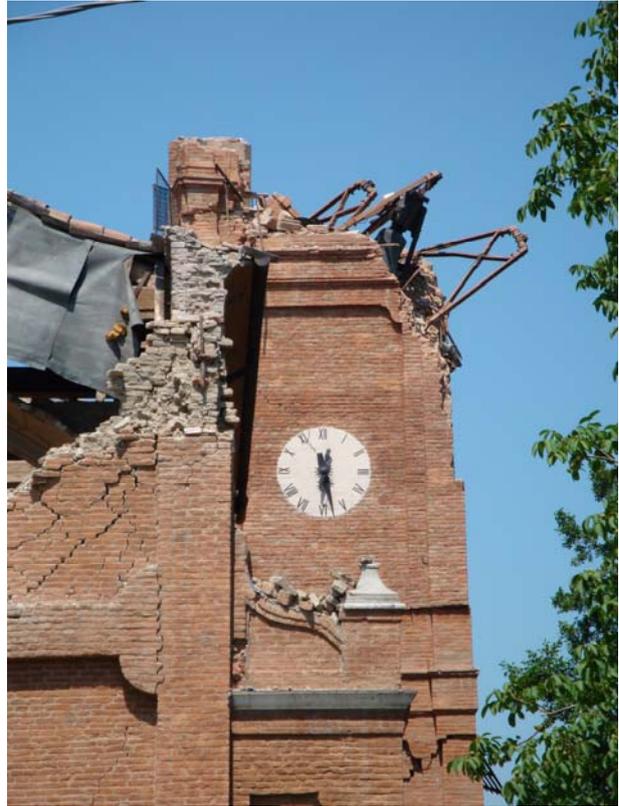
Figure 2.9. Brick masonry church in Mirandola (Lat. 44.863452, Lon. 11.077511): (a) Out-of-plane partial collapse of lateral façade (Note the rupture of steel tie below the level of the wooden truss support.);
(b) Partially collapsed bell tower.

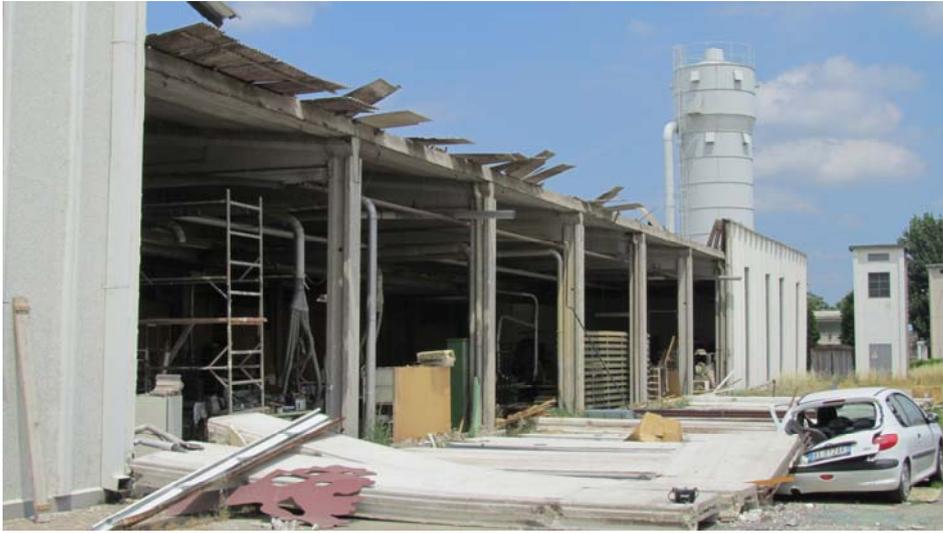
Figure 3.1. External view of the building (Lat. 44.825486, Lon. 11.039357). Overturning mechanism of vertical façade precast concrete (PC) panels.

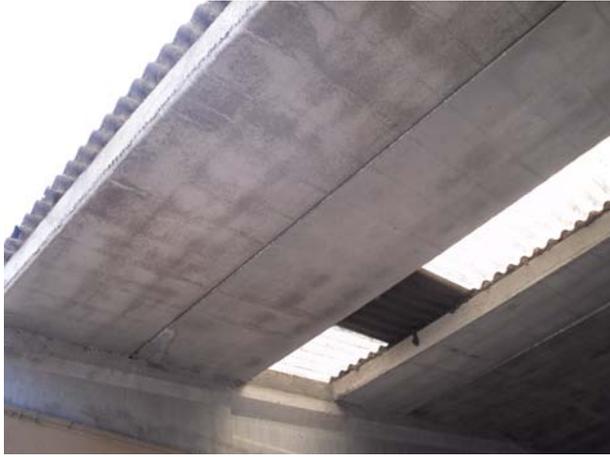
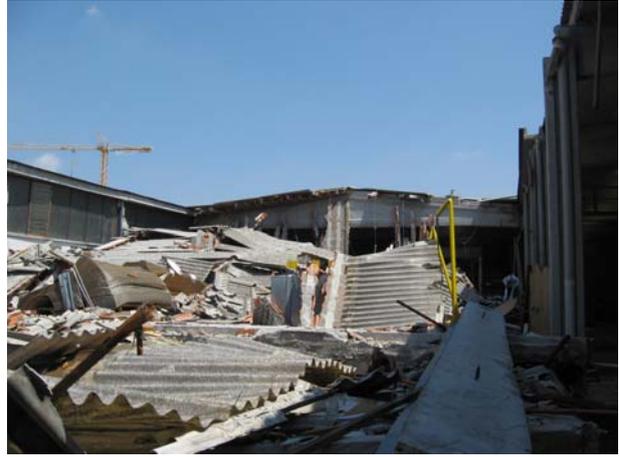
Figure 3.4. (a) Precast roof slab elements; (b) internal view of collapsed part of the building (Lat. 44.825486, Lon. 11.039357).

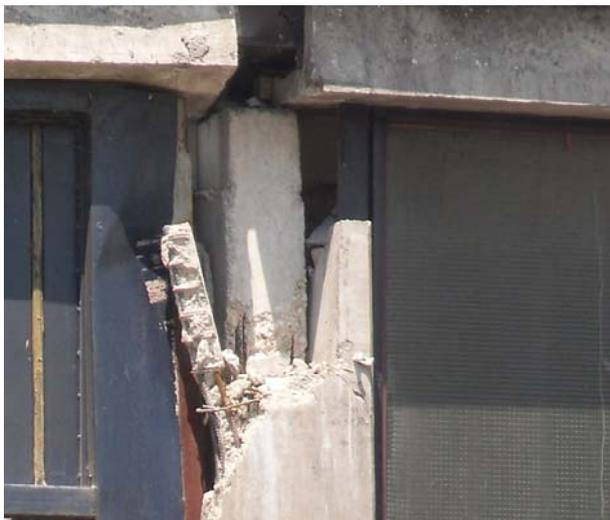
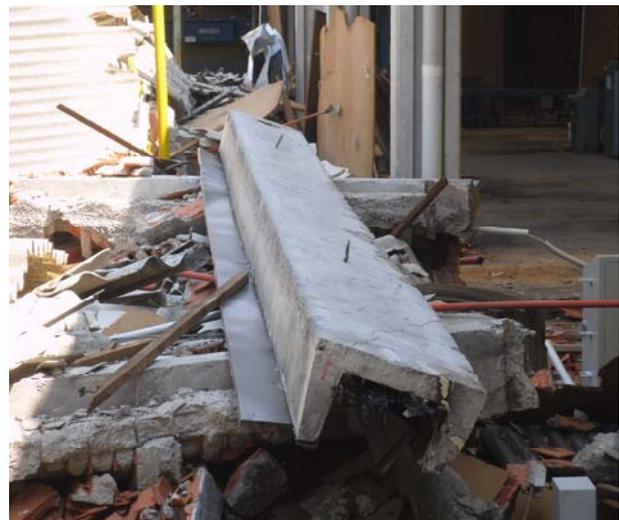
Figure 3.6. (a) Rupture of U-shaped seat on RC column; (b) Collapsed roof beam with U-shaped cross section (Lat. 44.825486, Lon. 11.039357).

- (5) The majority of heavy damaged or collapsed industrial buildings were designed for gravity loads only. Lacking or ineffective connections between RC precast roof beams and columns induced partially constrained roof systems which slipped off under large relative displacements between top sections of columns. Ineffective connections between vertical façade panels and the structure caused dangerous out-of-plane collapse mechanisms of the panels.

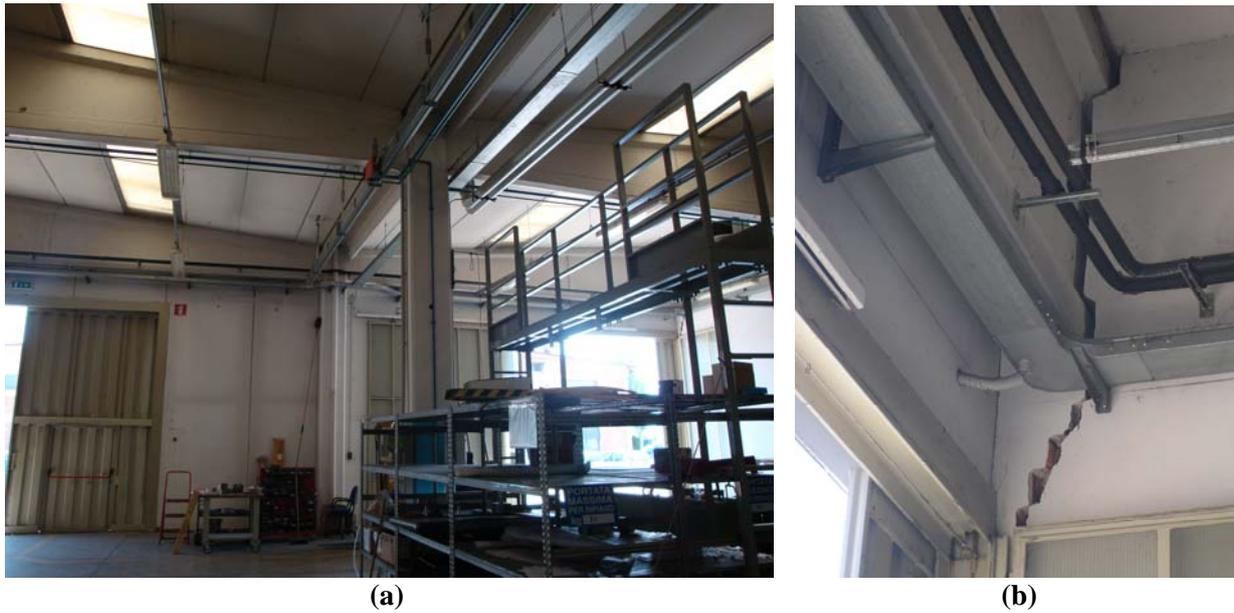
Figure 3.7. (a) Internal view of damaged building; (b) Detachment of façade from orthogonal partition wall due to out-of-plane earthquake excitation (Lat. 44.825486, Lon. 11.039357).

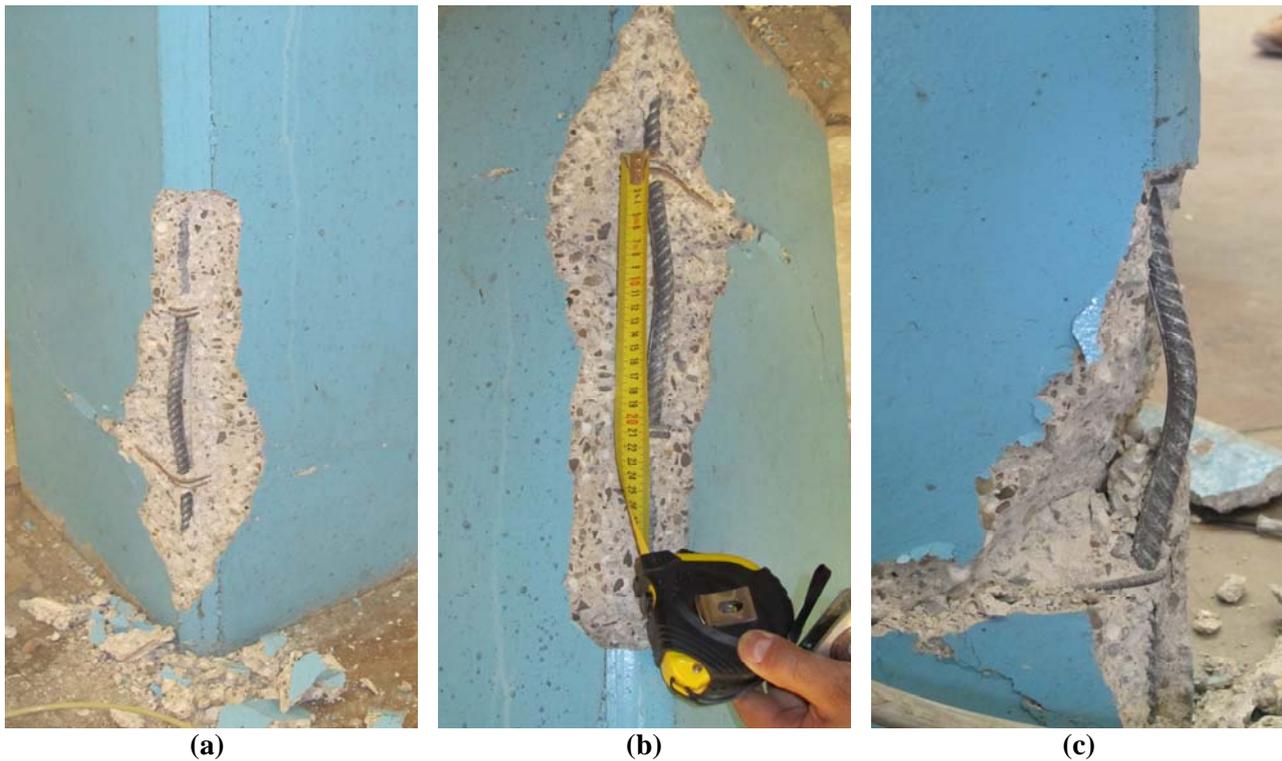
Figure 3.8. Buckling of longitudinal reinforcing steel bar due to biaxial bending (stirrup spacing was found to be about 200 mm) (Lat. 44.825486, Lon. 11.039357).

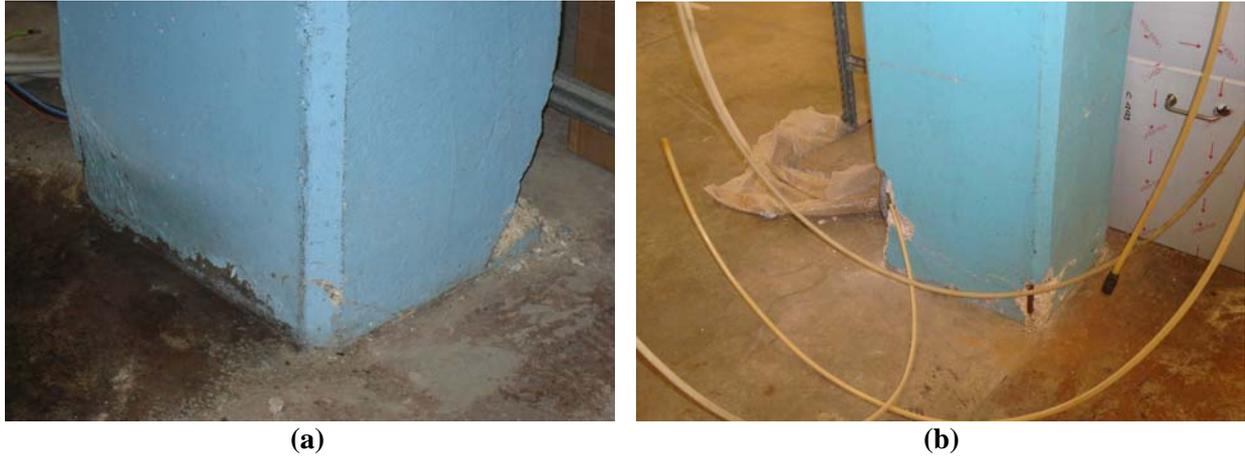
Figure 3.9. (a) Ejected cover at opposite column corners due to biaxial bending; (b) Ejected cover at the same column edge due to uniaxial bending (Lat. 44.825486, Lon. 11.039357).

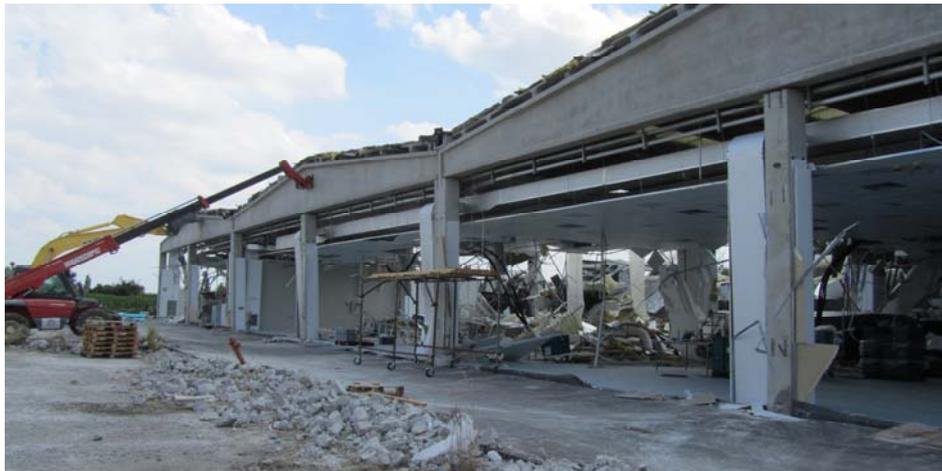
Figure 3.10. Temporary safety measures to avoid out-of-plane rotation of roof beams (Lat. 44.840301, Lon. 11.056790).

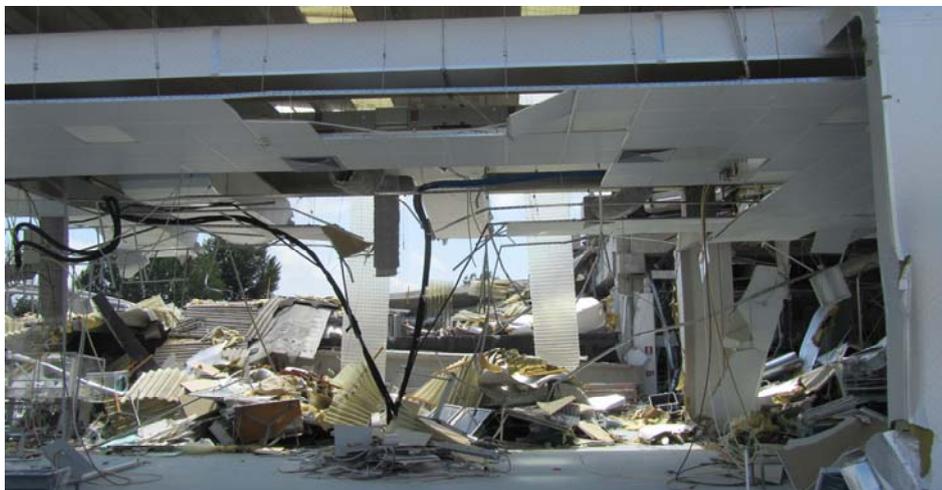
Figure 3.11. Internal view of collapsed ceilings (Lat. 44.840301, Lon. 11.056790).

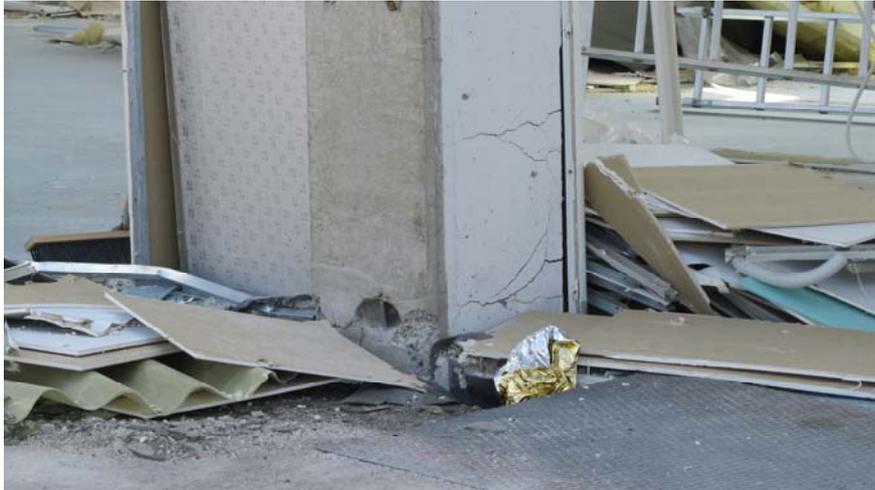
Figure 3.12. Cracks at column base (Lat. 44.840301, Lon. 11.056790).

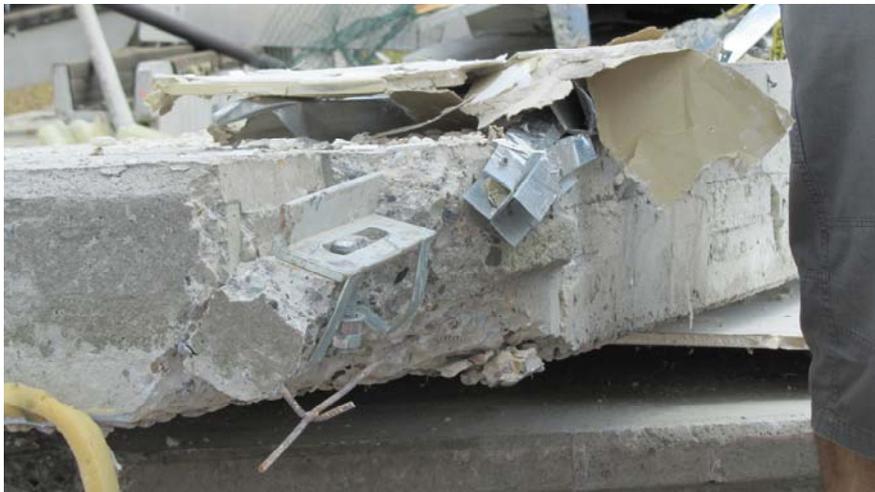
Figure 3.13. Detail of failed connection of façade panel to the structure (Lat. 44.840301, Lon. 11.056790).

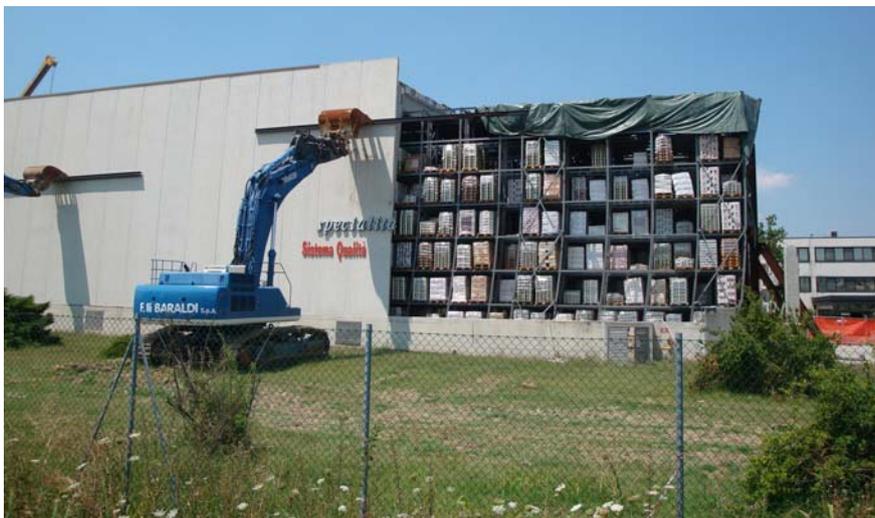
Figure 3.14. Safety measures to avoid façade overturning (Lat. 44.840301, Lon. 11.056790).

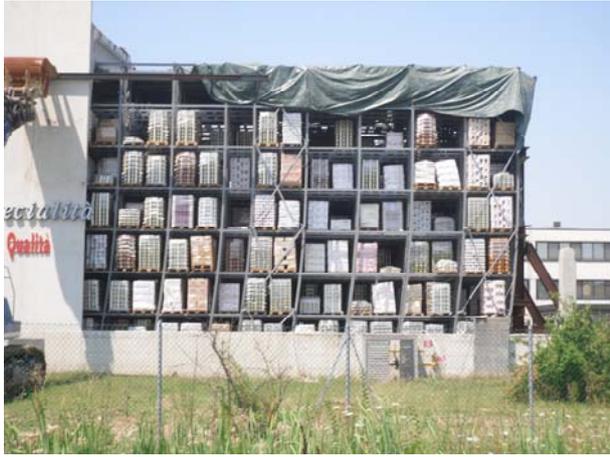
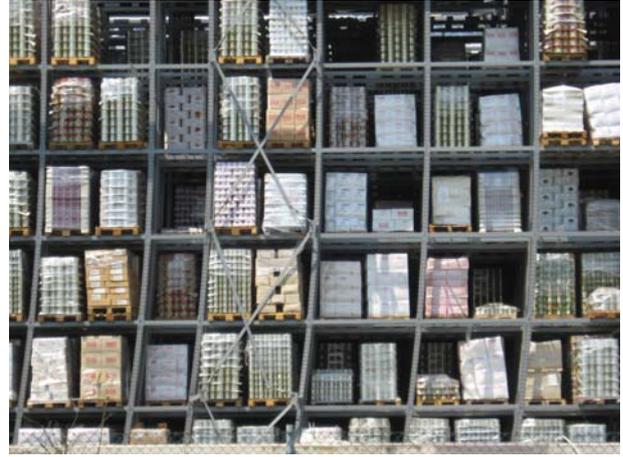
Figure 3.15. Deformed configuration of steel scaffolding system (Lat. 44.840301, Lon. 11.056790).

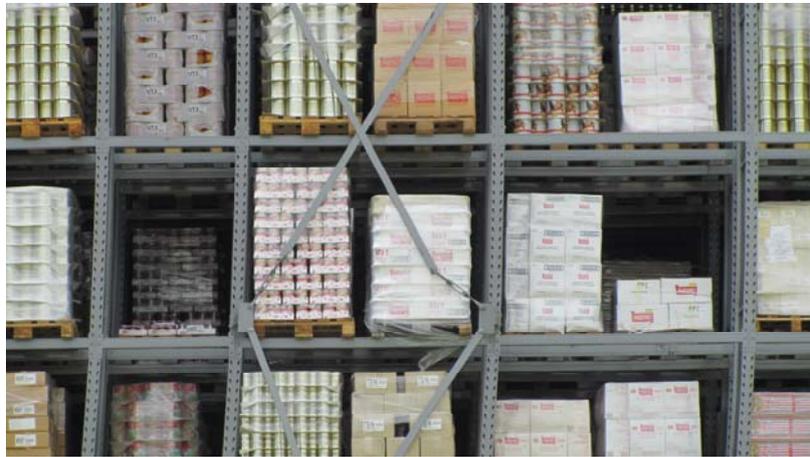
Figure 3.16. Rupture of steel diagonal in proximity of bracing joint (Lat. 44.840301, Lon. 11.056790).

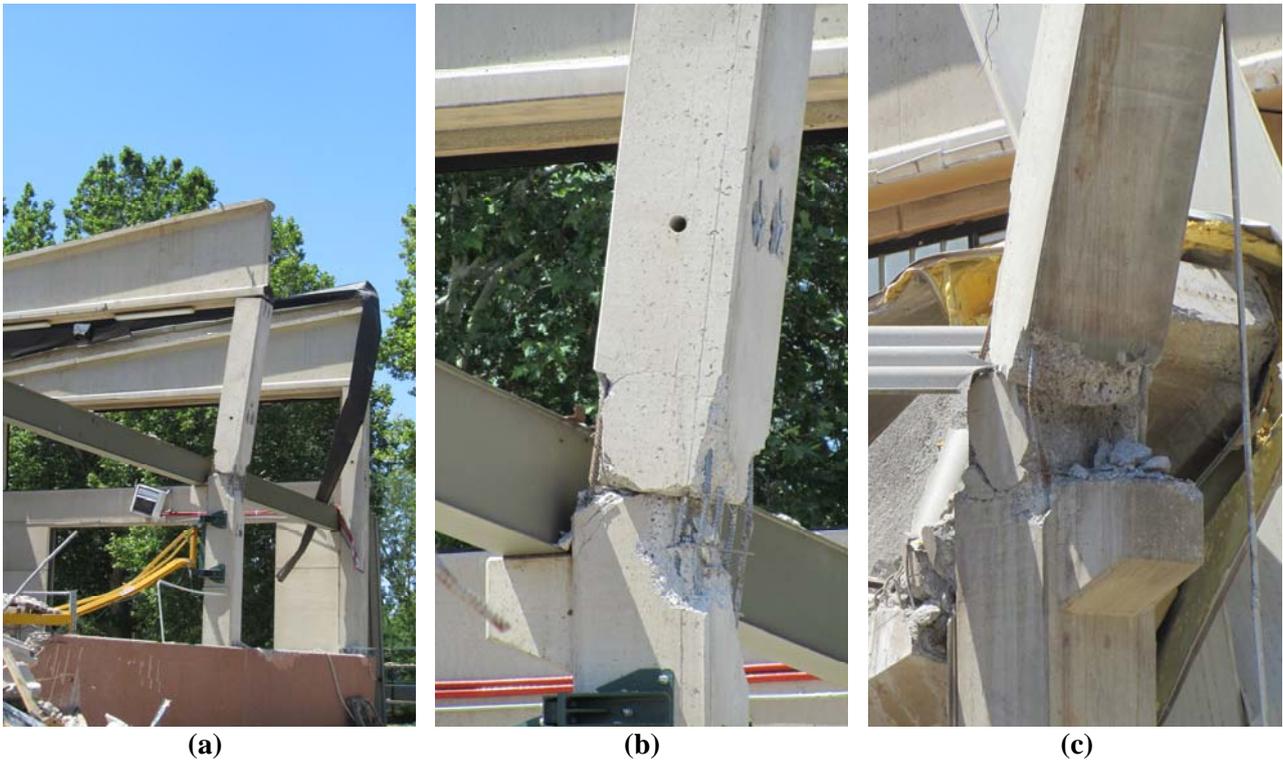
Figure 3.19. (a) Column damaged as a result of outward rotation; (b) damage to external beam-column joint; (c) damage close to beam seat (Lat. 44.847060, Lon. 11.208389).

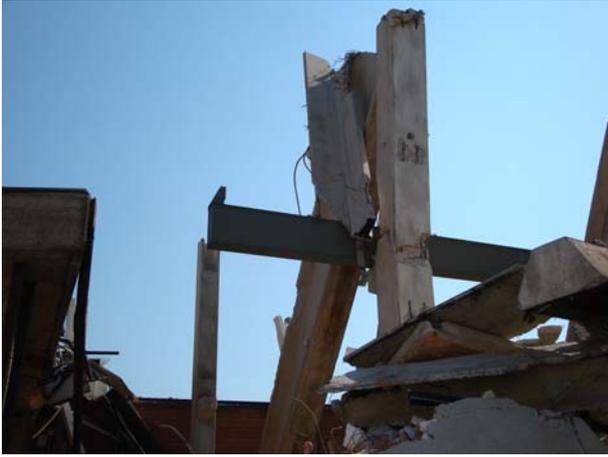
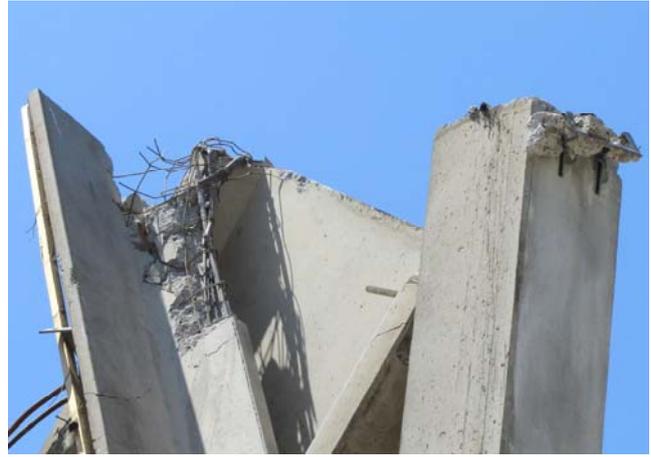
Figure 3.20. (a) General view and (b) detail of collapsed PC roof beam (Lat. 44.847060, Lon. 11.208389).

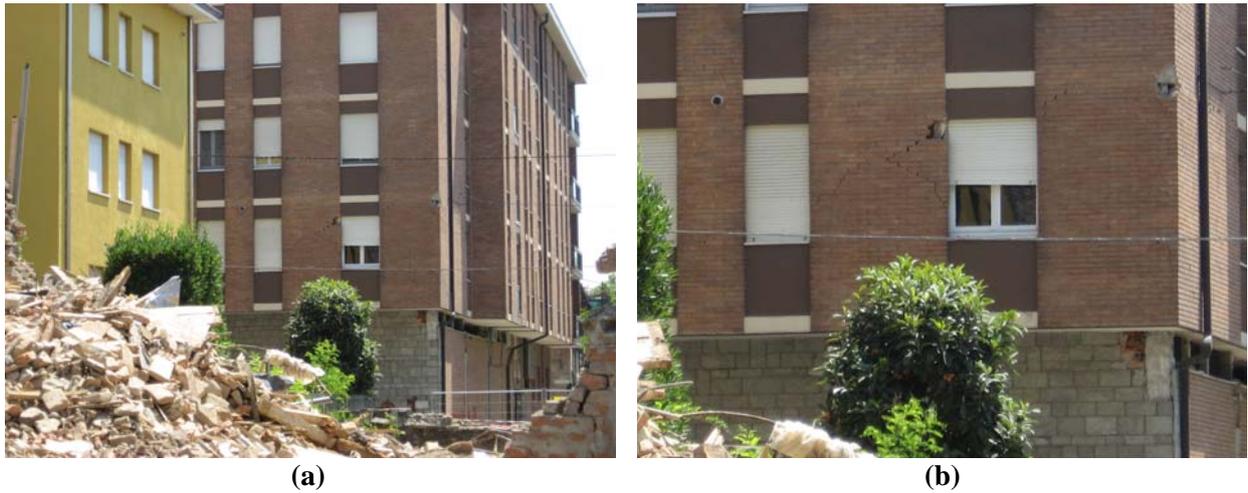
Figure 4.1. Non-structural damage to RC building in Mirandola (Lat. 44.885774, Lon. 11.065298): (a) General view of the building; (b) Detail of diagonal shear cracking of solid brick masonry infill wall at the first floor and local crushing of infill wall at the ground floor, close to the beam-column joint.

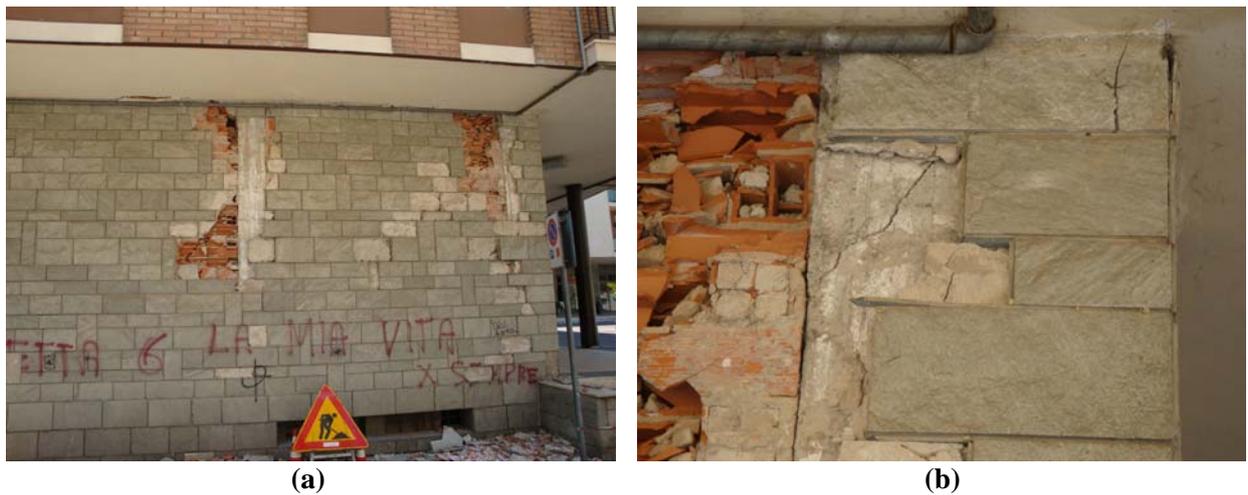
Figure 4.2. Non-structural damage to RC building in Mirandola (Lat. 44.885774, Lon. 11.065298): (a) Local crushing of hollow brick masonry infill wall at the interface with RC columns of ground floor; (b) Detail of shear cracking of RC column due to column-wall interaction under horizontal seismic actions.

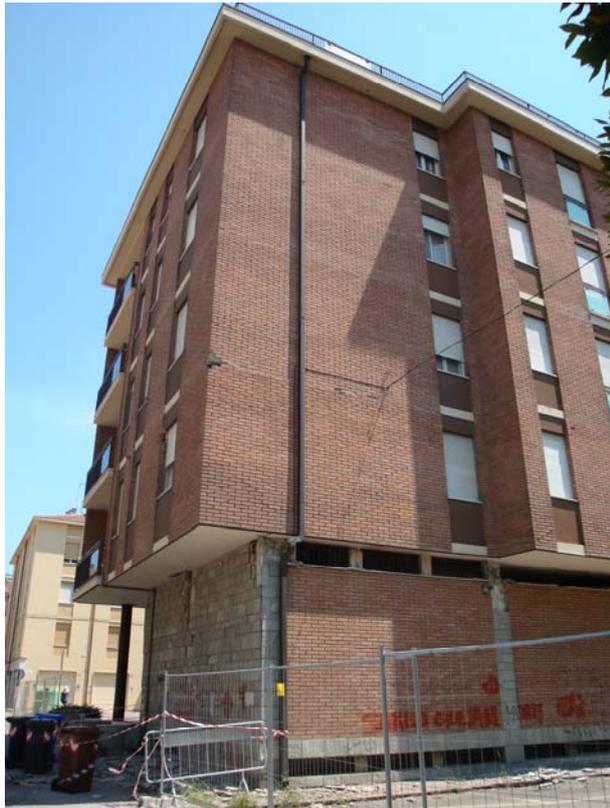
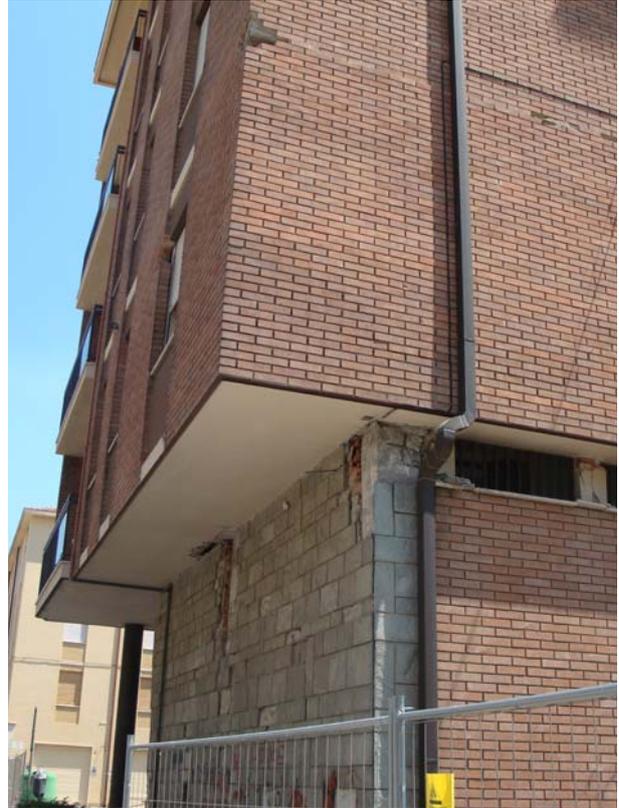
Figure 4.3. Damage to RC building in Mirandola (Lat. 44.885774, Lon. 11.065298): (a) Corner view; (b) Detail of local crushing of hollow brick masonry infill wall.

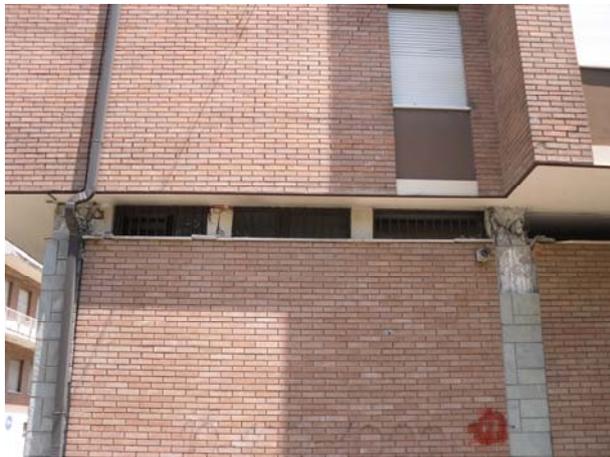
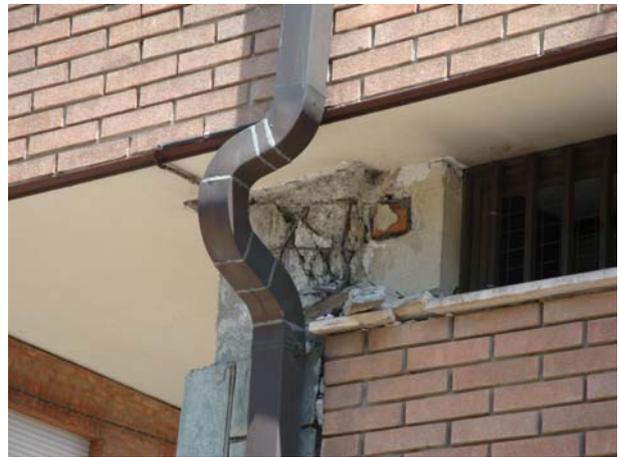
Figure 4.4. Structural damage to RC building in Mirandola (Lat. 44.885774, Lon. 11.065298): (a) Failure of columns due to interaction with partial infill wall; (b) Shear crack with typical diagonal shear crack in corner column.

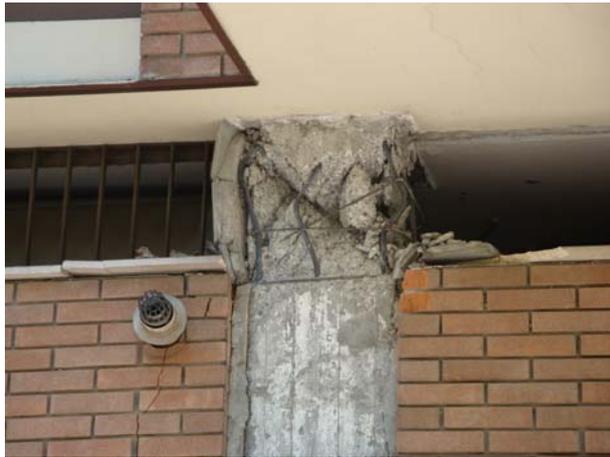
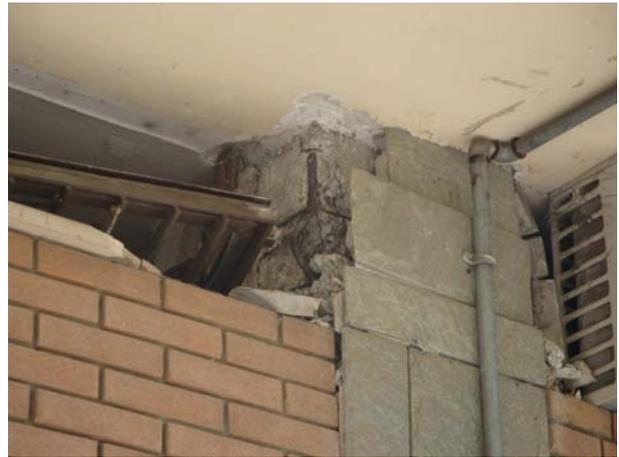
Figure 4.5. Structural damage to RC building in Mirandola (Lat. 44.885774, Lon. 11.065298): (a) Damage with large diagonal shear crack in intermediate column; (b) Buckling of longitudinal steel bar in intermediate column.

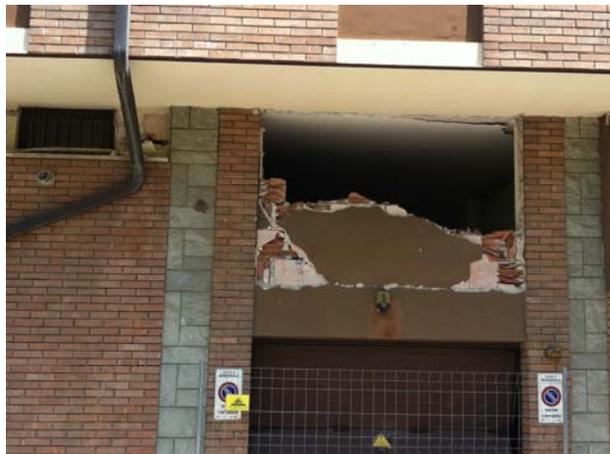
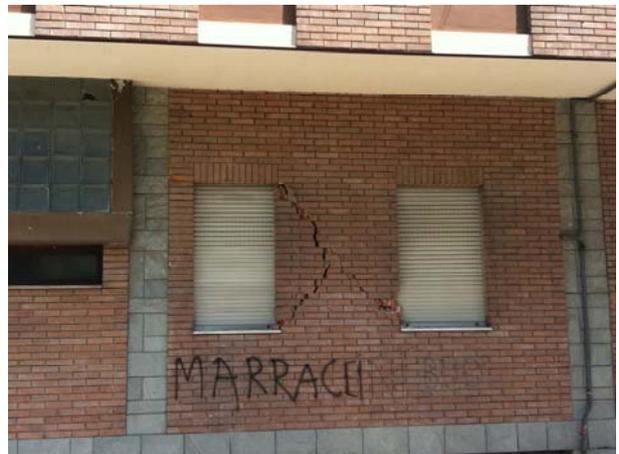
Figure 4.6. Non-structural damage to RC building in Mirandola (Lat. 44.885774, Lon. 11.065298): (a) Collapsed panel above large opening at the ground floor; (b) Diagonal shear cracks in solid brick masonry infill wall.

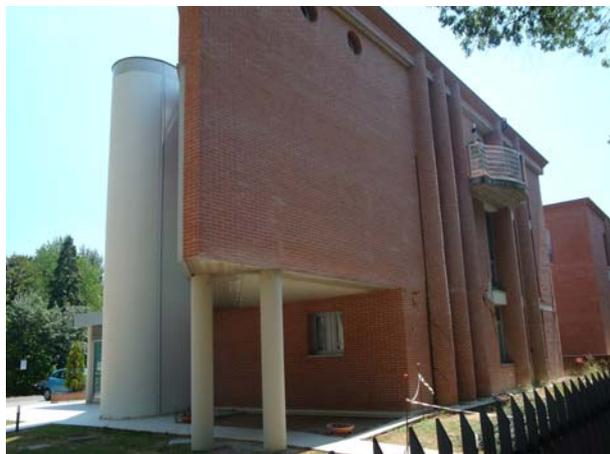
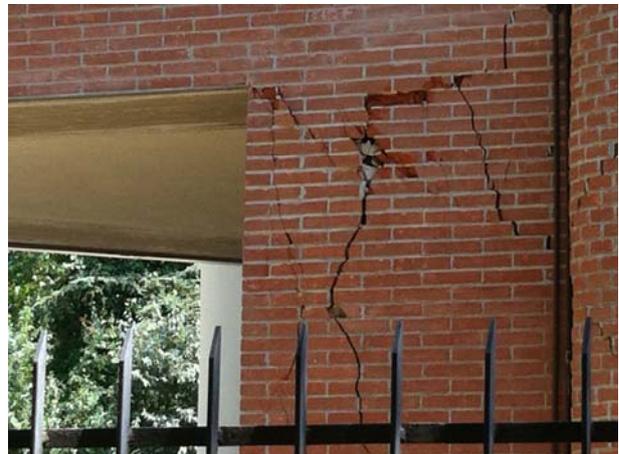
Figure 4.7. Damage to RC building in Mirandola (Lat. 44.883916, Lon. 11.065483).

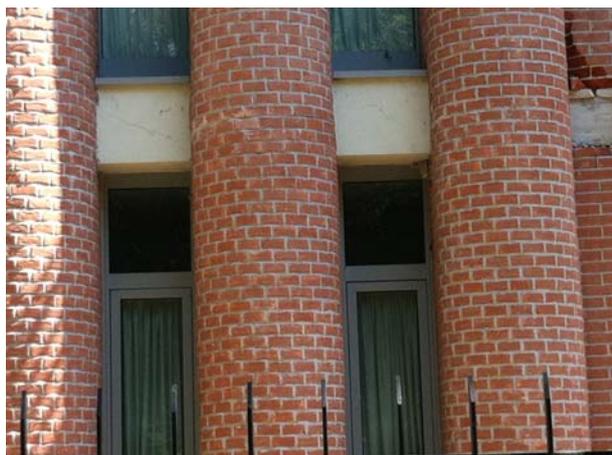
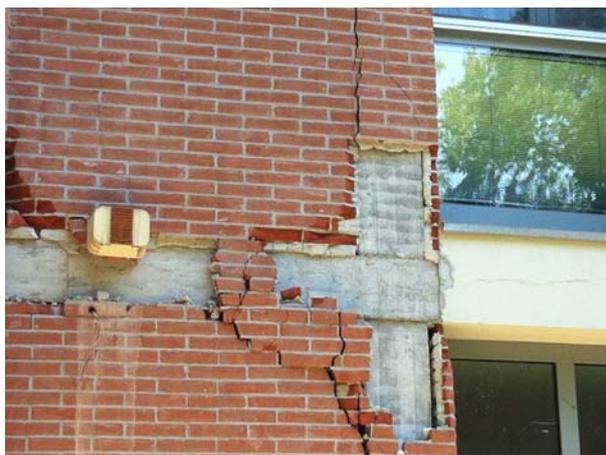
Figure 4.8. Damage to RC building in Mirandola (Lat. 44.883916, Lon. 11.065483): (a) Early shear cracking of deep beams; (b) Partial external leaf detachment of solid bricks infill wall.
