Case Study: Seismic Retrofitting of a Medieval Bell Tower with FRP

Edoardo Cosenza¹ and Iunio Iervolino²

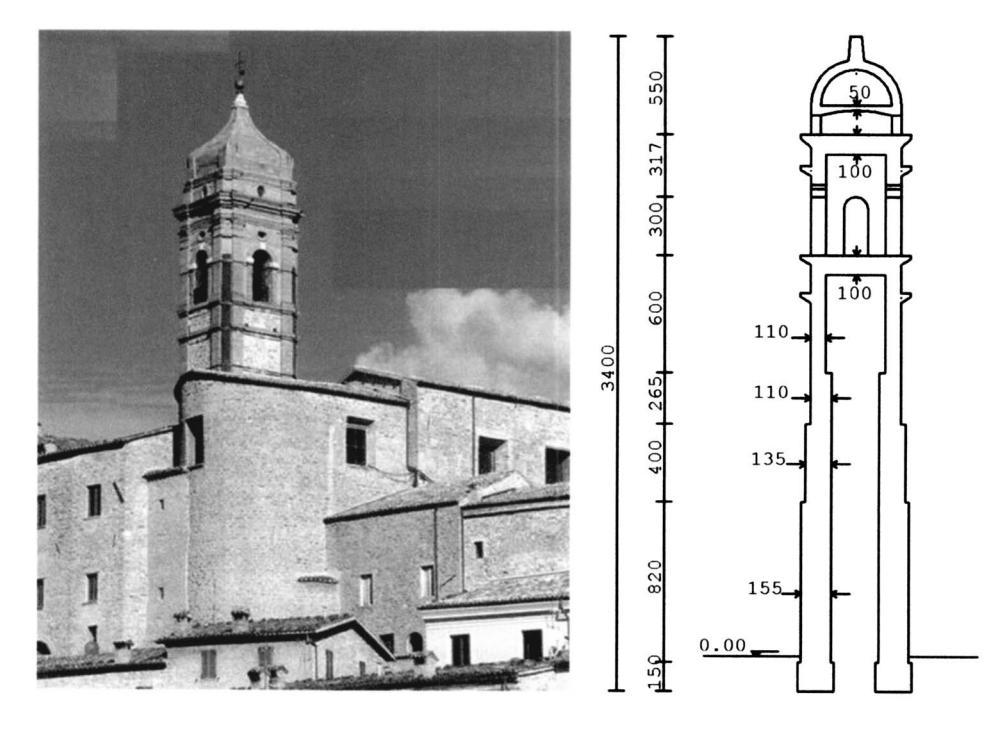
Fig. 1. Bell tower in Serra San Quirico after intervention and its longitudinal section (all measures in cm)

Affected by the Umbria–Marche earthquake (1997) (Mw 6), the bell tower of Santa Lucia's Church (Fig. 1) is a faced (multilayer) masonry structure built in the XVth century. It is located at the center of the little town of Serra San Quirico, a medieval suburb near Ancona, and is surrounded by many residential constructions of the same age. It is a calcareous masonry building, about 30 m in height and 1,200 tons in weight with a rectangular plan view. The wall thickness is 1.20 m at the basement and 0.80 m at the top. Along one direction the tower is connected to the vault roof of the church at about one-third of its height (see Fig. 5). The foundation is simply made of an augmentation of wall thickness 1.5 m underground. Nonstructural elements include wooden stairs and floors, the latter made of simply supported wooden boards, which should be preserved.

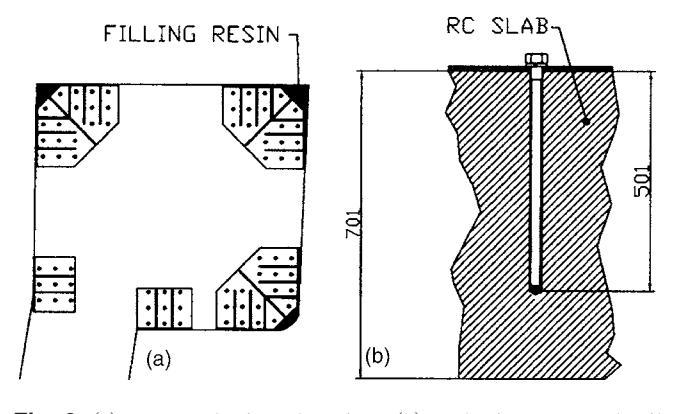
Fig. 6. (a) Base anchoring plan view; (b) anchoring system detail

At the base, four stainless steel plates [Fig. 6(a)] are fixed to the composite with resin. The contact area is 40 by 40 cm for each element. Anchoring plates are designed to be stiff because they should not be the weakest element of the system. The bottom of those plates is anchored into the RC slab by special stainless steel bolts [Fig. 6(b)], which were designed to transfer the ultimate force the FRP can sustain. A Hilti (http://www.hilti.com) anchoring system was used to achieve this target. In particular, expansive resins, injected into the drilled bolt holes, aid in transferring forces to concrete.

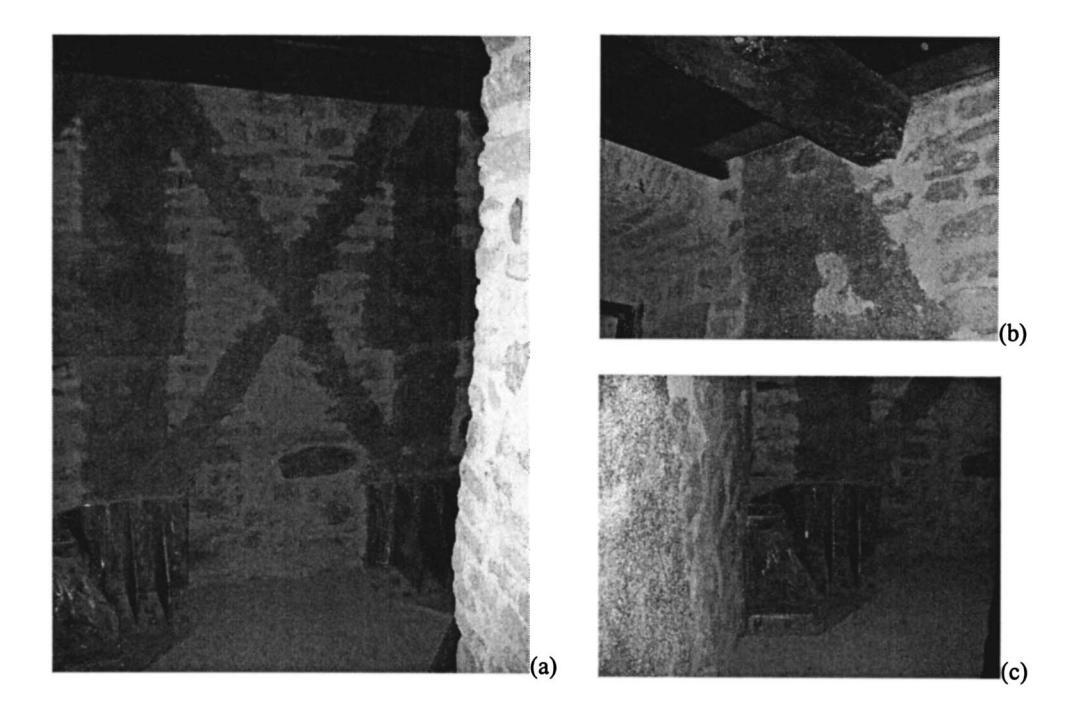
Fig. 13. (a) Installed composites and base anchorage; (b) composites near the unremoved wooden floor; and (c) intervention anchoring details

choring steel plate detail is shown, and the horizontal and oblique elements are displayed close to an original beam. The lack of brightness in the photos is because of the achievement of the "transparency" target by a surface treatment with sand, which gives the FRP an appearance more compatible with the original masonry.

Installation of composites strictly followed the design specifications. Even though the small available space and the presence of the nonstructural elements were constraining factors, the composite allowed a simple application and implementation of the intervention. The FRP was installed without removing the original wooden beams, while floors, which are made of wooden boards simply supported by the mentioned beams, were temporarily removed and put in place again at the end. The composite's reticular system geometry was also locally modified to not pass over the tower openings. Fig. 13 highlights those aspects where the an-
