# Analytic Back Calculation of Debris Flow Damage Incurred to a Masonry Building: The Case of Scaletta Zanclea 2009 Event

**Abstract.** In an attempt to do a back analysis of the damages caused to a nineteenth century masonry structure due to the October 2009 flash flood/debris flow event in Scaletta Zanclea, the flood discharge hydrograph is reconstructed in the ungauged conditions. The hydrograph for the solid discharge is then estimated by scaling up the liquid volume to the estimated debris volume. The debris flow diffusion is simulated by solving the differential equations for a single-phase 2D flow employing triangular mesh elements, taking into account also the channelling of the flow through the buildings. The damage to the building is modelled, based on the maximum hydraulic actions caused by the debris flow, using 2D finite shell elements to model the building, boundary conditions provided by the openings, floor slab, orthogonal wall panels, and the foundation. The reconstruction of the event and the damages to the case-study building confirms the location of the damages induced by the event.

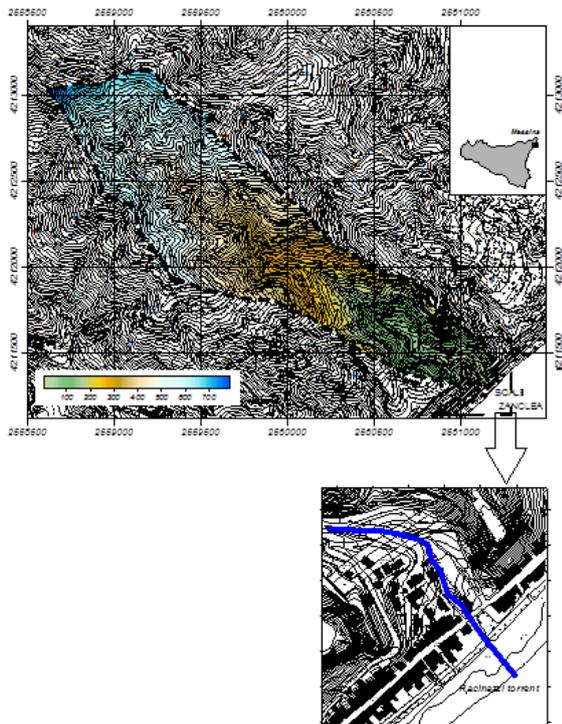
The small village of Scaletta Zanclea is located on the Ionic sea in the North-Eastern part of Sicily, and 20 km in the south-eastern side of the city of Messina. The village is crossed by the Racinazzi torrent whose catchment has an area of approximately 1.6 km<sup>2</sup> with elevations that range between 0 and 790 m a.s.l. and an average value of 384 m a.s.l. (**Errore. L'origine riferimento non è stata trovata.**). The topography is very rugged and the slope is steep (average value is 0.18) as is that of a number of its tributaries, some of which are incised into narrow pathways as they approach the main channel whose length is about 3.3 km.

Figure 1. Study area (Racinazzi catchment, left; Scaletta Zanclea village, right).

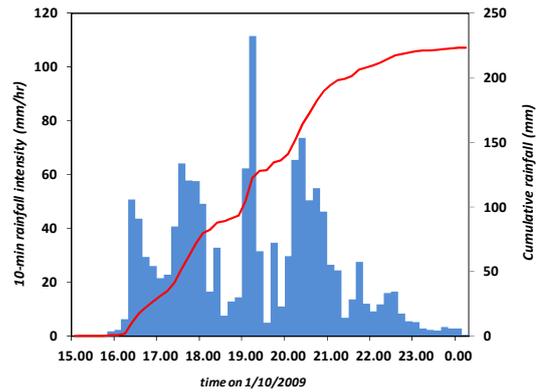
Rainfall maps (Aronica et al. 2010) show how the storm covered the southern part of the city of Messina and was concentrated on the Ionic sea coast and mainly in the area around Giampilieri and Scaletta Zanclea. The event happened over a few hours; more than 220 mm of rain fell in less than 4 hours with a peak of about 120 mm/hr in 10-minutes (**Errore. L'origine riferimento non è stata trovata.**).

Figure 2. 2009 event recorded hyetograph.

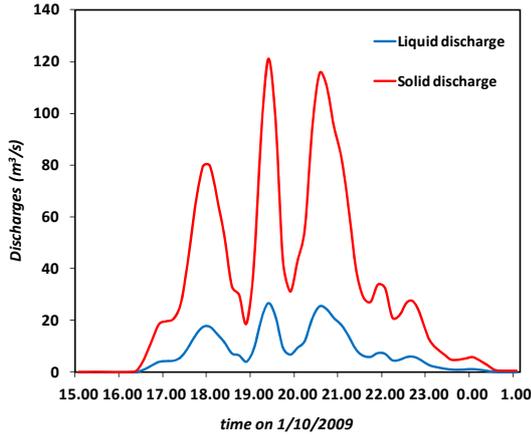
Post-event analysis and a comparison with similar events in a catchment close to the Racinazzi (Aronica et al. 2012) led to an estimation of solid debris volume around 0.54 Mm<sup>3</sup>. Now, by considering an equilibrium solid concentration of 0.45 the resulting mixture volume is around 1.2 Mm<sup>3</sup> and the Takahashi amplification coefficient is equal to 4.5. The resulting hydrographs are reported in **Errore. L'origine riferimento non è stata trovata.**

Figure 3. Reconstructed liquid and solid flood hydrograph.

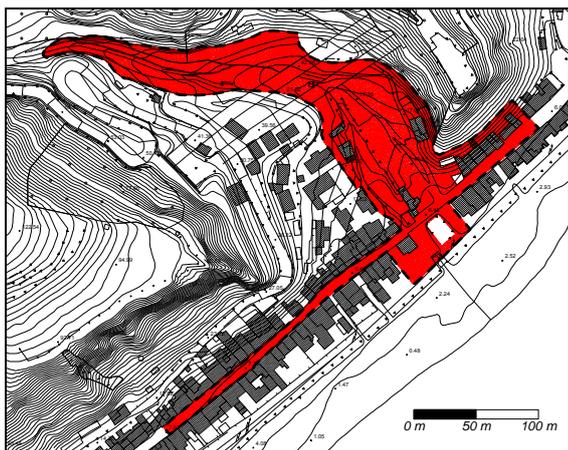
The definition of the finite element mesh boundary (Fig.3) was based upon the morphology of the study area in order to cover alluvial fan, to leave the blocks and the single houses out of the domain and to take in account internal barriers and hydraulic discontinuities. The total domain area is about 0.22 km<sup>2</sup> and was discretized in 13419 triangular elements. The geometric features ( $x,y,z$  coordinates) of 7282 nodes have been derived from the Digital Elevation Map (DEM) with 2m resolution (Fig.1). Regarding the parameters of the equations (2) expressing the friction terms the following values have been considered according to the results of a field survey carried out after the 2009 event:  $d = 2.5$  cm,  $\phi = 36^\circ$ ,  $c = 0.43$ ,  $c_s = 0.58$ ,  $\rho_s = 2650$  kg/m<sup>3</sup>,  $\rho = 1000$  kg/m<sup>3</sup>,  $a_B = 0.045$  and  $n = 0.025$  m<sup>-1/3</sup>/s.

Figure 4. Layout of the Finite elements mesh used for the hydrodynamic simulations.

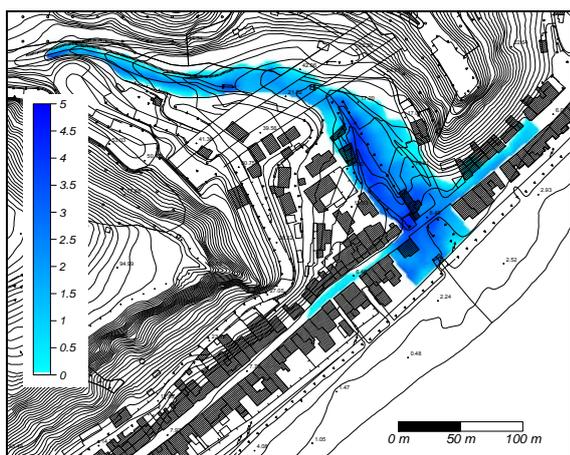
Given the reconstructed debris flow hydrograph (Errore. L'origine riferimento non è stata trovata.), maximum values of flow depths and flow velocity modules were computed in each node and element of the computational domain. Their spatial distribution is reported respectively in **Errore. L'origine riferimento non è stata trovata.** and **Errore. L'origine riferimento non è stata trovata.**

Figure 5. Map of maximum flow depths (colour scale in meters).

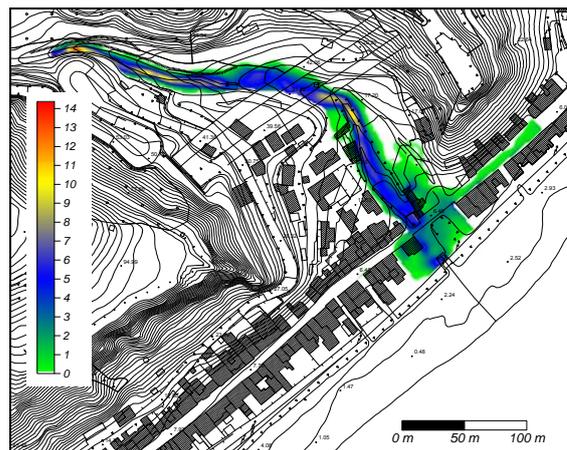
Figure 6. Map of maximum flow velocity modules (colour scale in m/s).

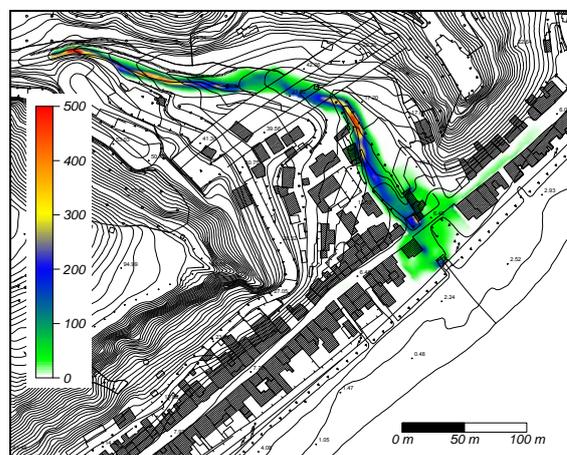
Moreover, for the purpose of this study the total hydrodynamic force per unit width (debris flow impact pressure) has been considered. This force can be calculated as follows (see e.g., Zanchetta et al. (2004)):

Figure 1. Map of maximum total hydrodynamic force for unit width (color scale in kN/m)

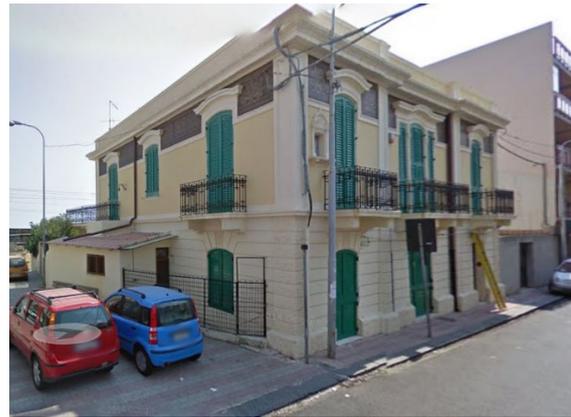
This edifice has been built at the end of 1800 and was restored after the 1908 Messina earthquake. It is composed of two levels; with a reinforced concrete slab in the first floor and a wooden roof with tiles. The structure is constituted by irregular masonry with fractured stone and parts of brick of little/medium size (Errore. L'origine riferimento non è stata trovata. and 10). This type of masonry was very common in Messina area during the past until 1950 years when it has been substituted by masonry totally in brick.

Figure 3. Edifice before the event of October 2009.

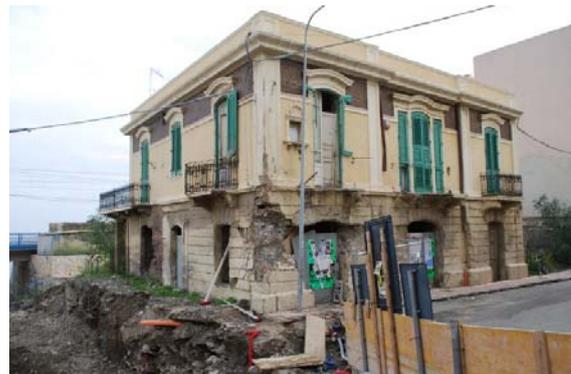
Figure 10. Edifice after the event of October 2009.

During the event of October 2009 the structure was seriously damaged. The Northern wall in principal facade (in front of "Consolare Valeria" road) presents the major damages in correspondence of the corner with Eastern wall, the upper-right corner of the left door and the right side of the middle door. Also the wall that is positioned parallel to the Racinazzi Torrent has suffered major damage in the wall panel to the left of the window in the corner with Northern wall. Moreover, a small dependent structure on this side of the building seems to have been swept away completely by the debris flow. All the doors were carried away by the mud that invaded the ground floor. The balconies of the first level and the parapets were broken and the edifice is not still inhabited.

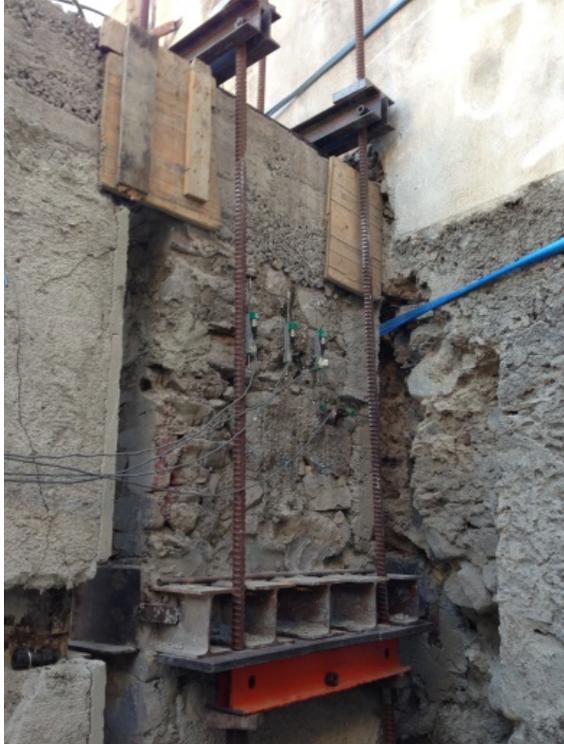
interposed between the metallic plates (Figure 41). Each side of the upper half of the panel was instrumented with three vertical transducers. A horizontal transducer was positioned at the centre line of both face of the upper half of the panel (Figure 11). The test was destructive and consisted in several cycles of loading and unloading with increasing the maximum values of the vertical compression load (Spinella et al. 2014).

Figure 4. Test setup for panel in compression.

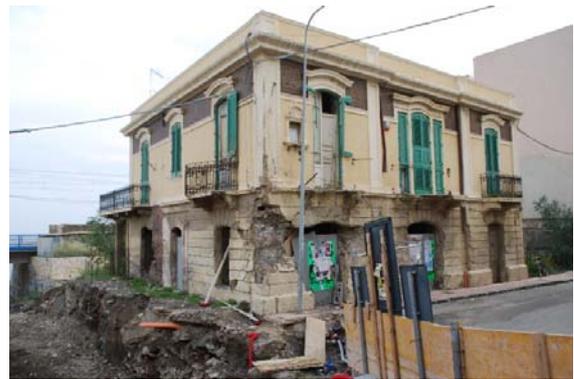
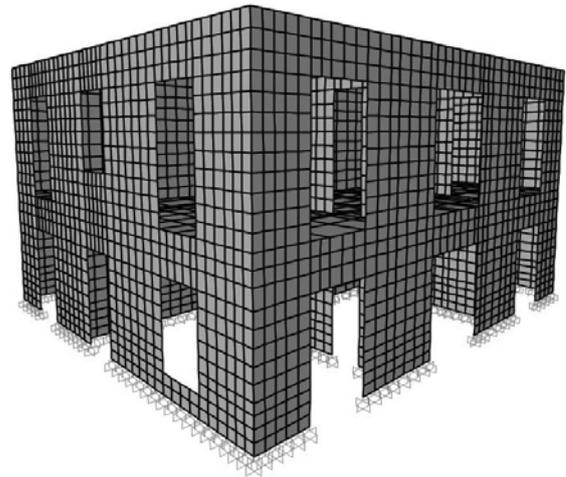
In order to model the building in question, the elastic 2D shell element of the SAP2000 software (**Errore. L'origine riferimento non è stata trovata.**) with a rectangular mesh discretization of dimension almost  $250 \times 250 \text{ mm}$  has been used. The thickness of the external walls in the first story are equal to  $750 \text{ mm}$ . **Errore. L'origine riferimento non è stata trovata.** shows the damaged wing in the building. As it can be seen in **Errore. L'origine riferimento non è stata trovata.**, the intact structure shows a small dependence in the correspondence of the eastern wall. We have not modeled this small structure because a) it seems to be built in a

Figure 5. a) Damaged building, b) 3D structural model in SAP 2000.

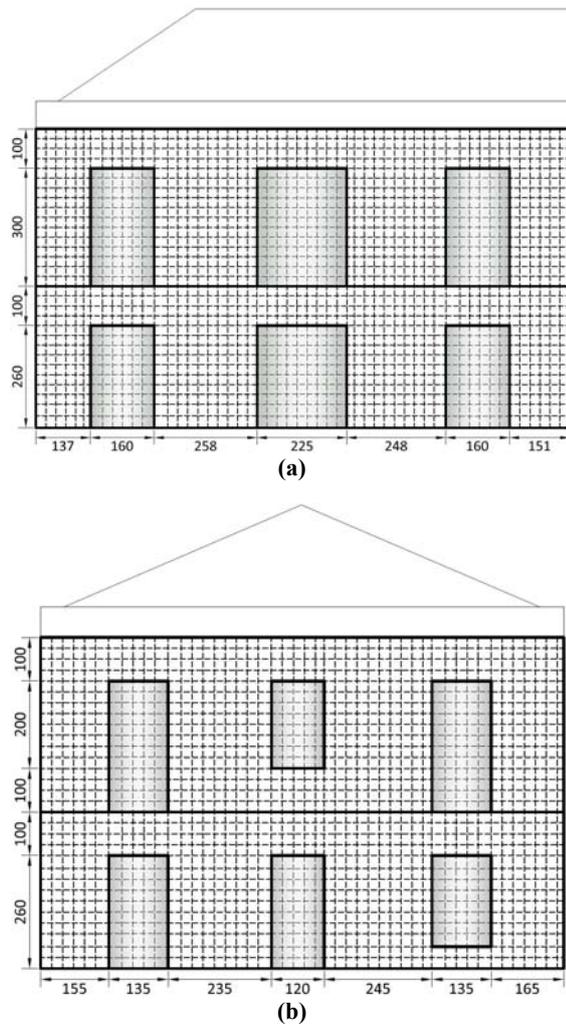
**Figure 6.** a) Northern wall, b) Eastern wall.

The structural analyses are based on the hypothesis that the openings (doors and windows) have remained closed during the flow. The reactions due to debris flow that acts on doors and windows are calculated and applied as forces to the door and windows' sides (assuming that doors and windows are just connected to two sides and they and their connections are not going to fail during the event and transfer all the loads to the sides). This hypothesis is only partially true; that is the openings were most probably closed at the beginning (given the fact that the event has taken place after midnight) but the evidence suggests that they were washed away during the event. It is to note that this hypothesis is conservative with respect to the alternative hypothesis that the doors and windows were not present. In the latter case, the hydrostatic forces will decrease due to the fact that the flow will infiltrate and fill the buildings' interior space. The analyses are done by neglecting the tangential component of hydrodynamic forces that act parallel to the wall panel. The effect of the accidental impact of the flow borne large objects has been considered in this analysis. As it can be seen in **Errore. L'origine riferimento non è stata trovata.** it seems a large pipe has impacted building and it is cause of local damages in the North-Eastern part of the building.

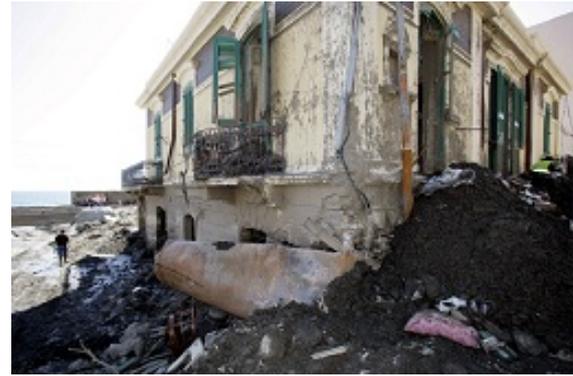
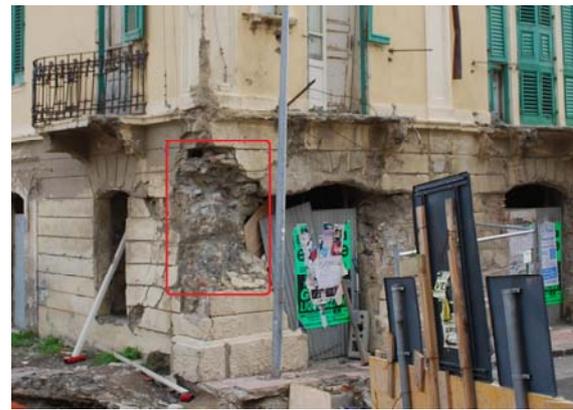
**Figure 74.** a) Large pipe that has impacted the building b) The local damage due to impact-type load.

The impact load applied by the pipe has roughly been estimated herein. The weight of the pipe is roughly estimated around  $W_D \approx 125$  kN (based on dimensions of the pipe with respect to dimensions of the building in Figure (14a)), the velocity of object assumed to be equal to the maximum velocity of flow at Northern wall  $v_D \approx 2$  m/s (Figure 6), and duration of the impact is considered around  $t \approx 0.1$  sec. So, the estimated impact load is equal to:

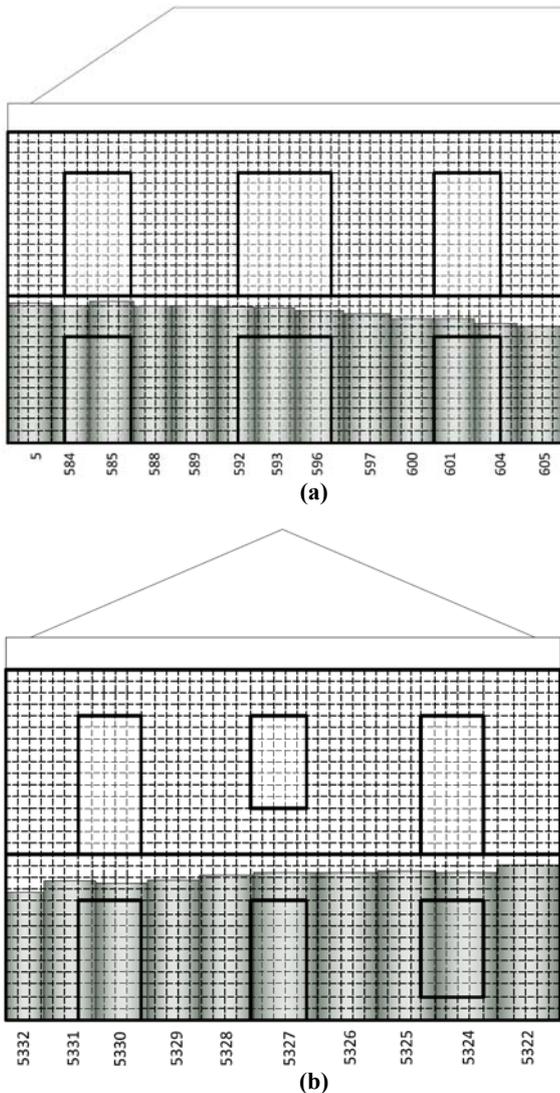
elements provides the depths, velocity modules and phases for each element in the mesh. Assuming a linear profile for the hydrostatic component, a constant value for the hydro-dynamic profile, and a concentrated force for impact. The total forces exerted to the exposed walls can be evaluated from Equation (3) and (3). **Errore. L'origine riferimento non è stata trovata.** demonstrates the footprint of the flow depth envelope on both walls of the building that is exposed to debris flow.

**Figure 8.** Maximum depth of the debris flow for a) The Northern wall, b) The Eastern wall.

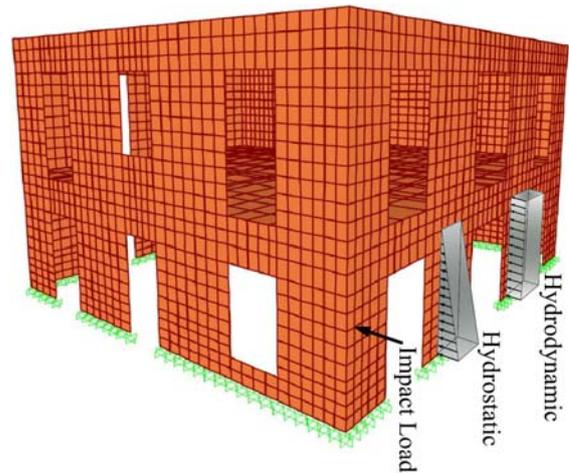
**Errore. L'origine riferimento non è stata trovata.** shows the graphical scheme of hydrostatic pressure, hydrodynamic pressure, and impact load due to debris flow on the building.

**Figure 96.** The schematic representation of hydrostatic and hydrodynamic components of debris flow pressure and the impact load due to flow borne object.

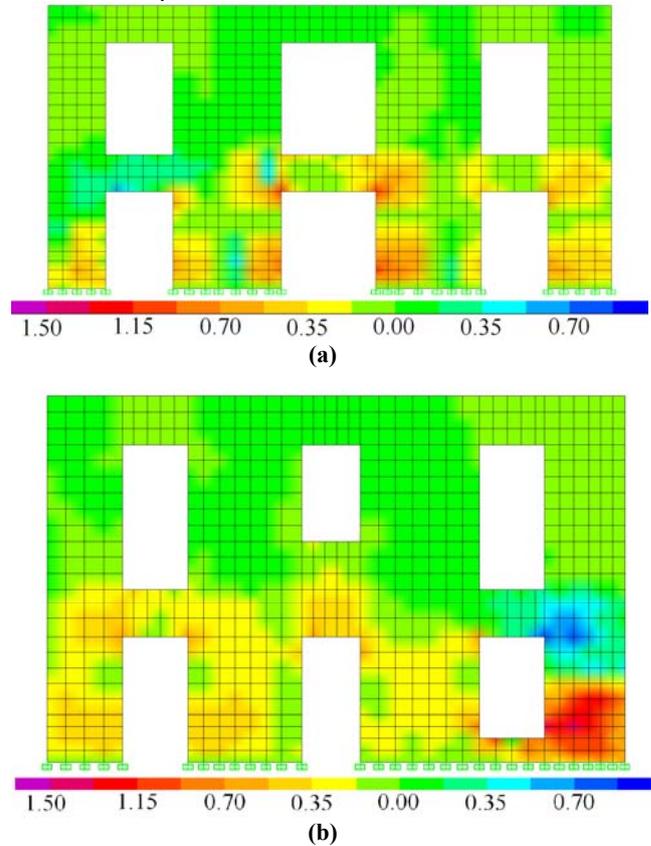
**Errore. L'origine riferimento non è stata trovata.** illustrates the damage pattern in the Northern and Eastern walls of the building due to in-plane shear stresses (the  $Y_{in-shear}$  is calculated in the previous section from Equation (5)). Since Equation (7) gives the average shear strength on the whole section, it must be compared with the average shear stress acting on the section. So, to compare the shear stresses calculated by SAP 2000 which are not the average value on a given section, the maximum allowed shear stress  $\tau_{lim}$  (Equation (7)) is multiplied by the ratio of  $(\tau_{max}/\tau_{average})$  estimated to be around 1.5 and then compared with the results of SAP 2000.

It can be observed that the Northern wall remains in the safe zone although some parts of the wall are close to the failure surface. On the other hand, the Eastern wall shows that the panel to the left of the window crosses the failure surface. It is important to note that the mathematical model used herein has limited capability in tracing the failure pattern in the walls. That is, the presumable stress re-distribution in the wall after the cracks progressively form cannot be captured by this linear-elastic model. Nevertheless, the model is reasonably capable of indicating where and how the wall starts to have problems due to stress concentration.

**Figure 17.** In-Plane ( $Y_{in-shear}$ ) axial-shear demand to capacity ratio for a) The Northern wall, b) The Eastern wall.

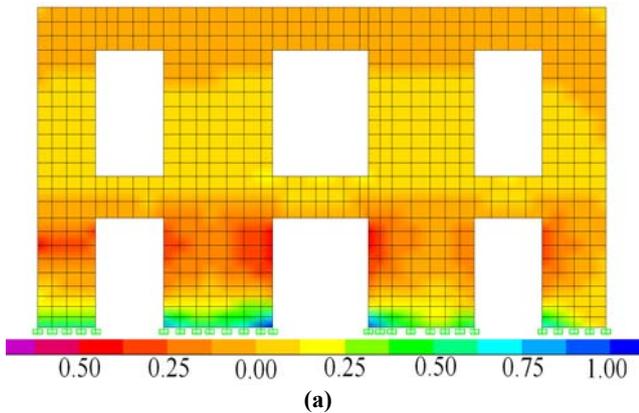
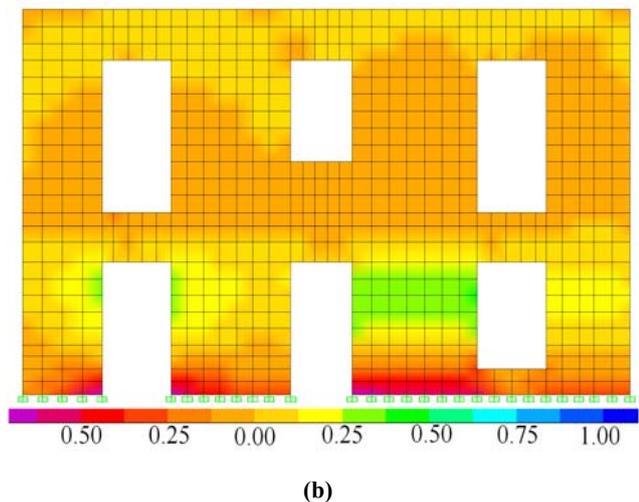
Figure 18 shows the  $Y_{op-f}$  distribution for out-of-plane base moment for the wall panels. As it was expected, given the width of the wall, the out-of-plane over-turning moment does not seem to be as critical as the in-plane shear failure modes considered before.

**Figure 18.** Out-of-Plane ( $Y_{op-f}$ ) moment demand to capacity ratio for a) The Northern wall, b) The Eastern wall.

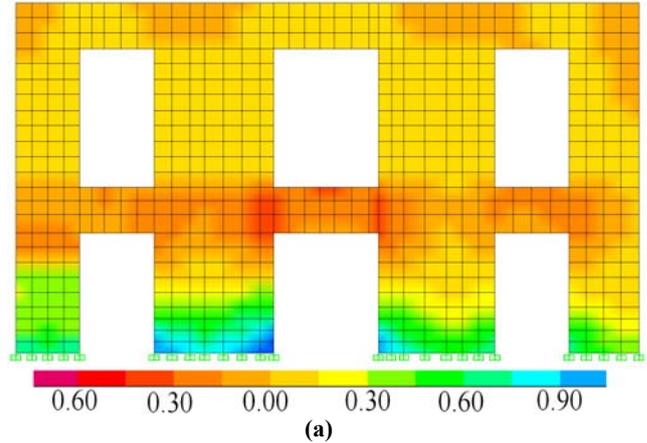
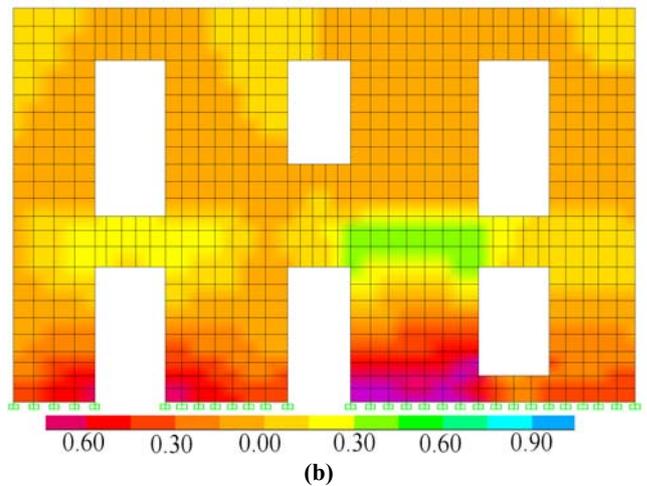
**Errore. L'origine riferimento non è stata trovata.** shows the damage pattern in the wall due to out-of-plane shear stresses ( $Y_{op-sliding}$  is calculated in the previous section from Equation **Errore. L'origine riferimento non è stata trovata.**). It can be seen that the Northern wall is more affected by the out-of-plane stress. In other words, it seems that it suffers more from the direct hydraulic forces exerted by the flow. This is while the Eastern wall seems to be affected more drastically by the reactions transferred from the orthogonal Northern wall.

**Figure 19.** Out-of-Plane ( $Y_{op-sliding}$ ) shear demand to capacity ratio for a) The Northern wall, b) The Eastern wall.

Recall that the analyses do not consider the component of the hydro-dynamic forces parallel to the wall panels. These forces seem to be small for the Northern wall. However, they seem to be quite large for the Eastern wall. This is backed both by the hydraulic calculations and the evidence provided by the balcony railing that is completely deformed by the flow. We have presumed that the hydrodynamic component parallel to the Eastern wall has mainly contributed to washing away the small dependence on the side of the building and has had little effect on the damage pattern observed on the rightmost panel in this wall.

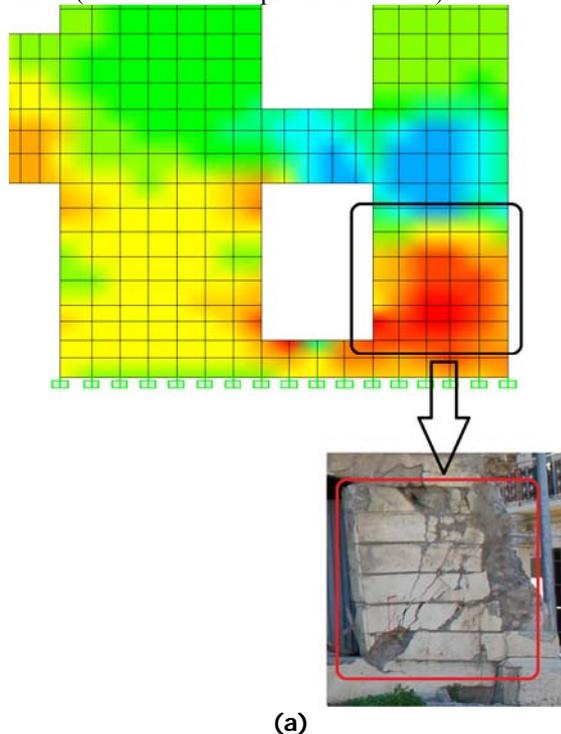
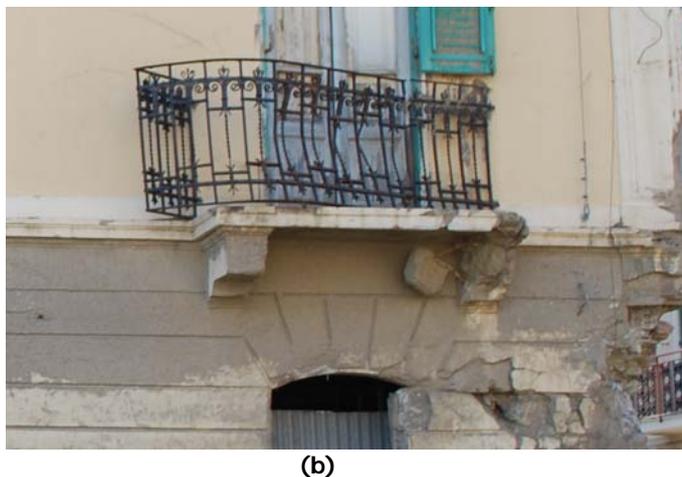
The results in terms of shear demand to capacity ratio are visually compared with the damage observed after the debris-flow. Figure highlights the visual signs of cracks on the Eastern wall panel and compares it with the in-plane stress pattern in the finite-element model. It can be seen that the finite element model manages to capture the in-plane shear failure in the rightmost panel. The figure shows also the deformation of the balcony railing due to the flow (discussed in the previous section).

**Figure 20.** a) Comparison between analysis result and the observed damage for the Eastern wall, b) Deformation of the balcony in the eastern side of building.

Damage on the Northern wall seems to be due to the effects of impact load as discussed before. As can be observed, the Northern wall shows signs of major damage in correspondence of the corner with Eastern wall.

The Figure demonstrates that the observed damage state is congruent with the results of the FEM analysis (as much as an elastic model can do). The damage pattern observed in the walls, apart from being a direct result of
