ADEGUAMENTO SISMICO REVERSIBILE DEL CAMPANILE DI SANTA LUCIA

SEISMIC AND REVERSIBLE UPGRADE OF THE BELL TOWER OF SANTA LUCIA

Seismic retrofitting of structures belonging to the architectural heritage requires meeting of constraints which are related to preservation of artistic features. Any developed intervention must do not change appearance, structural mechanism and must be also not invasive. These innovative principles, that are quite obvious from a cultural and artistic point of view, are very restrictive constraints to engineer's jobs but innovative materials, such as composites, may be helpful in the matter. This philosophy was applied to the design process of the retrofitting intervention for the bell tower of Serra S. Quirico (Ancona – Italy). A light FRP ties system have been gripped on the inner walls; this reinforcing

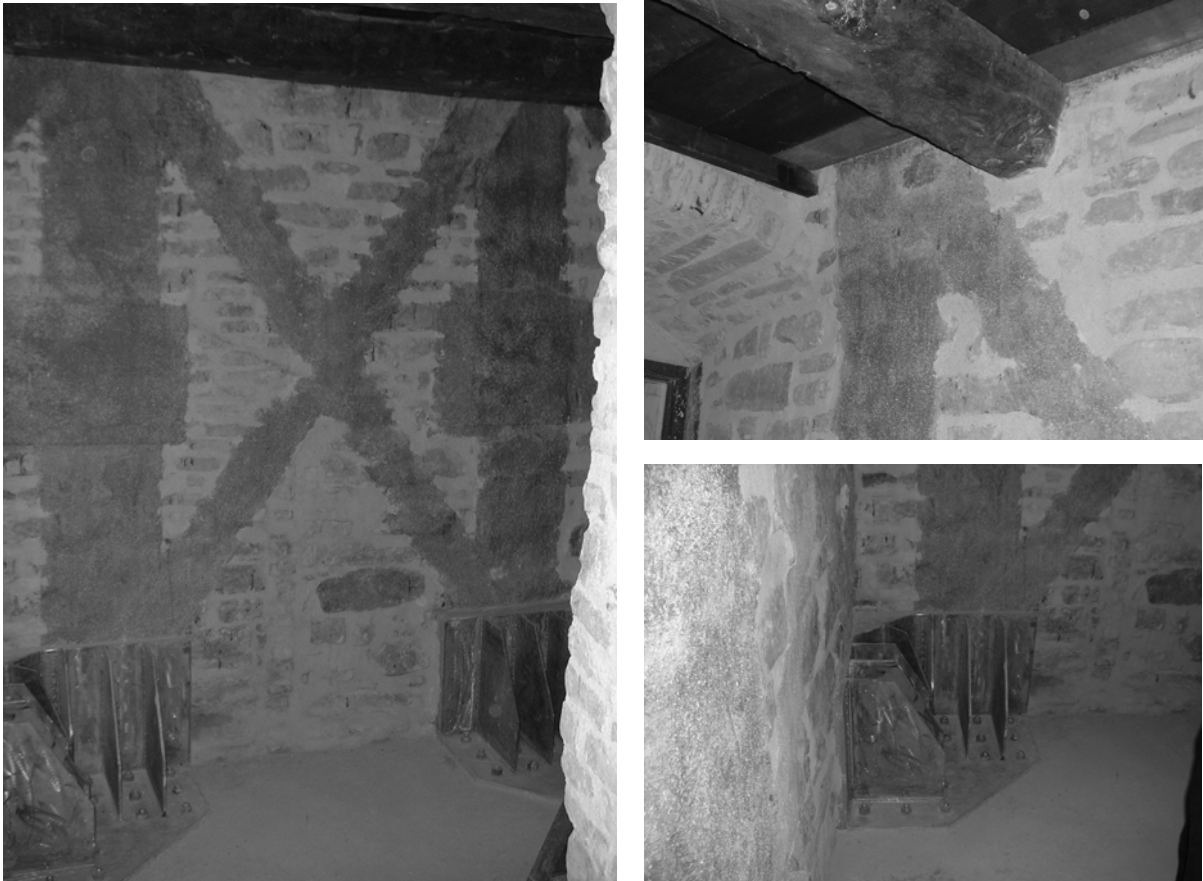
The composites installation strictly followed design specifications. Even though the small available space and the presence of the wood beams, the composite textile allowed a simple intervention installation. To obtain a good grip masonry samples were analysed to get the optimum surface treatment. In Figure 3 aspects are highlighted. Anchoring steel plate detail is shown, also the horizontal and oblique elements are displayed close to an original wooden beam. Anchoring plates are very stiff since it should not be the weakest element of the whole system. The focused plate is in the most irregular corner of the inner part of the bell tower, and then a large quantity of filling resin was needed. Horizontal elements improve FRP grip on masonry. The composite structural system geometry was locally modified to do not pass over the tower openings.

Figure 3. Installed composites and base anchorage. Composites near to un-removed wooden floor. Intervention anchoring details.

The lack of pictures brightness in the pictures is due to the achievement of the “transparency” target of the intervention design process: the improvement of structural strength is strong but the installation is “light”.

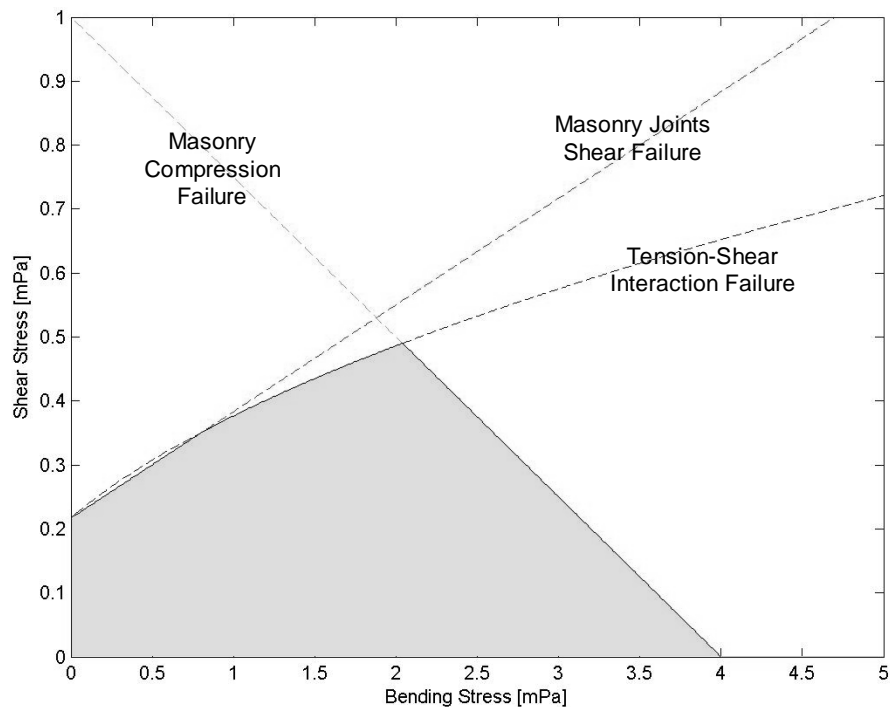
For the structure as un-retrofitted interaction of bending and shear has to be taken into account; it may induce early collapse. The Mann & Müller model [5] has been considered to plot the bending-shear stresses interaction domain which is given in Figure 5.

Figure 5. Bending-Shear Interaction domain.

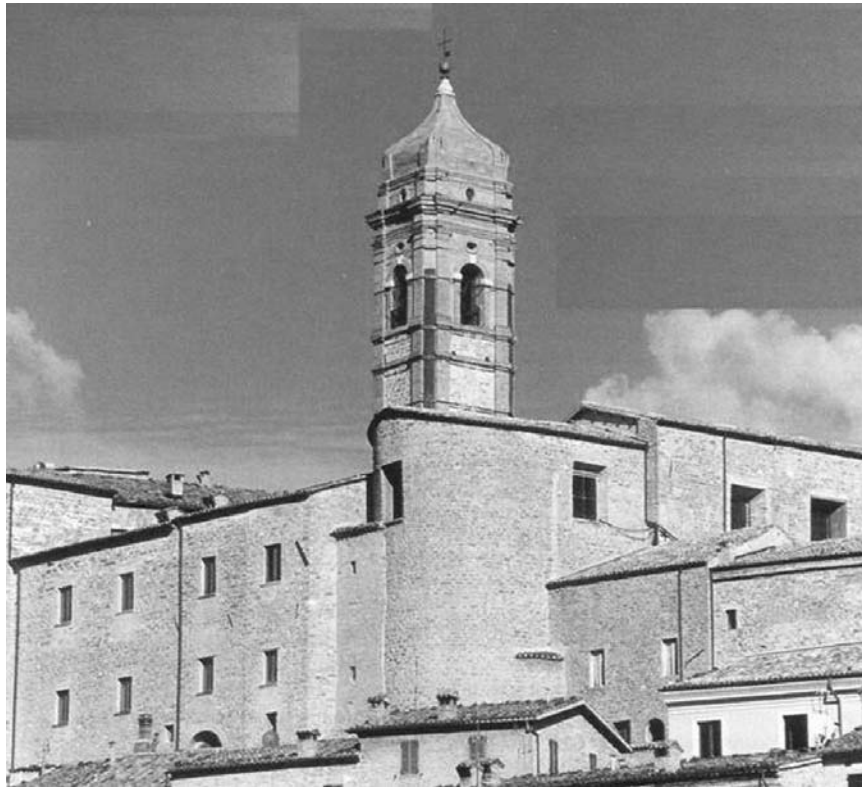
Figure 8. Bell tower after intervention.

The intervention on the bell tower of the S. Lucia's church is an interesting application of composite materials in the structural restoration. Transparency and low impact target are fully achieved avoiding holes and removal of wooden beams and slabs. The composites are placed directly on the masonry surface so they are removable and almost invisible. In Figure 8 one can see the bell tower after retrofitting application; one can see no evidence of the intervention.
