## 2.11 Post-event analysis of industrial structures behavior during L'Aquila earthquake

B. Faggiano<sup>1</sup>, I. Iervolino<sup>1</sup>, G. Magliulo<sup>1</sup>, G. Manfredi<sup>1</sup>, I. Vanzi<sup>2</sup> ■

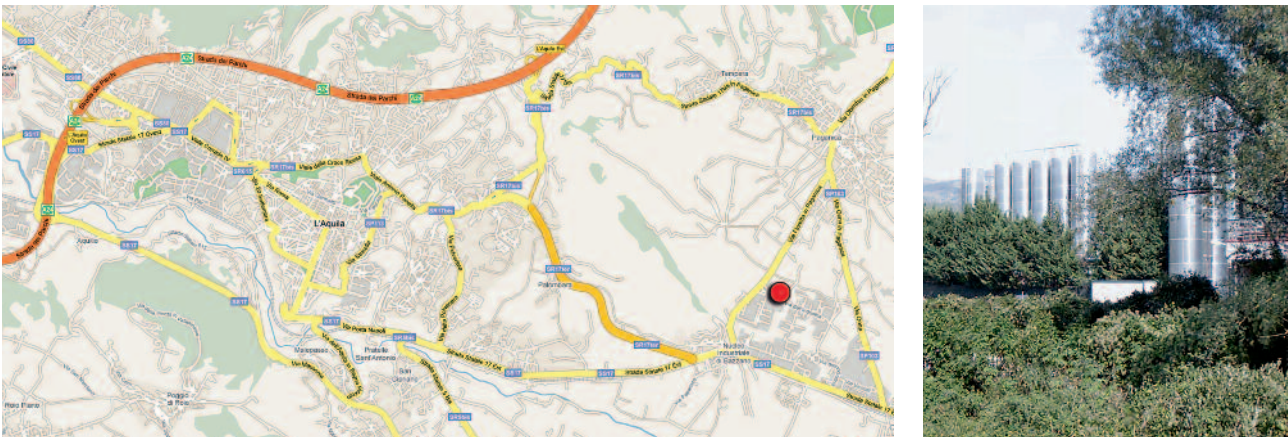
The sili of the Vibac multinational (a chemical company which produces plastic films), located in Bazzano, close to Onna (Fig. 6) represent an exceptional case of damage to steel constructions. They also represent an emblematic case of damage induced by the earthquake of April 6<sup>th</sup>. The sili are used for the storage of polypropylene pearls and they were full when earthquake struck (EERI, 2009). Some sili collapsed, some other remained standing even though strongly deformed, both locally at some rings and diffusely (Fig. 7).

Fig. 6  
(a) Localization of the plant VIBAC in the Bazzano municipality (AQ).  
(b) Sili before the earthquake.
