2.12 Emergency management for lifelines and rapid response after L'Aquila earthquake

M. Dolce¹⁻³, S. Giovinazzi², I. Iervolino³, E. Nigro³, A. Tang⁴ ■

2.12.1 Introduction

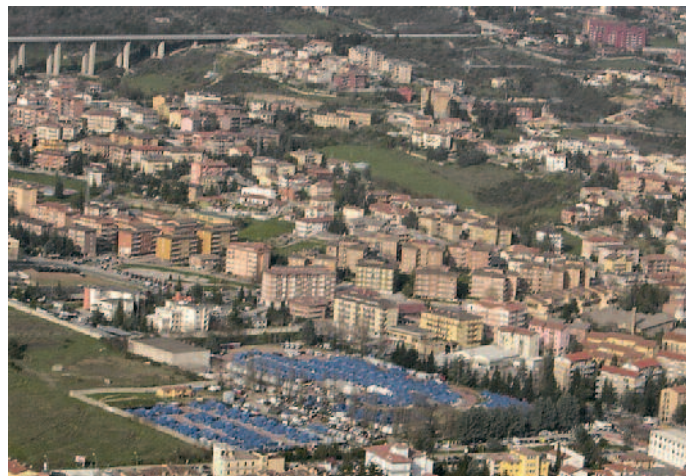
Fig. 7
 One of the relief campsite in L'Aquila set up by the Civil Defence.

to be completed by September 2009 (before winter arrives) for the victims, figure 7. These houses will be on a base isolation system to protect residents from future earthquakes. There were more than 30,000 victims settling in more than 160 campsites.
