# SEISMIC PERFORMANCE IMPROVEMENT OF THE BELL TOWER IN SERRA S. QUIRICO BY COMPOSITES

EDOARDO COSENZA AND IUNIO IERVOLINO

The focused structure is an aging bell tower affected by the Umbria-Marche earthquake (1997). the S. Lucia's church bell tower is a sac-masonry structure built during the xv century. It is a very tall structure (approx. 32 m; 1100 tons in weight) at the centre of the little town of serra S. Quirico that is a mid-age suburb near ancona (see Figure 1a).

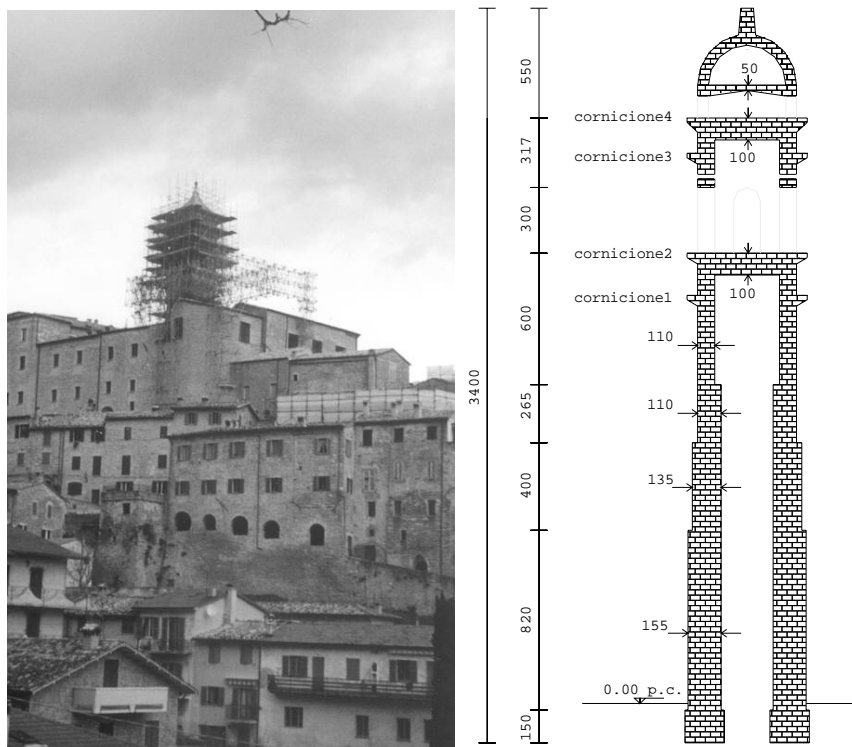
Figure 1. The bell tower in Serra S. Quirico and its structural section.

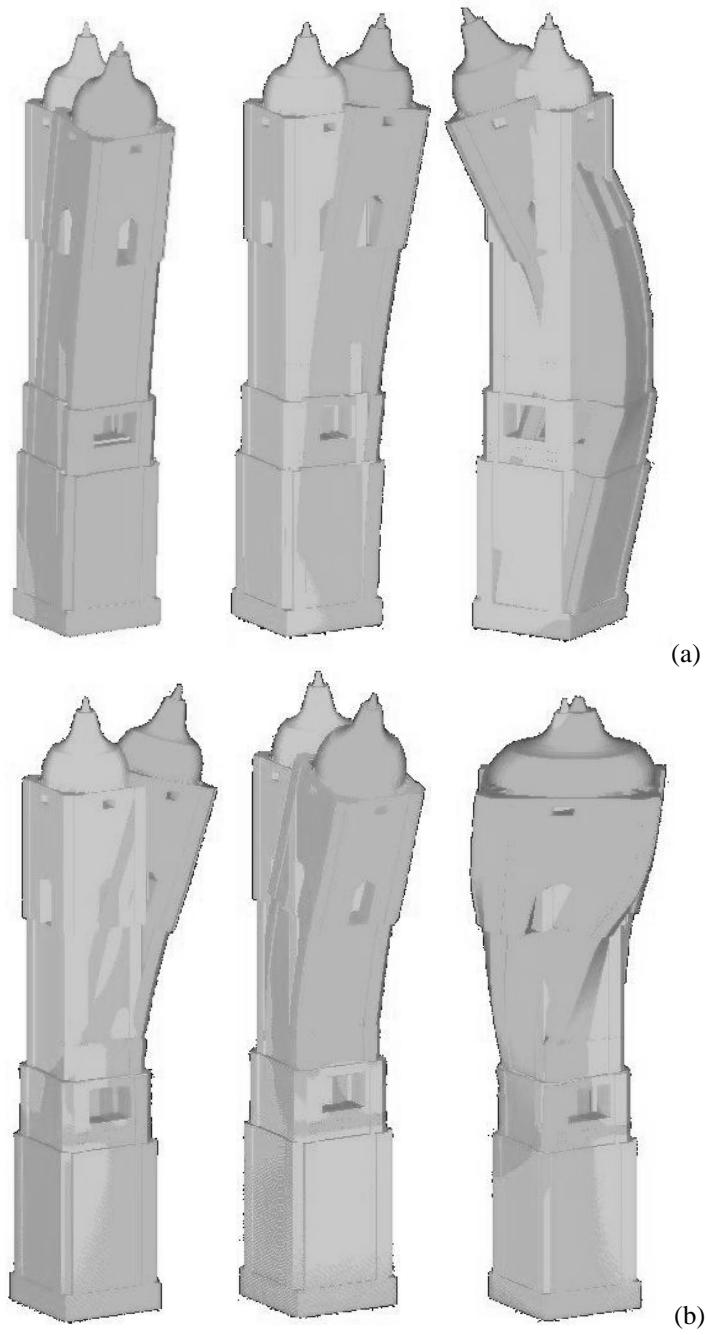
Experimental and numerical analyses are summarized in Table 1. The results in terms of natural frequencies and shapes clearly show constrain from surrounding buildings.

In Figure 2 modal shapes coming out from 3D FEM analysis are plotted for the first three modes in both the free and side-constrained subcases.

Figure 2. F.E. modal analysis for free (a) and constrained (b) conditions.
