Case Study: Seismic Retrofitting of a Medieval Bell Tower with FRP

Edoardo Cosenza¹ and Iunio Iervolino²

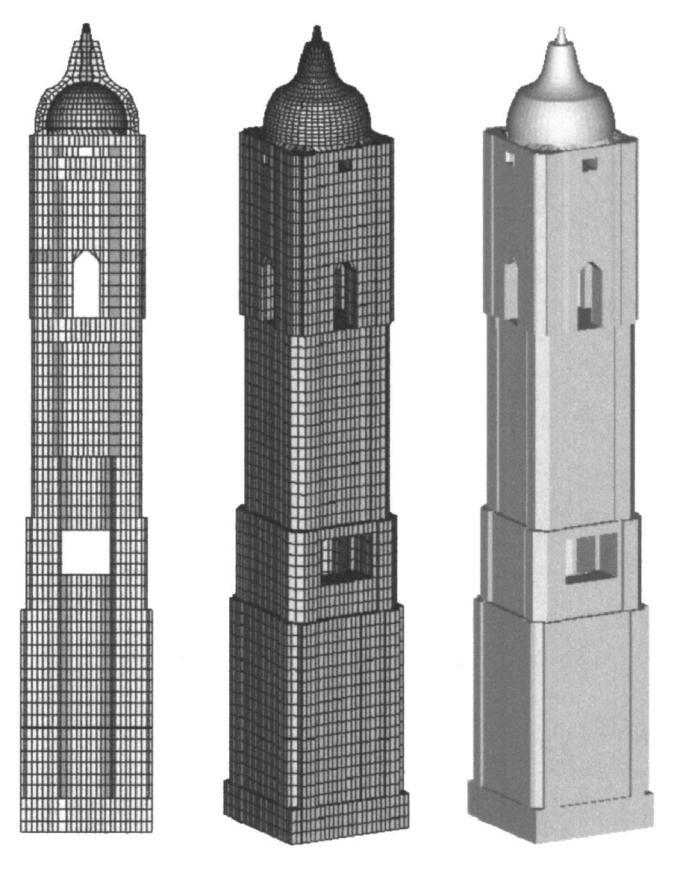
Fig. 2. 3D finite-element model and 3D rendering of structure

To evaluate the dynamic properties and the stress levels (from self-weight and seismic horizontal actions) of the masonry in ideal conditions, a finite-element model (FEM) was developed on the basis of a detailed relief of the structure specifically commissioned. The 3D model, defined by 33,000 nodes and 27,000 8-node solid elements (Fig. 2), was developed with Altair Hypermesh software (http://www.altair.com).

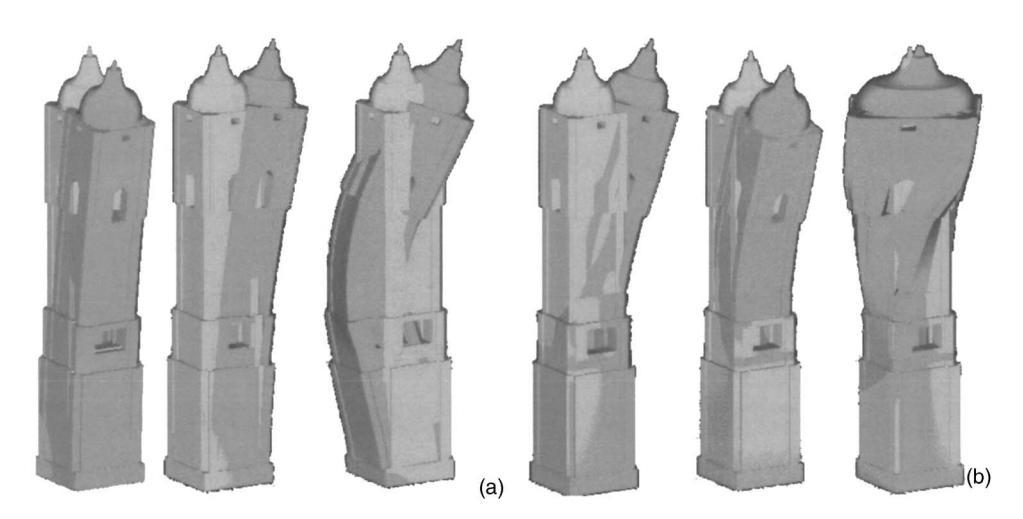
Fig. 3. Finite-element modal shapes for (a) free; (b) constrained cases

As discussed, the tower is connected to the nearby building at 9 m from the first floor. The degree of constraint exerted by the connected church was uncertain, and therefore two FE subcases

were analyzed: (1) the tower is considered constrained at its base only, and hence it is assumed that the adjacent structure does not have any influence on the static mechanism; and (2) the cloister's roof-line connection is simulated by lateral constraints, not allowing horizontal translations while permitting rotations. It is recognized that the real condition is defined within these two cases, providing an upper and lower bound, respectively. The FE analysis results (in terms of deformed shape) for the first three vibration modes are given in Fig. 3. In Table 2, for the same modes, the oscillation frequencies and corresponding periods are given for the tower when it is not constrained by the roof of the church and when the constraint given by the adjacent structure is considered. The two different conditions result in very different shapes and periods, and consequently in different seismic forces. This numerical analysis also suggested that the tower's ideal state is adequate, since compression stress because of self-weight does not exceed 5 kg/cm² (maximum at the base of the tower), which is far below the estimated masonry strength (about 40 kg/cm²).

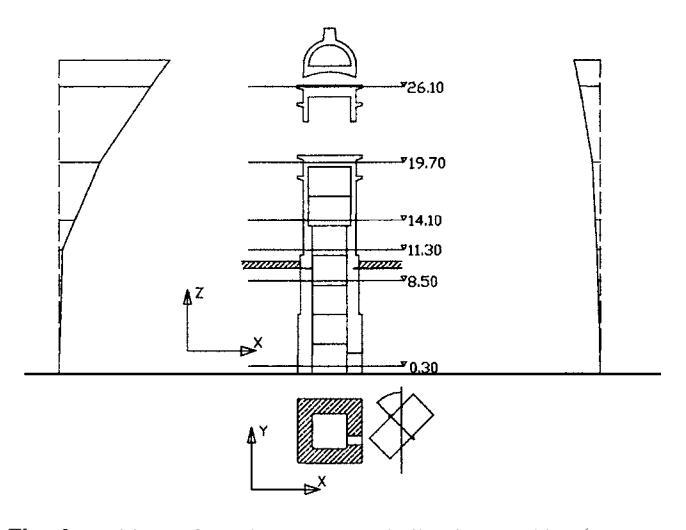
Fig. 4. Positions of accelerometers and vibrating machine (measures in m); experimental normalized first mode shapes in x- (right) and y-directions (left)

tional vibrating machine placed at the base of the structure with a 45° angle in respect to the plan view of the tower to excite both x- and y-directions at the same time. For the structural response measurements, 16 accelerometers positioned across two perpendicular directions at different heights (Fig. 4) were used. Inducing strong vibrations in this kind of structure can be dangerous, sometimes destroying what should be preserved, and therefore, very sensitive instruments were employed. These instruments can measure acceleration as low as 10 µg to identify the tower's natural frequencies by moderate dynamic forces, which do not induce any damage to the structure or to the adjacent buildings. The first two observed frequencies (Table 3) are 1.95 and 2.20 Hz. These values are bounded by those obtained in the 3D FE analyses considering the tower to be constrained only at its base (1.10 and 1.13 Hz) and closely related to the interaction with the adjacent church (2.27 and 2.40 Hz). The real constraint level is closer to the latter FE simulation rather than the former.

The experimental structural identification also shows that the natural frequency (corresponding to a bending mode) in the x-direction is lower than in the y-direction (Fig. 4). This happens because of a lower bending stiffness in the x-direction and/or because of the different constraint conditions. In fact, in the displacement diagram, a slope change happens at the bell tower's junction with the rest of the structure, which demonstrates a good connection with the church. The reliability of results from dynamic and FE analyses is established by the common identification of a third torsional mode. Because of the similarity of the numerical (ideal) and on-site data, it was also possible to conclude that no major damage or degradation were present in the structure. However, as described in the following paragraphs, the structure does not withstand the seismic demand at the site. and therefore the retrofit is still needed to reduce the seismic risk. The experiment also suggested that from the static point of view,

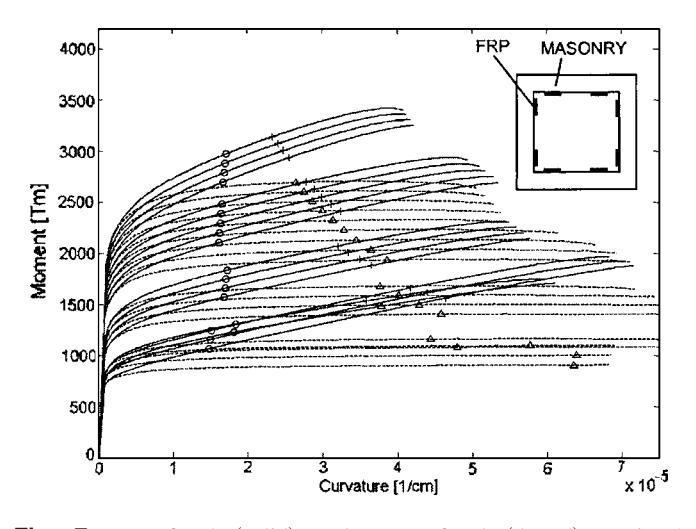
Fig. 7. Retrofitted (solid) and unretrofitted (dotted) sections' moment–curvature diagrams and scheme of typical reinforced cross section

peak deformation was 0.2% and ultimate deformation was 0.4%. The masonry was assumed to sustain no tension, and FRP has been considered linear-elastic in tension and not contributing to compression. Other mechanical assumptions were the equal deformation of FRP and masonry and that sections remained plane after deformation. Circles on the MC curves of Fig. 7 correspond to a 0.5% FRP deformation, while crosses and triangles refer to a 0.2% deformation of the masonry.

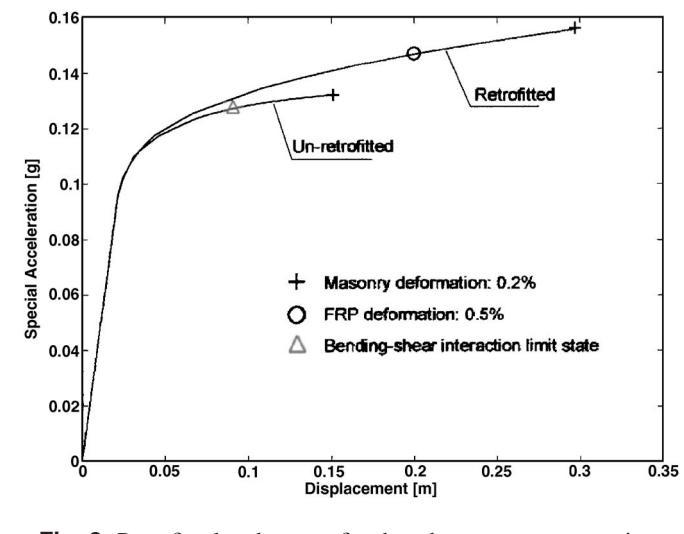
PO curves for the retrofitted and unretrofitted structures are given in Fig. 9, in which a *shear* limit state is considered. In fact, for the unretrofitted structure, the interaction of bending and shear has to be taken into account. The Mann and Müller model (1982) has been considered to include this failure mode as it reflects three limit states for the masonry: compression failure, shear failure (Mohr–Coulomb mechanism), and tension failure. The resulting bending–shear stress interaction domain is given in Fig. 10. Since the unretrofitted structure's real capacity is bounded by limit states of maximum masonry deformation and shear failure, both conditions are reported on the corresponding curve.

The effectiveness of the intervention can be preliminarily recognized by direct comparison of the two curves in Fig. 9; the capacity of the structure is enhanced independently of the limit state considered. The reticular composite system does not change the elastic behavior and the base-shear strength. On the other hand, by providing additional tensile capacity, the FRP system increases the maximum displacement the structure can undergo.

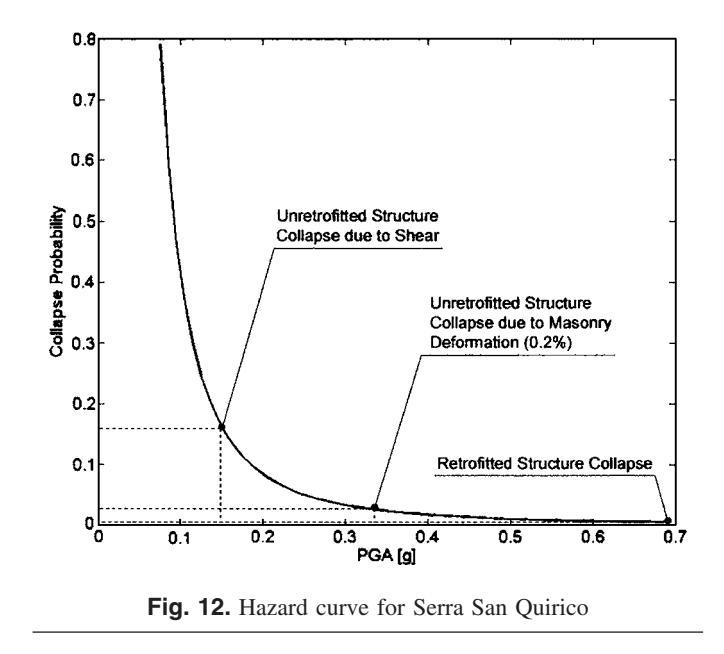
The seismic risk reduction (Fig. 12) induced by FRP retrofit is obtained by first computing the maximum PGA the structure can sustain. It is the PGA of the elastic spectrum that gives a performance point coincident with the collapse point of the PO curve. Second, the exceeding probability associated with this PGA (and therefore the collapse probability or seismic risk) is retrieved by the probabilistic hazard curve at the site. Fig. 12 shows the hazard curve for Serra San Quirico (SSN 2001), as well as the collapse PGAs for both the unretrofitted (referring to the two possible limit states) and the retrofitted structures. This risk analysis predicts a relatively high failure probability for the unreinforced structure, while the retrofitted design increases the safety margin by reducing the probability of the ground motion causing collapse to a value compatible with the historic and artistic relevance of the bell tower.
