Performance of the L'Aquila (central Italy) gas distribution network in the 2009 (M_w 6.3) earthquake

Simona Esposito · Sonia Giovinazzi ·
Ludovica Elefante · Iunio Iervolino

Received: 28 December 2012 / Accepted: 23 June 2013 / Published online: 2 July 2013
© Springer Science+Business Media Dordrecht 2013

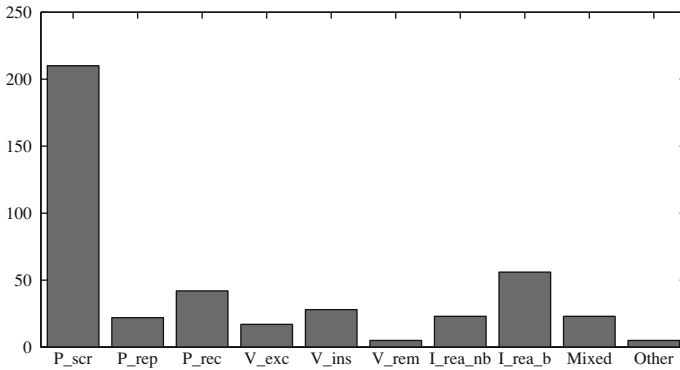
Fig. 3 Number of interventions to the components of L’Aquila gas system for each identified maintenance/repair category, as defined in Table 1

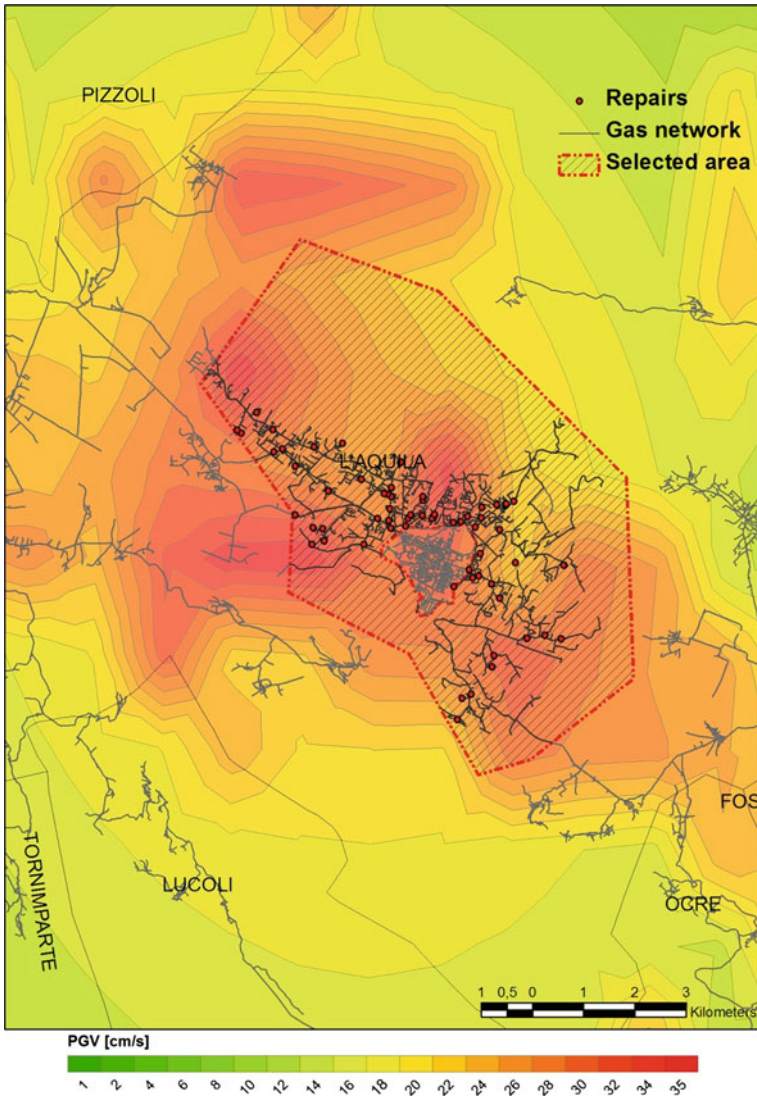
Fig. 8 Map of PGV (cm/s) relative to L'Aquila earthquake (superimposed to the gas network and repair data for the selected area)

Observed ground failure deformations (Vittori et al. 2011; Monaco et al. 2009) were also analyzed to understand their possible influence on the repair rate. Comparing earthquake-induced ground failure locations with the repair data points, it was concluded that in the analyzed area, namely Zone 1 (Fig. 8), none of the repairs was interested by ground deformations.
